Annual Inspection

Winchester City Council

Stratton Bates Recreation Ground (New Alresford)

Inspected: 11-March-2024 - 13:44 by Dom Park (RPII Annual Inspector)

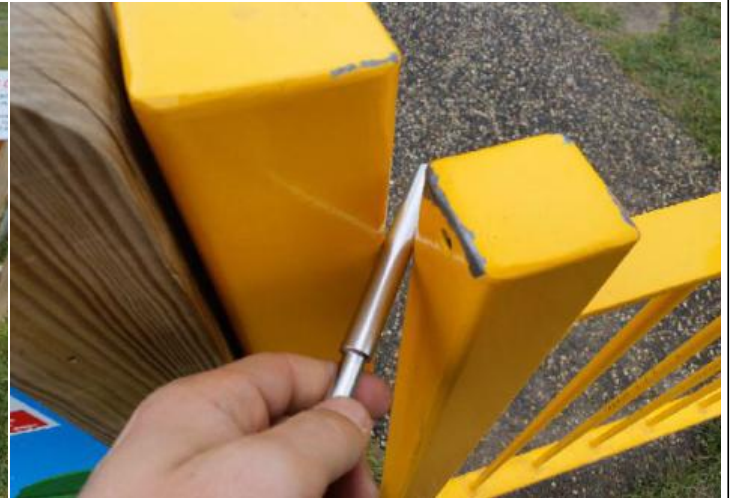
Item: Gates - Gate - Self Closing
Manufacturer: Not Identified

Finding: There are openings that are less than 12mm that could trap or crush fingers

Action: Provide a 12mm gap throughout full range of motion at both sides of gate

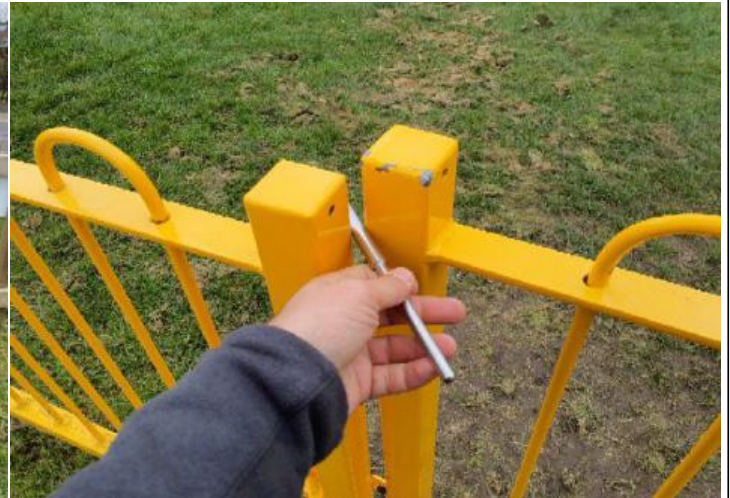
Item: Gates - Gate - Combination
Manufacturer: Not Identified

Finding: There are openings that are less than 12mm that could trap or crush fingers

Action: Provide a 12mm gap throughout full range of motion at both sides of gate

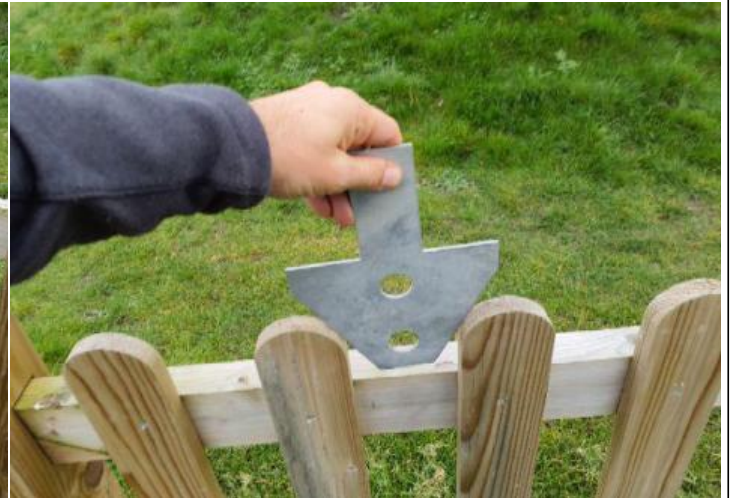
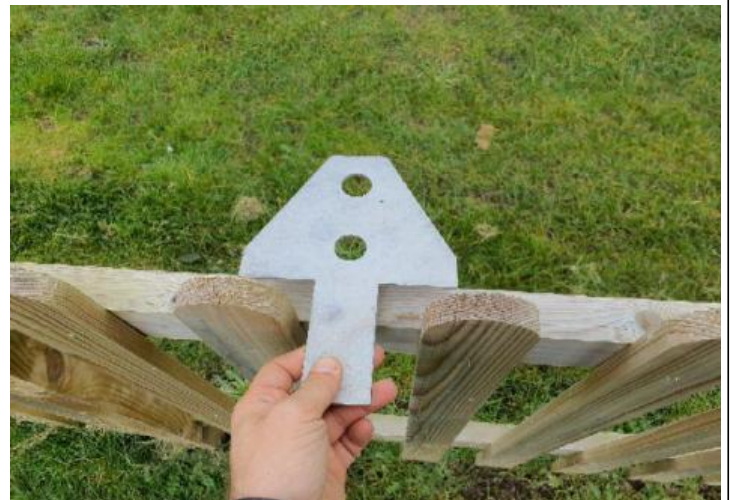
Item: Fences - Fencing - Timber
Manufacturer: Jacksons Fencing

Finding: There is a potential head and neck entrapment in the fence

Action: No further action required

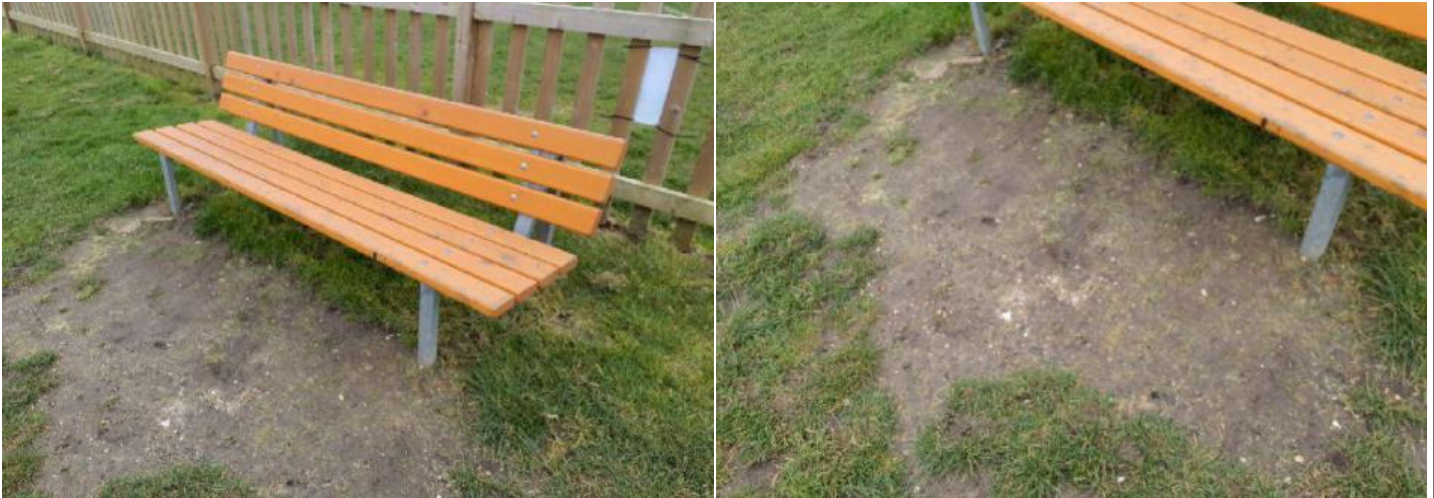
Item:	Ancillary Items - Bench	Risk Level:	L - Low Risk
Manufacturer:	Not Identified	Surface:	Grass

Finding: The area around the item has eroded and may become slippery	Action: Reinstate eroded area
---	--------------------------------------

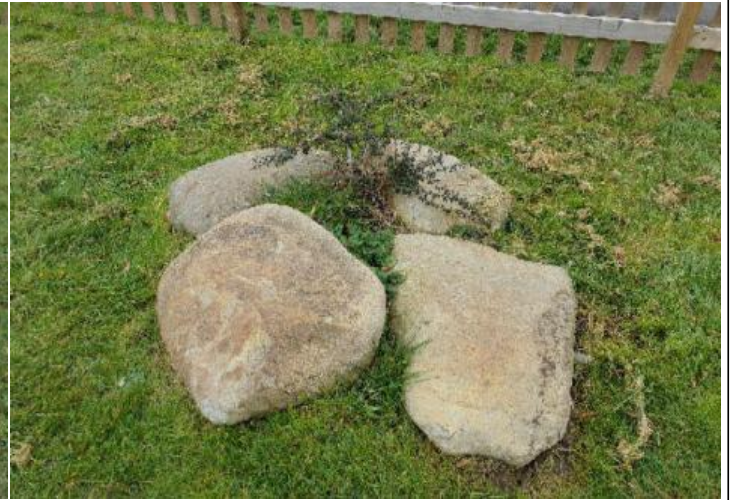
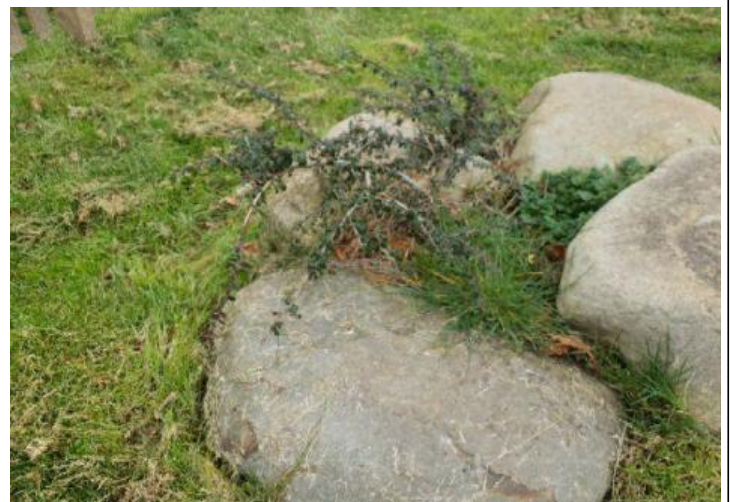
Item: Ancillary Items - Boulders
Manufacturer: Natural Feature

Finding: There is weed / vegetation growth on, between, or around the edges of the surfacing
Action: Remove weed / vegetation growth

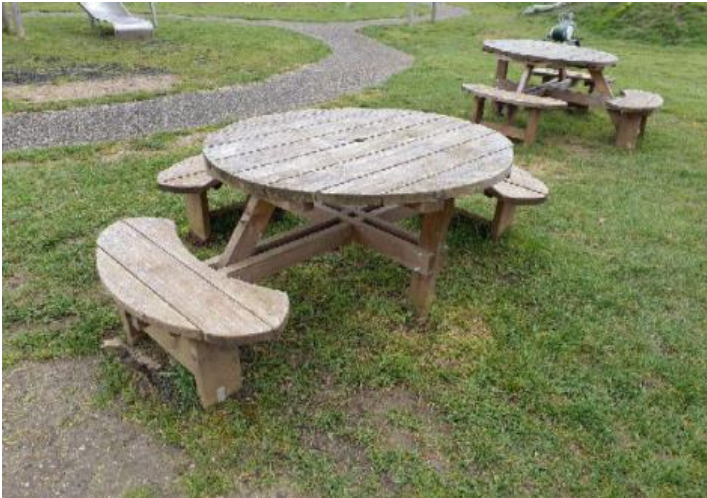
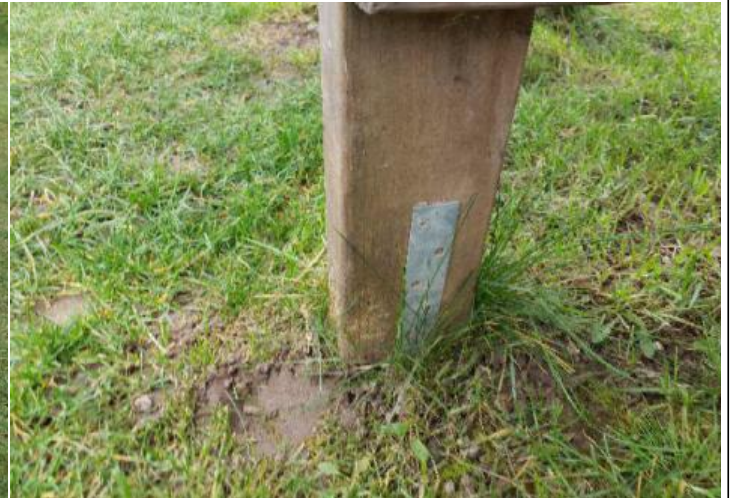
Item: Ancillary Items - Picnic Table
Manufacturer: Not Identified

Finding: There is or are fixings missing on the item

Action: Replace all missing fixings

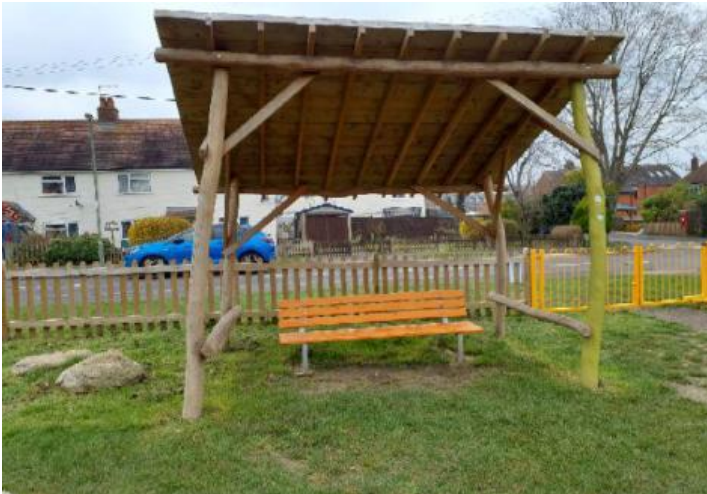
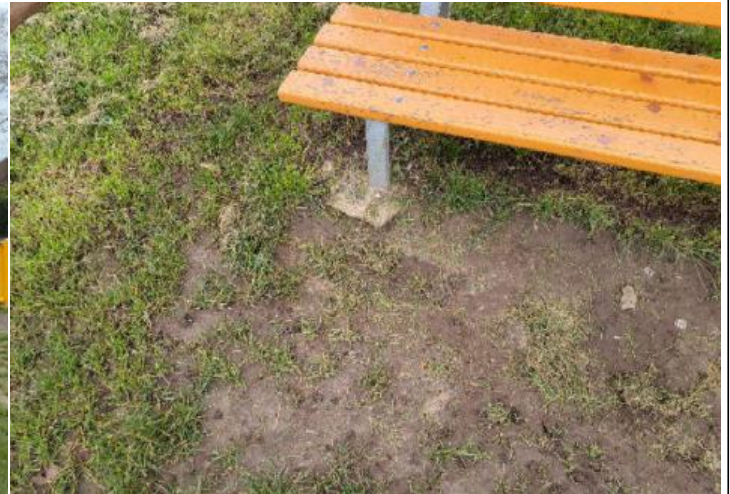
Item: Ancillary Items - Shelter
Manufacturer: Eibe Play Ltd

Finding: The surface has eroded and the foundations are exposed

Action: Reinstate surrounding surfaces to cover the foundations

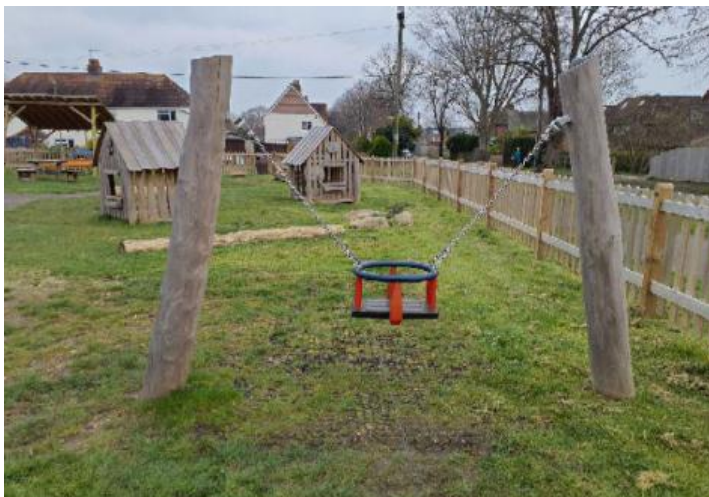
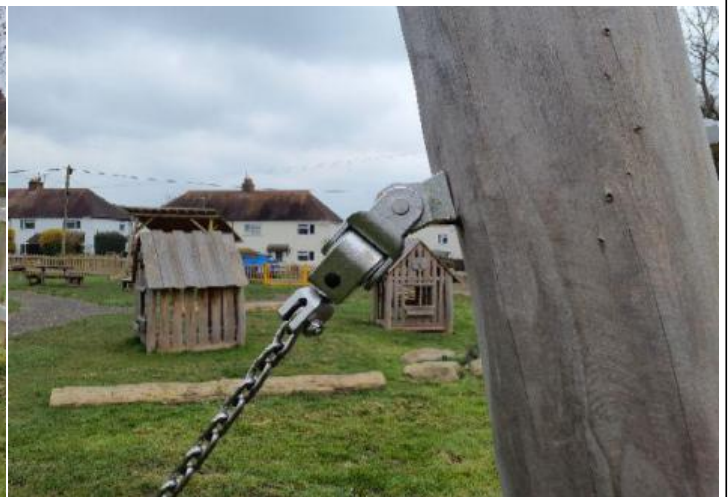
Item: Swings - 1 Bay 1 Seat (Cradle) - Type 1
Manufacturer: Eibe Play Ltd

Finding: This design of swing joint has been known to fail on the weld connecting the joint to the threaded stud

Action: We would recommend that the joint be dismantled and checked on a regular basis or consulting with manufacturer on whether a Secondary Safety Device can be fitted

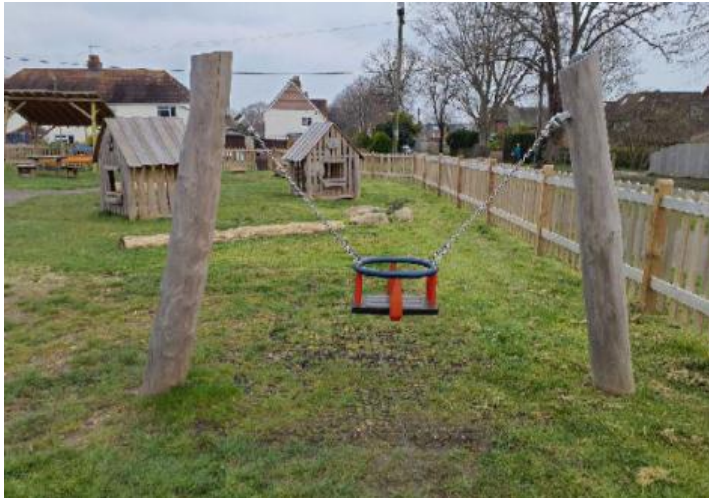
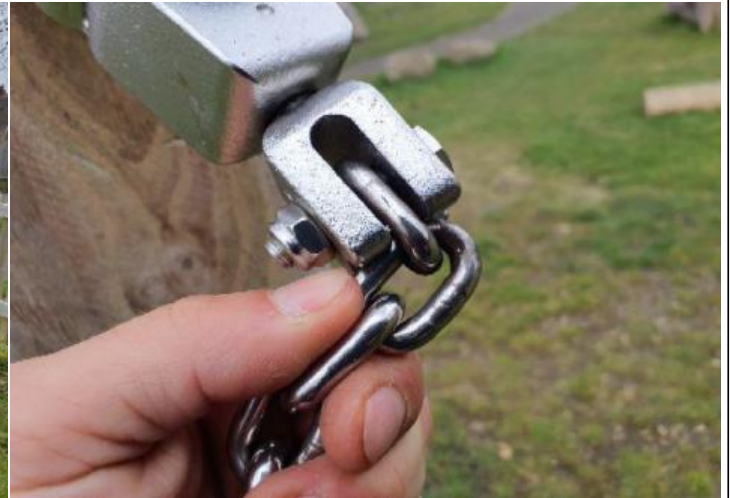
Item: Swings - 1 Bay 1 Seat (Cradle) - Type 1
Manufacturer: Eibe Play Ltd

Finding: There is some notable evidence of chain wear

Action: Monitor for any further deterioration and replace when 40% worn

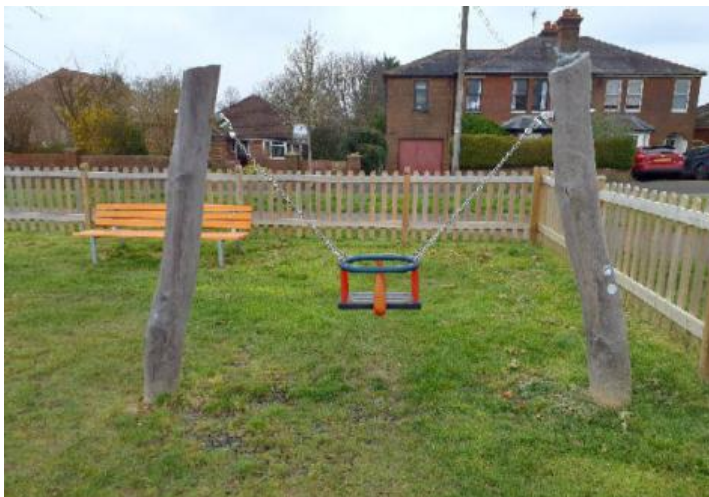
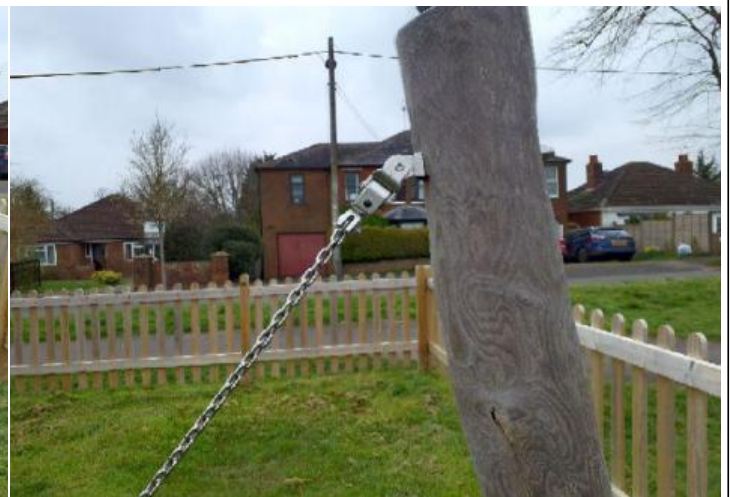
Item: Swings - 1 Bay 1 Seat (Cradle) - Type 1
Manufacturer: Eibe Play Ltd

Finding: This design of swing joint has been known to fail on the weld connecting the joint to the threaded stud

Action: We would recommend that the joint be dismantled and checked on a regular basis or consulting with manufacturer on whether a Secondary Safety Device can be fitted

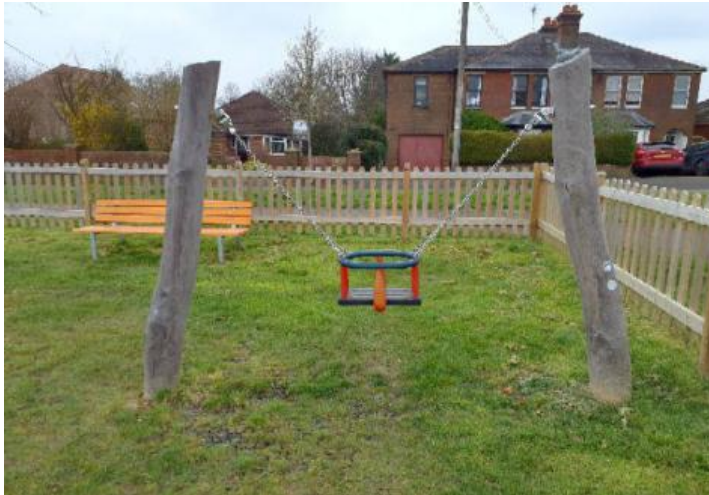
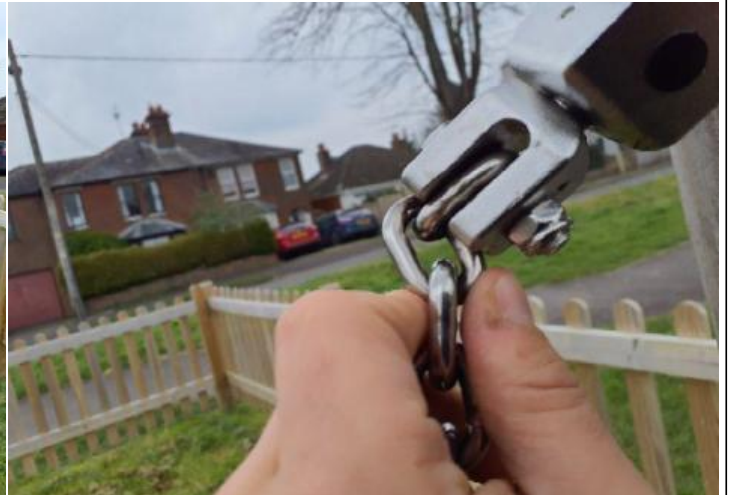
Item: Swings - 1 Bay 1 Seat (Cradle) - Type 1
Manufacturer: Eibe Play Ltd

Finding: There is some notable evidence of chain wear

Action: Monitor for any further deterioration and replace when 40% worn

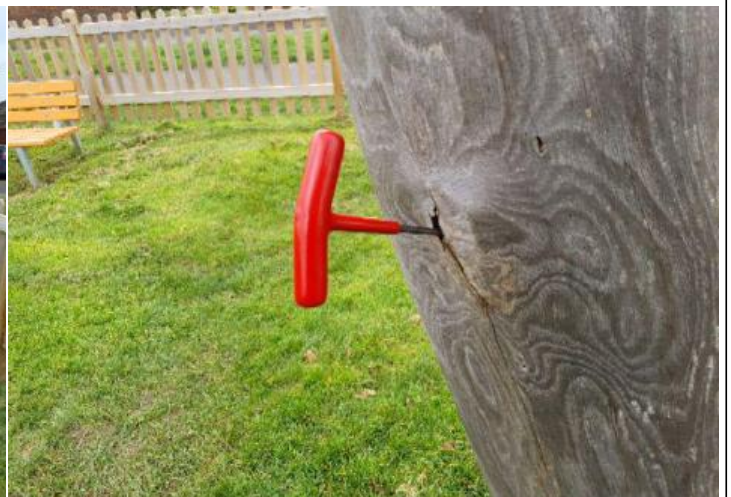
Item: Swings - 1 Bay 1 Seat (Cradle) - Type 1
Manufacturer: Eibe Play Ltd

Finding: There is a cavity in the timber

Action: Refer to manufacturer

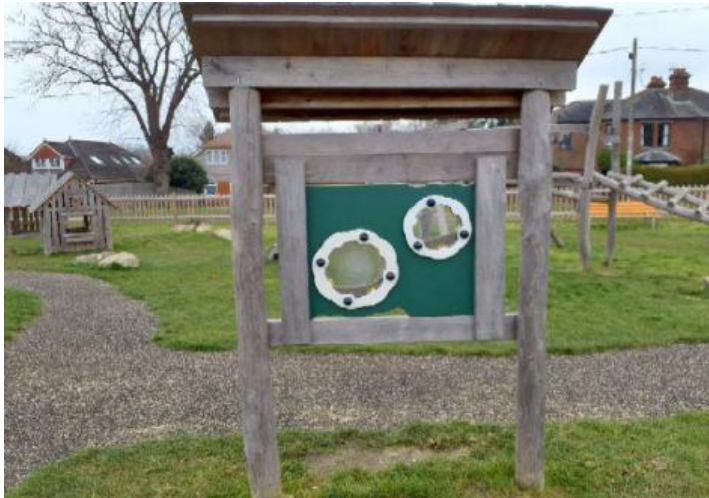
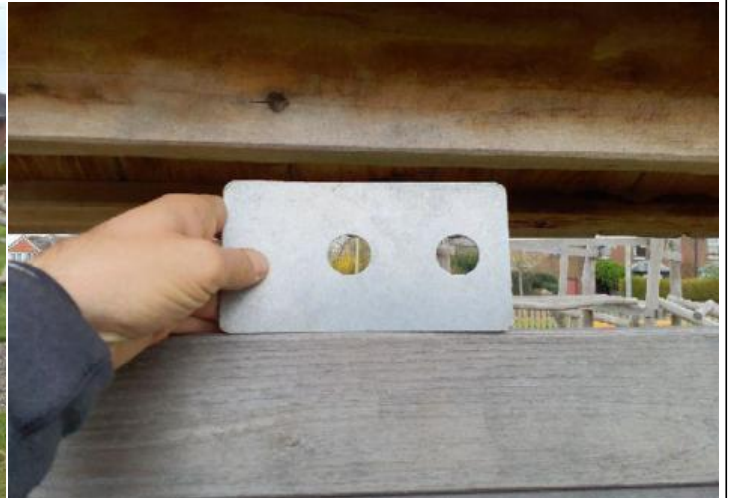
Item: Activity Equipment - Play Panel
Manufacturer: Eibe Play Ltd

Finding: The item fails to meet the requirements of BS EN 1176 Part 1 4.2.7.2 for head and neck entrapment in the structure

Action: Monitor - No remedial work recommended

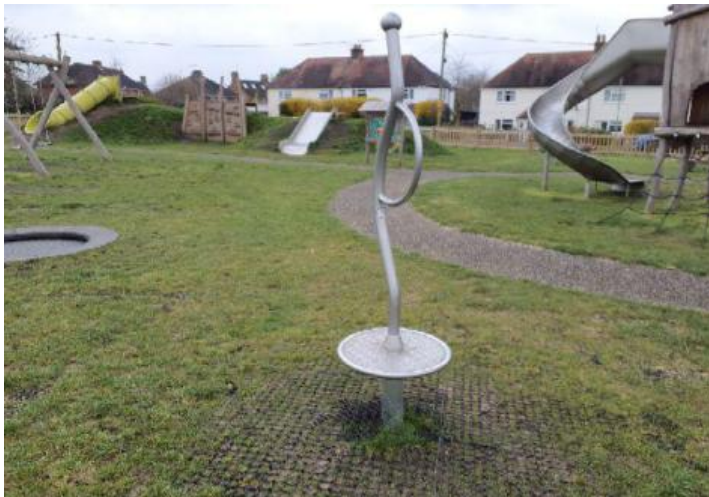
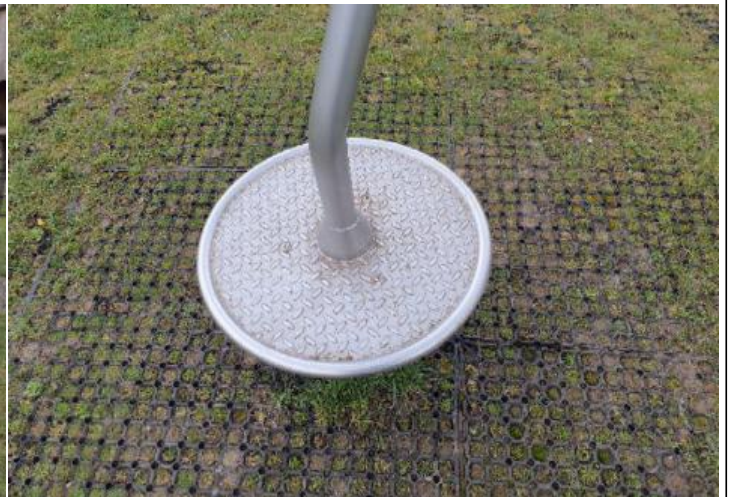
Item: Rotor Play - Spinning Pole
Manufacturer: Not Identified

Finding: The bearing is showing signs of wear

Action: Monitor for any further deterioration and replace as required

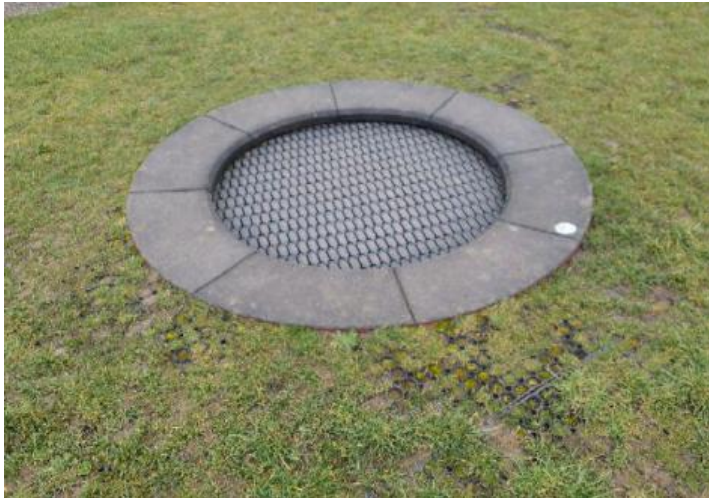
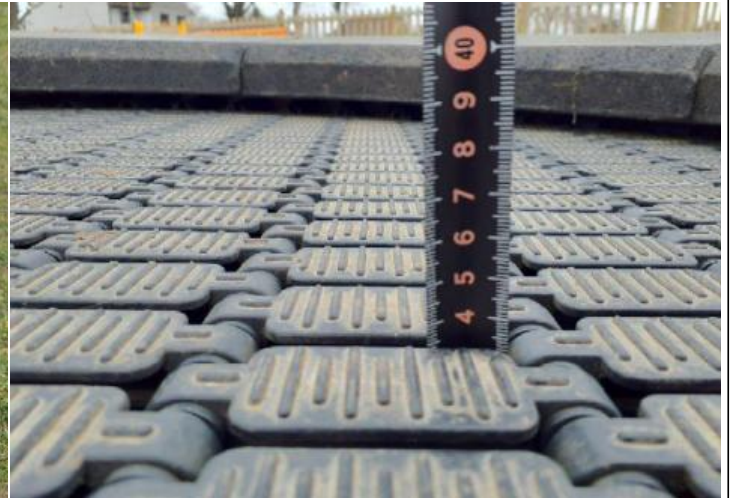
Item: Other - Bouncing Facility
Manufacturer: Seilfabrik Ullmann

Finding: On site visits it is not possible to test the ground clearance of the Bouncing Facility bed as specified in BS EN 1176; ensure that the clearance between the Bouncing Facility Bed and the ground underneath is in accordance with the manufacturers recommendations (recorded nominal depth at time of inspection 330mm measured unloaded).

Action: Refer to the manufacturers recommendations

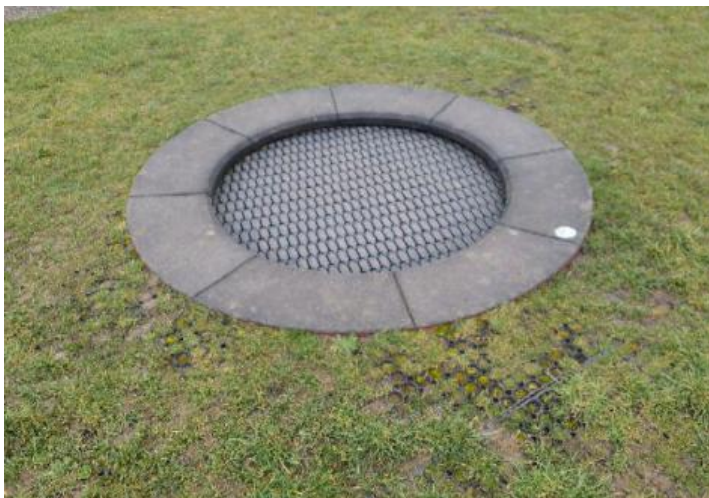
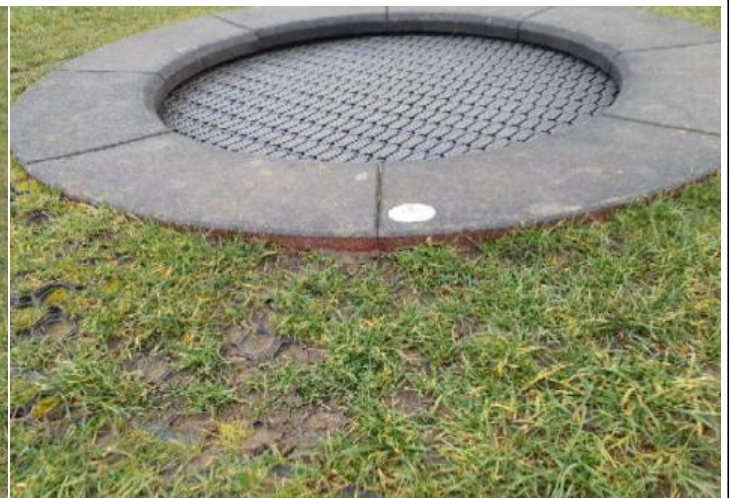
Item: Other - Bouncing Facility
Manufacturer: Seilfabrik Ullmann

Finding: There are trip hazards present

Action: Reinststate surrounding surfaces to level to remove the trip points

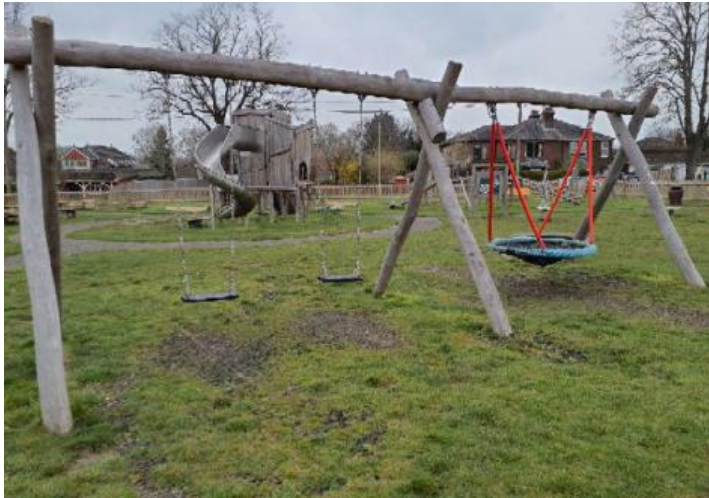
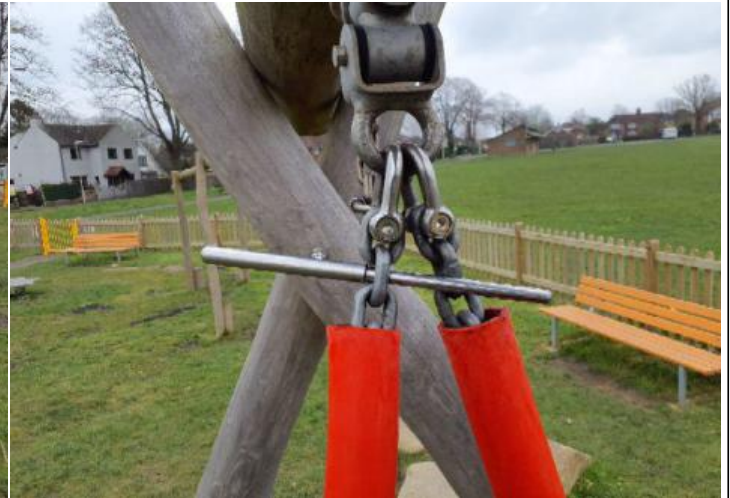
Item: Swings - 2 Bay 2 Flat 1 Basket Seat
Manufacturer: Eibe Play Ltd

Finding: The chain openings are in excess of the 8.6mm as recommended by BS EN 1176 **Action:** Monitor - No remedial work recommended

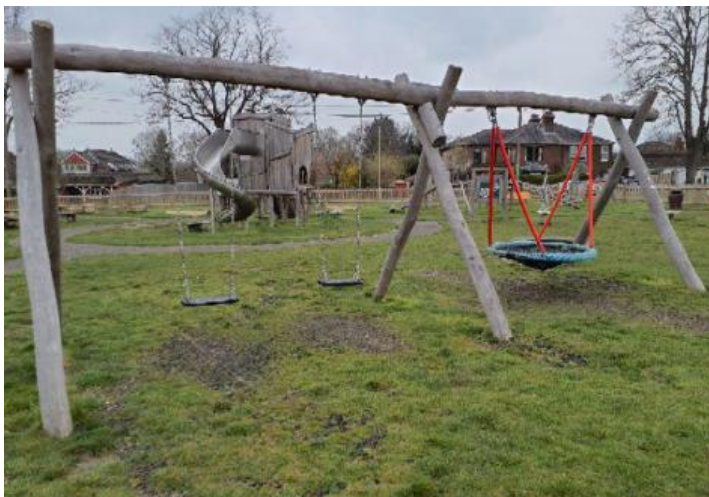
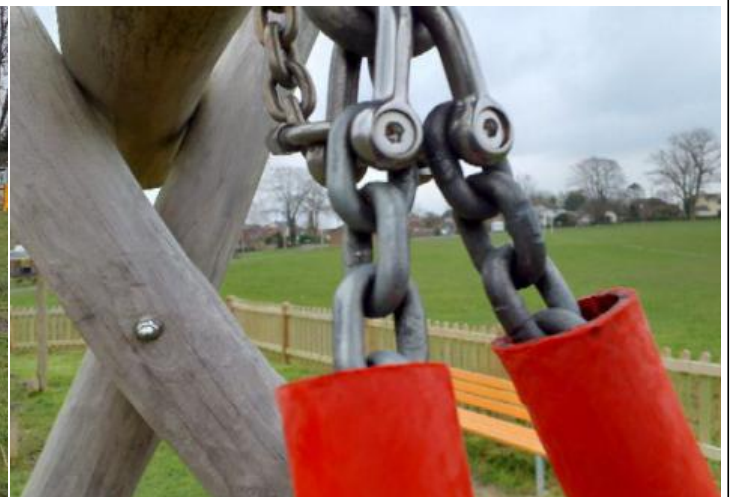
Item: Swings - 2 Bay 2 Flat 1 Basket Seat
Manufacturer: Eibe Play Ltd

Finding: The chain openings are in excess of the 8.6mm as recommended by BS EN 1176 **Action:** Monitor - No remedial work recommended

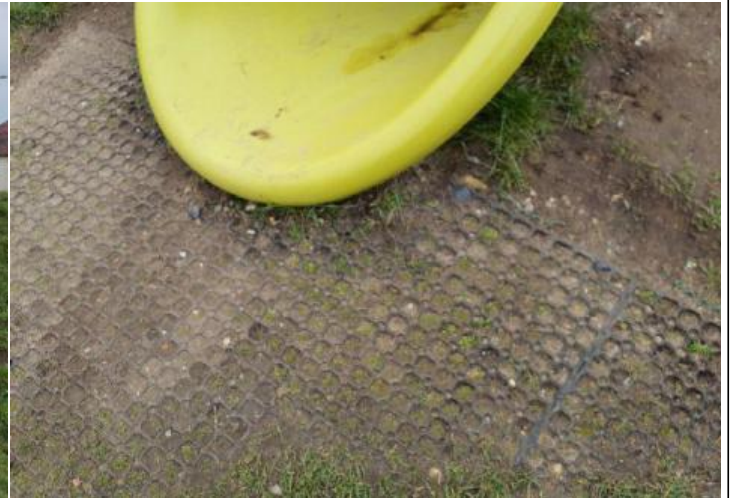
Item: Other - Tube Slide
Manufacturer: Eibe Play Ltd

Finding: Fixing Pins have been installed in the impact areas of the grass mats
Action: Remove pins from impact areas

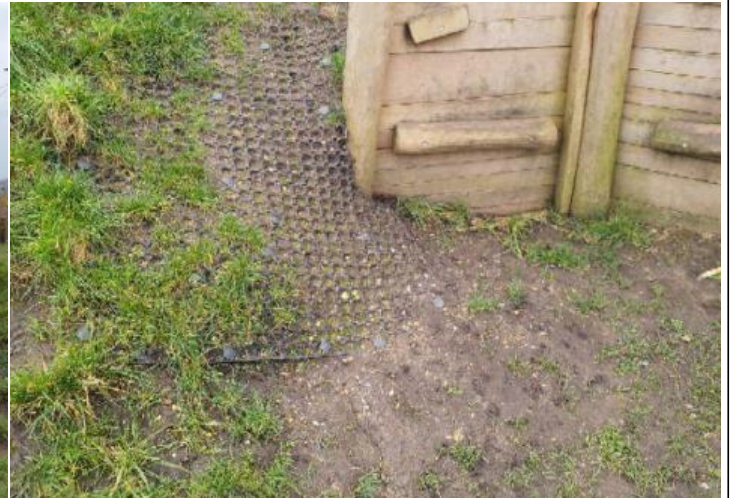
Item: Activity Equipment - Climbing Wall
Manufacturer: Eibe Play Ltd

Finding: Fixing Pins have been installed in the impact areas **Action:** Remove pins from impact areas of the grass mats

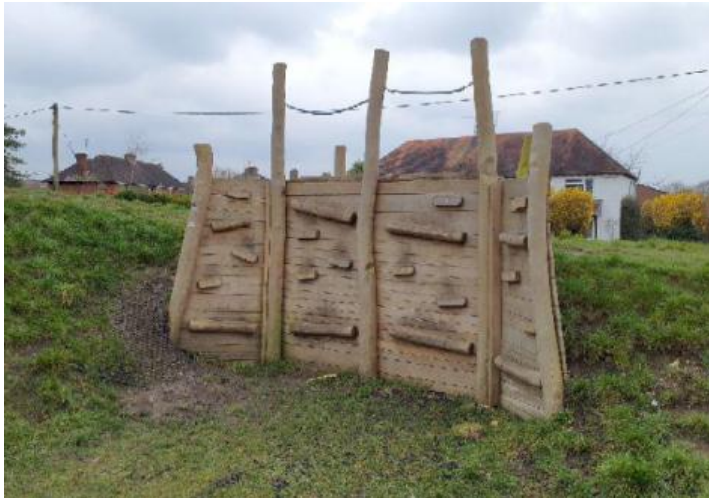
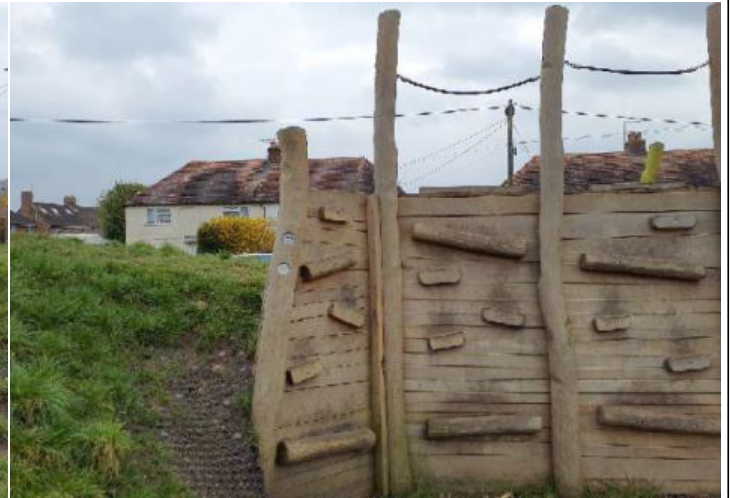
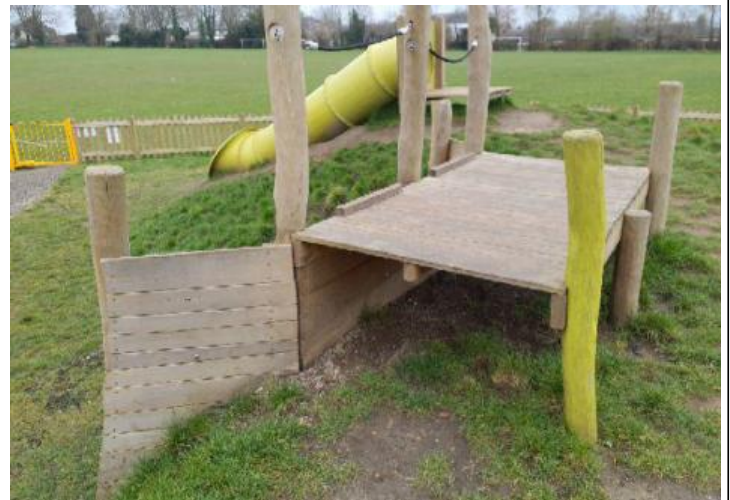
Item: Activity Equipment - Climbing Wall
Manufacturer: Eibe Play Ltd

Finding: There is an opening in the barriers exceeding the width allowed (500mm) in BS EN 1176, this is a low risk failure and no remedial action is required

Action: Monitor - No remedial work recommended

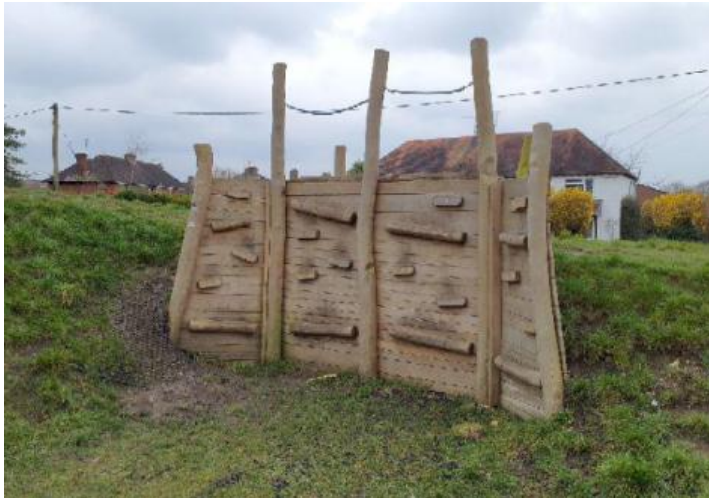
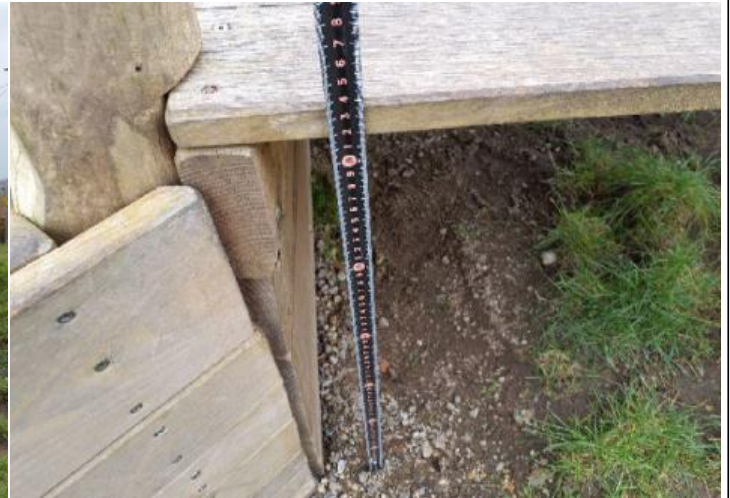
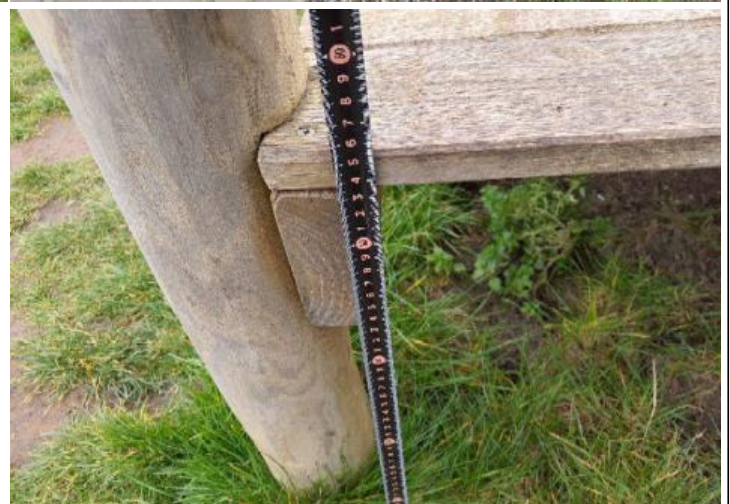
Finding: The unit is easily accessible and should have the appropriate barriers installed to meet the requirements of BS EN 1176 Part 1 as the height of the unit exceeds 600mm

Action: Monitor - No remedial work recommended

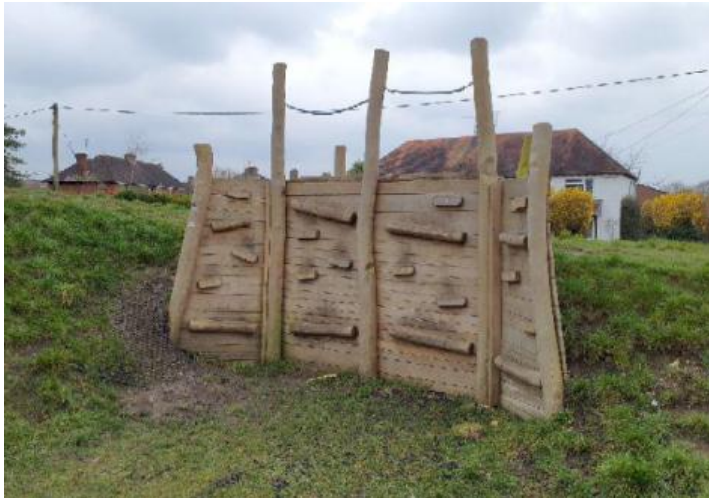
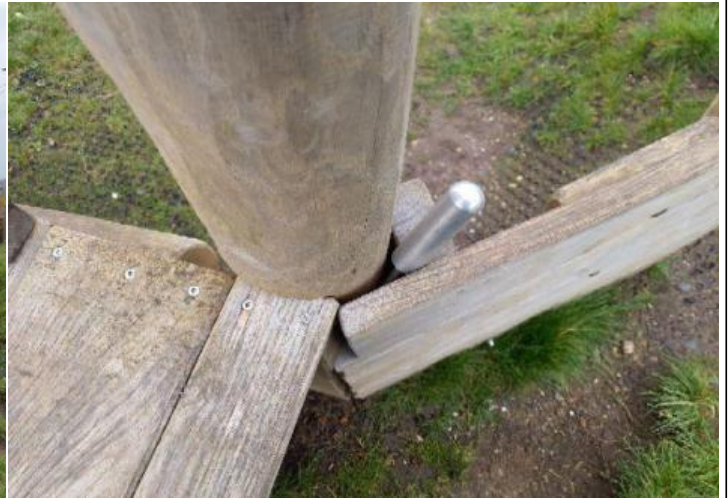
Finding: There is/are finger entrapment/s in the structure and the item fails to meet the requirements of BS EN 1176 Part 1 4.2.7.6 Entrapment of fingers

Action: Monitor - No remedial work recommended

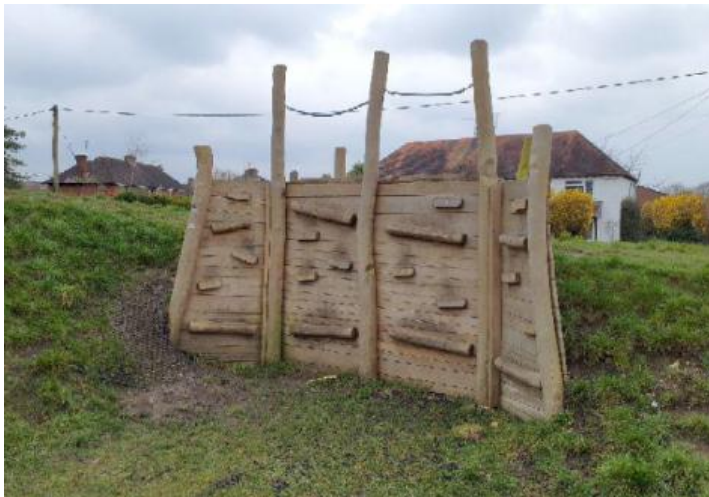
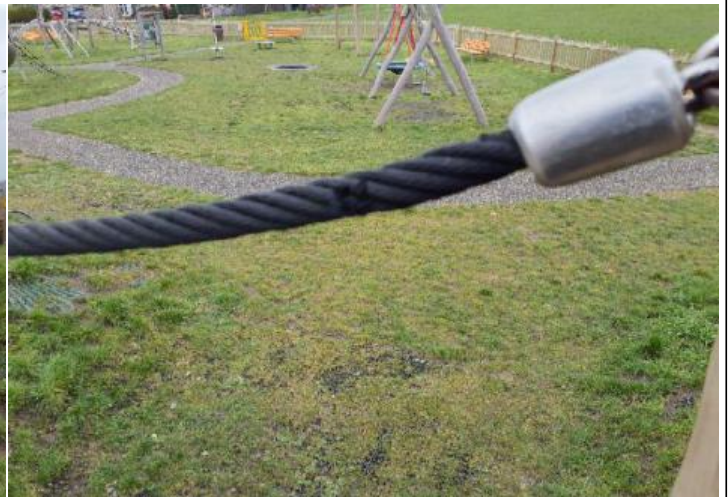
Finding: The ropes/nets are worn/damaged in places

Action: Monitor for any further deterioration and repair or replace as required

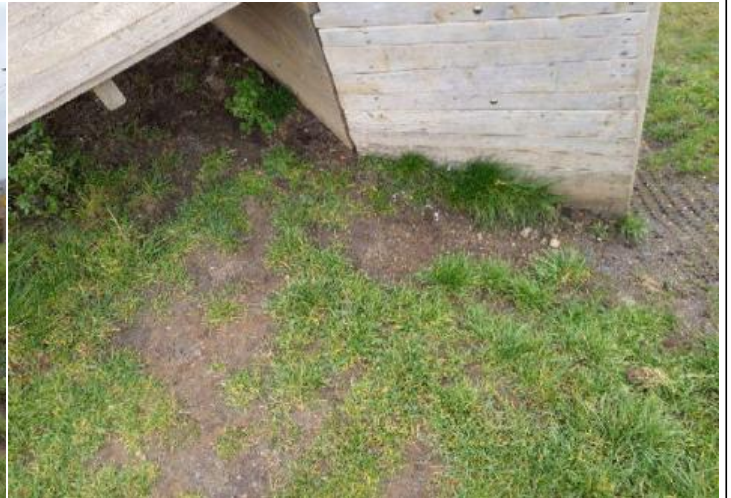
Finding: The area around the item has eroded and may become slippery

Action: Reinstate eroded area

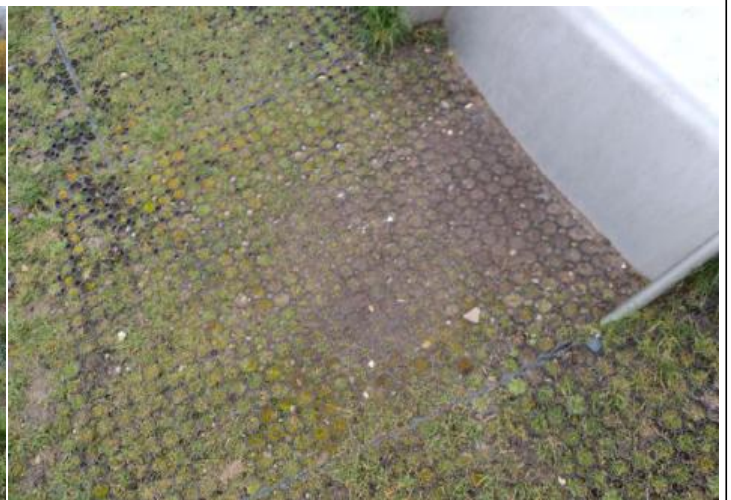
Finding: Fixing Pins have been installed in the impact areas of the grass mats

Action: Remove pins from impact areas

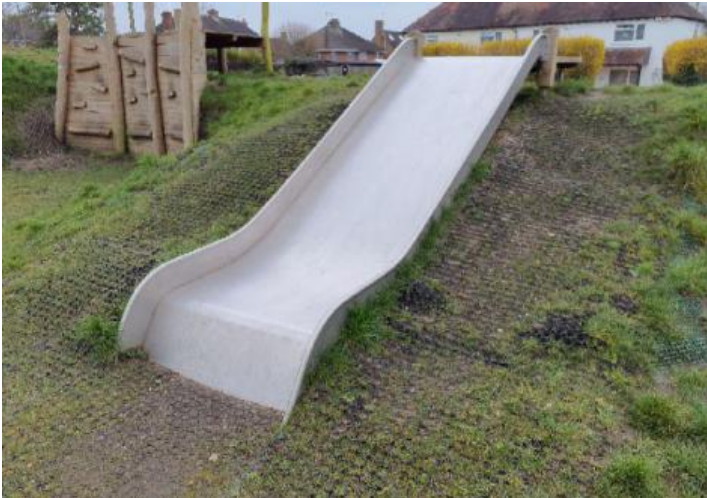
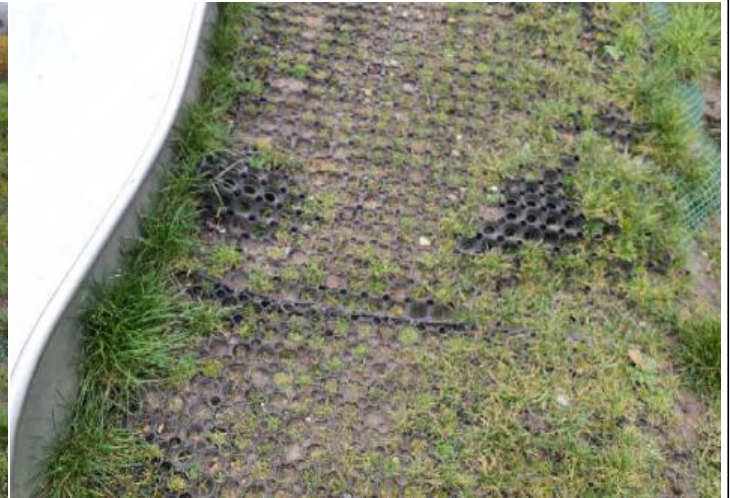
Finding: The grass matrix tiles have buckled in places, causing trip hazards

Action: Provide additional ties or secure / reinstate surface

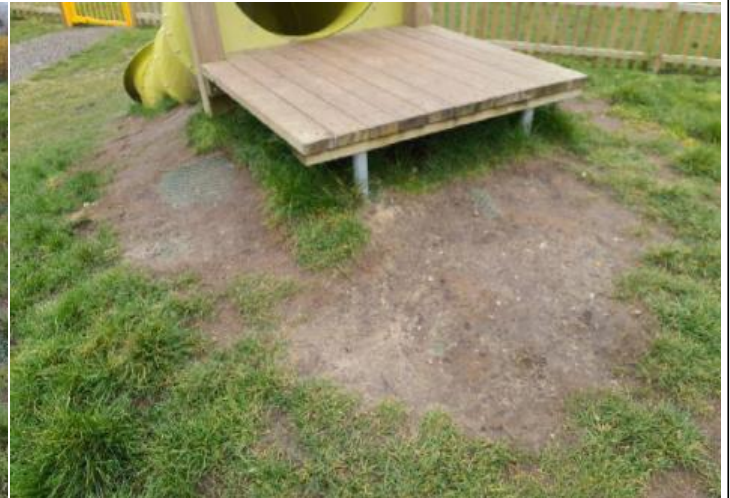
Finding: The area around the item has eroded and may become slippery

Action: Reinstate eroded area

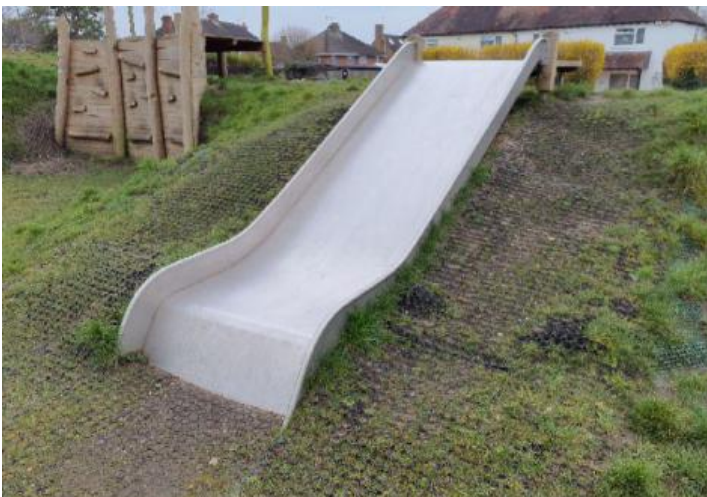
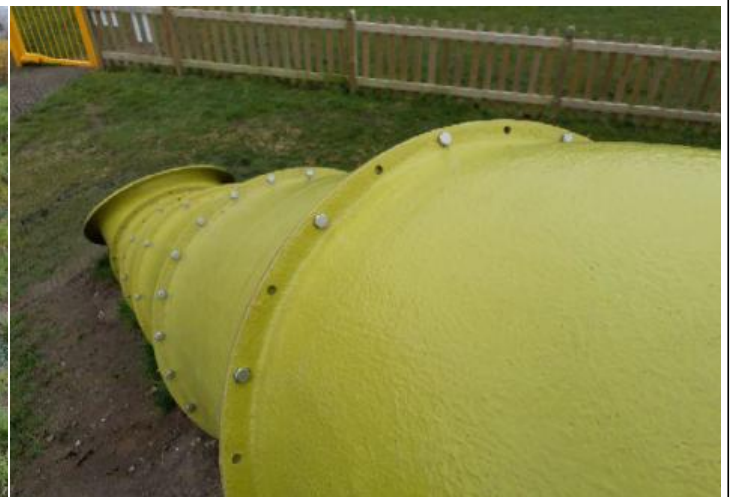
Finding: There are unused fixing holes on the item

Action: Replace as required

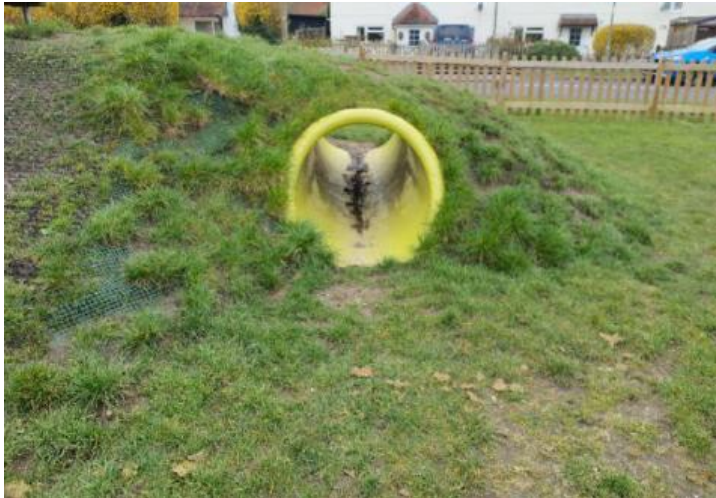
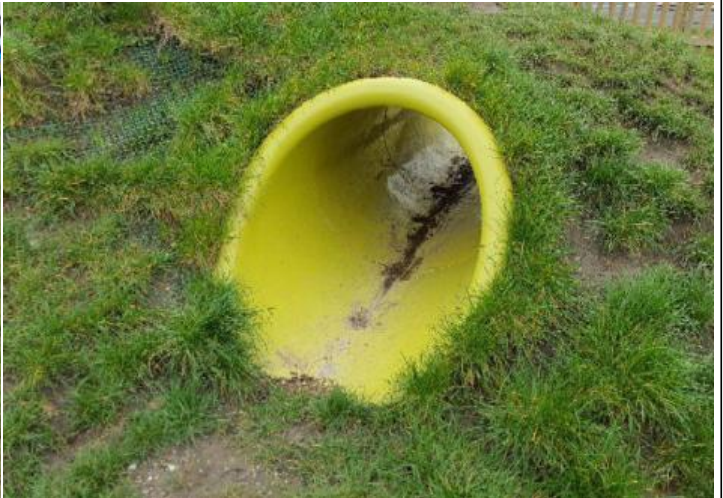
Finding: This design / configuration of tunnel mound is well established and has been successfully included in large quantities of playgrounds throughout the UK. Whilst the design does not fully meet the requirements of BS EN 1176 with regards to falls in excess of 600mm over the edge of the tunnel to the surface below, it has been risk assessed as fit for purpose in this regard and no changes are recommended to the design unless otherwise stated in additional findings

Action: Monitor - No remedial work recommended

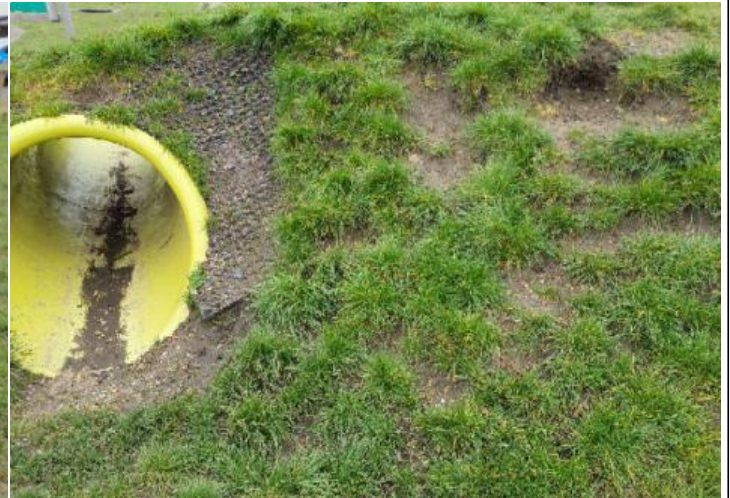
Item: Other - Tunnel Mound
Manufacturer: Eibe Play Ltd
Risk Level: L - Low Risk
Surface: Grass

Finding: The area around the item has eroded and may become slippery

Action: Reinststate eroded area

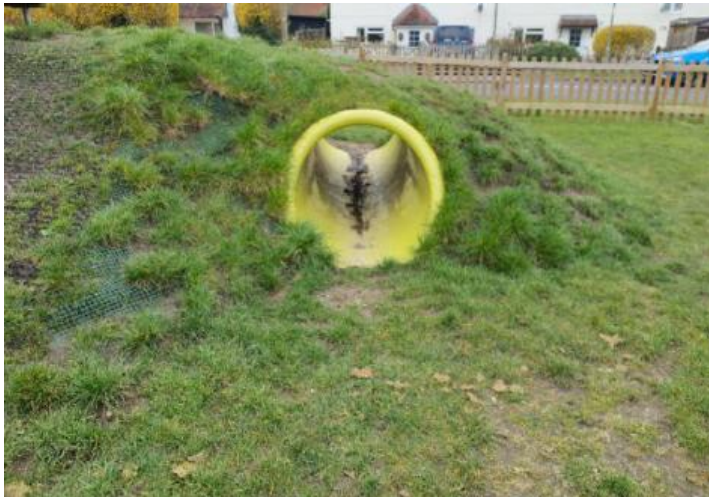
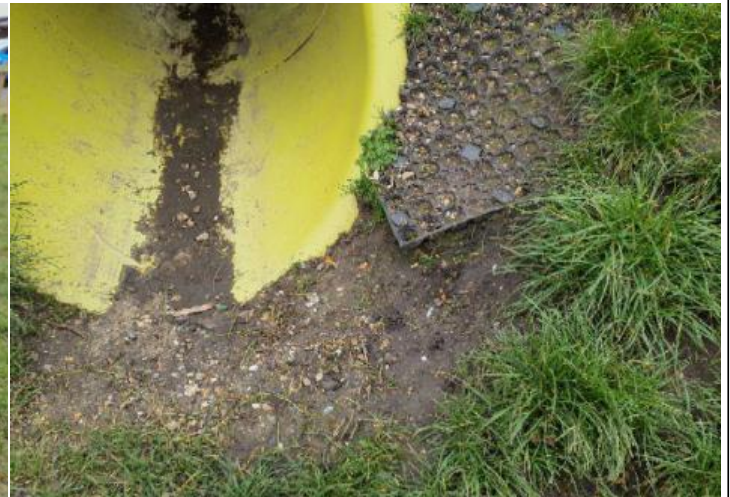
Item: Other - Tunnel Mound
Manufacturer: Eibe Play Ltd
Risk Level: L - Low Risk
Surface: Grass

Finding: The edges of the grass mat surface are raised / lifting above the surrounding surface

Action: Tuck in or pin edges of grass mats as per the API Code of Practice to remove trip hazards

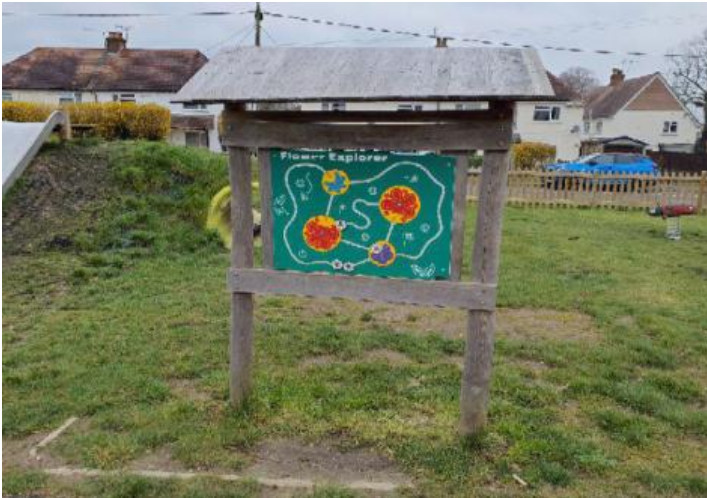
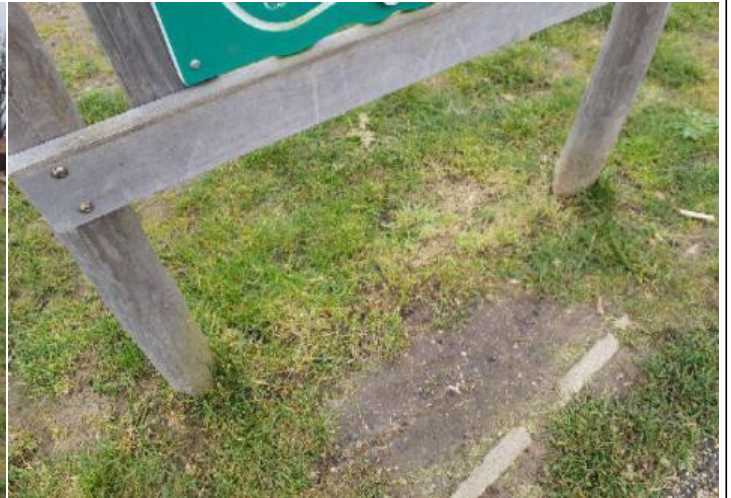
Finding: The item is slightly loose in its foundations

Action: Monitor for any further deterioration and repair as required
