Annual Inspection

Winchester City Council

Stratton Bates Recreation Ground (New Alresford)

Inspected: 11-March-2024 - 13:44 by Dom Park (RPII Annual Inspector)

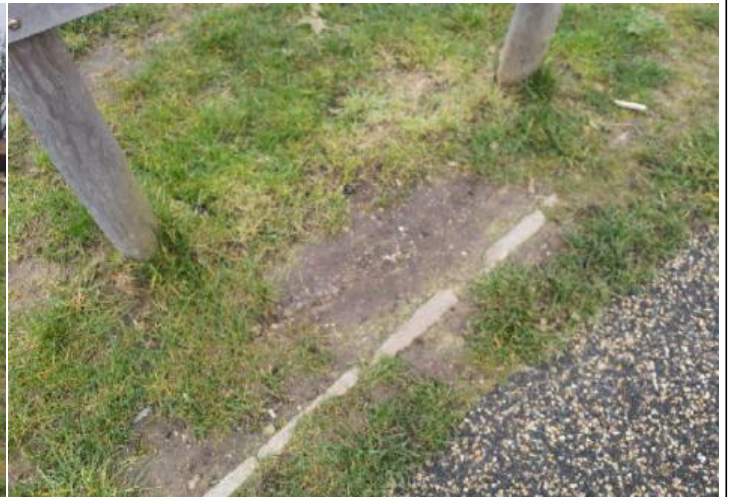
Finding: The area around the item has eroded and may become slippery

Action: Reinstate eroded area

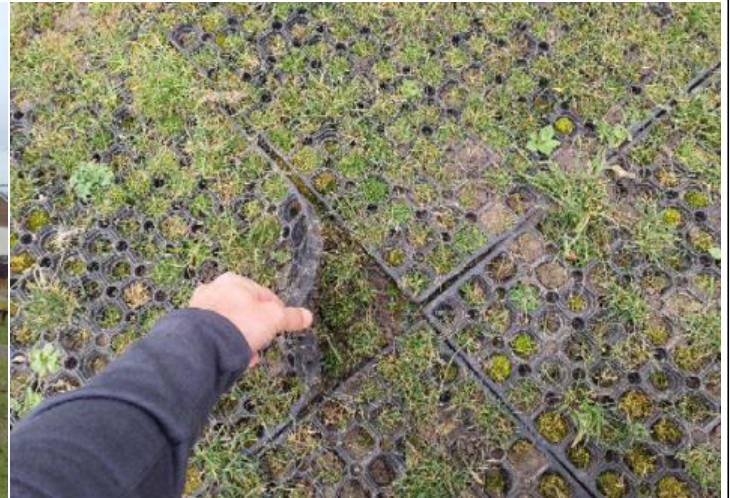
Finding: There are gaps opening between the grass mat tiles

Action: Provide additional ties or secure / reinstate surface

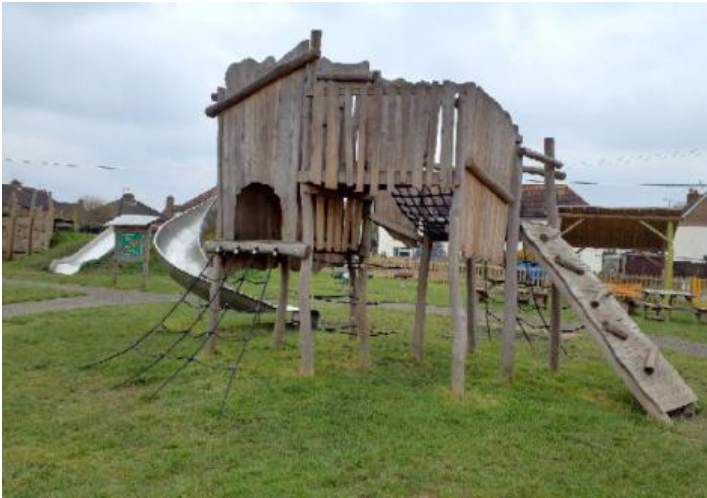
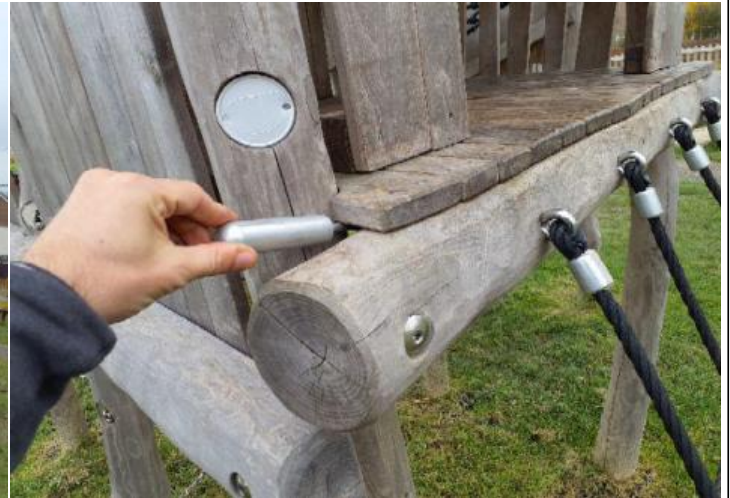
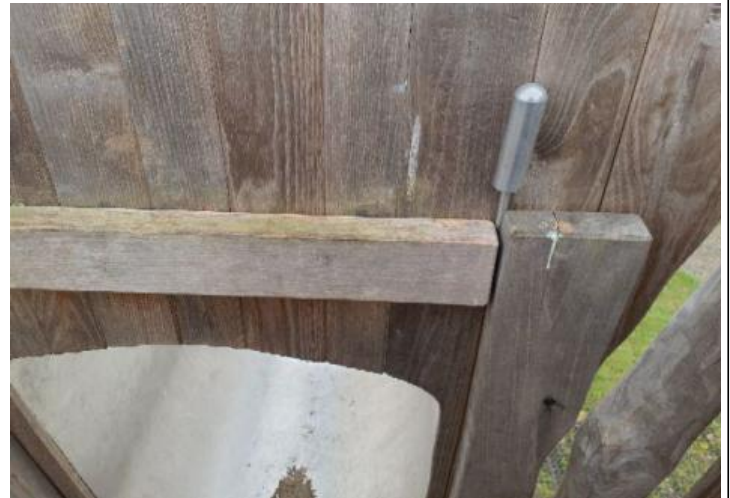
Finding: There is/are finger entrapment/s in the structure and the item fails to meet the requirements of BS EN 1176 Part 1 4.2.7.6 Entrapment of fingers

Action: Monitor - No remedial work recommended

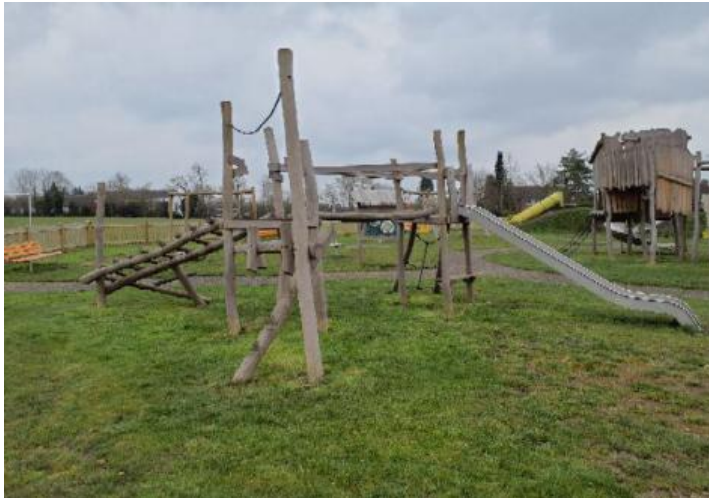
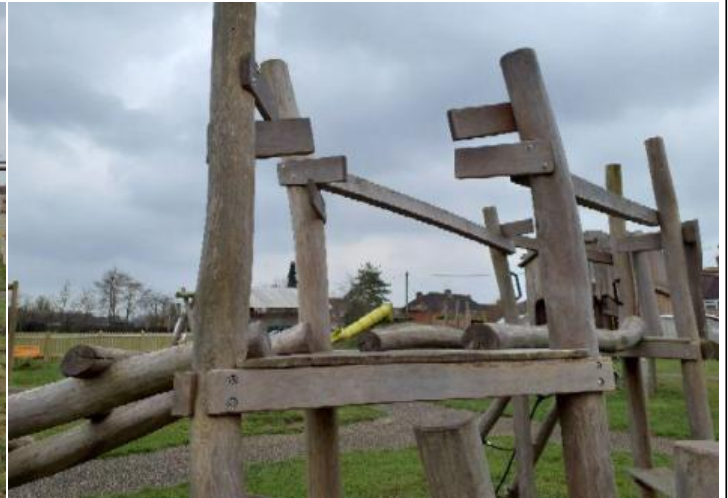
Finding: There is an opening in the barriers exceeding the width allowed (500mm) in BS EN 1176, and no guardrail has been provided; this is a low risk failure and no remedial action is required

Action: Refer to the manufacturer

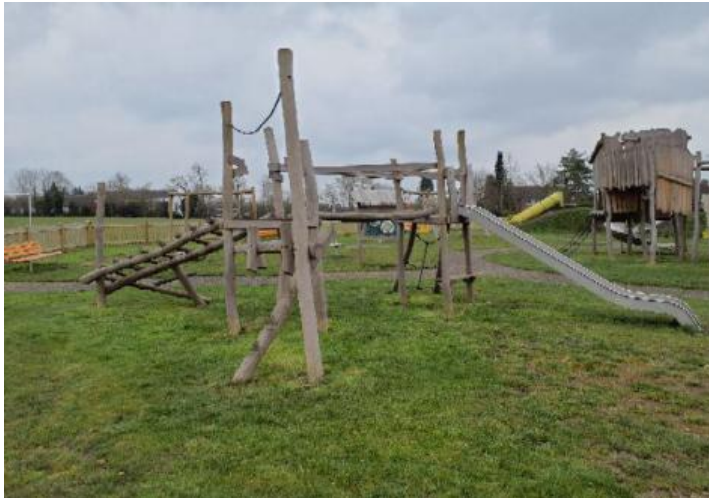
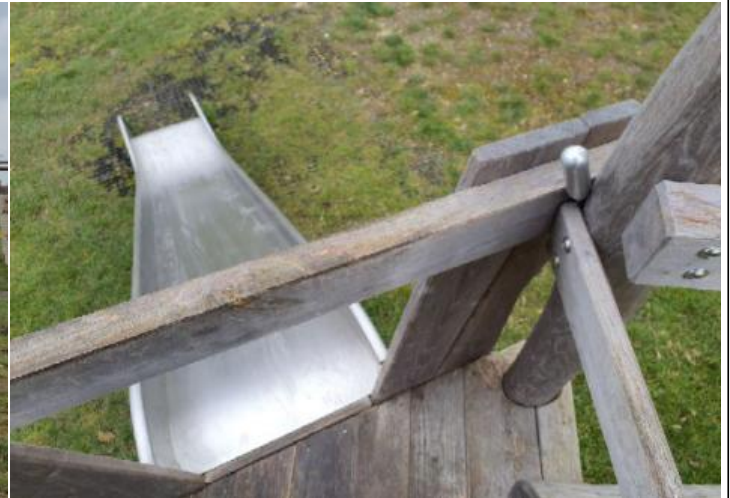
Finding: There is/are finger entrapment/s in the slide starting section and the item fails to meet the requirements of BS EN 1176 Part 1 4.2.7.6 Entrapment of fingers

Action: Monitor - No remedial work recommended
