## Annual Inspection

Winchester City Council

Stratton Bates Recreation Ground (New Alresford)

Grange Road, Alresford, SO24 9HF

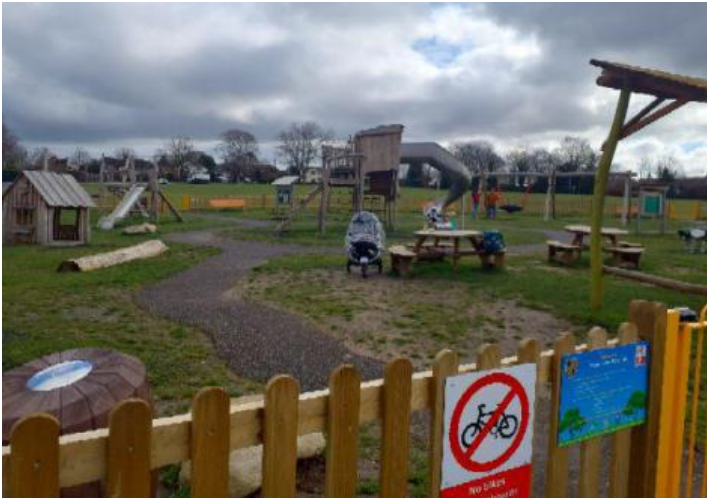
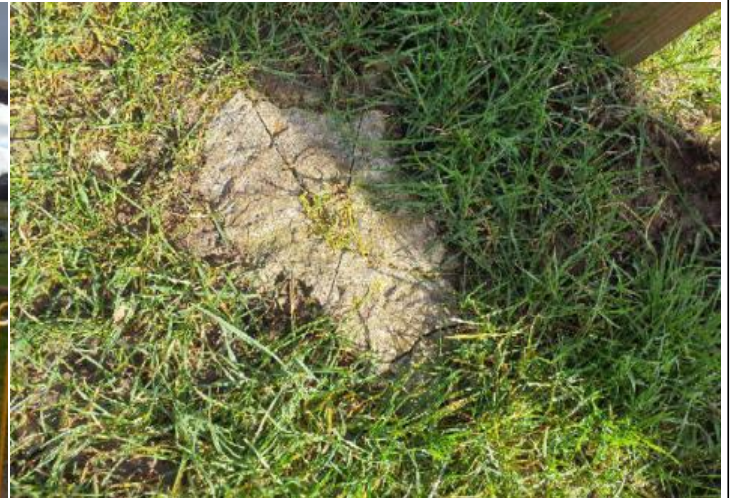
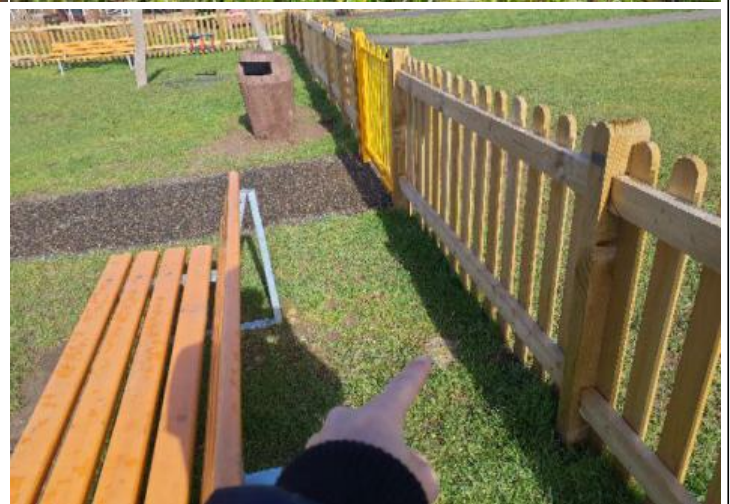
**Finding:** The surface has eroded and the foundations are exposed

**Action:** Reinstate surrounding surfaces to cover the foundations

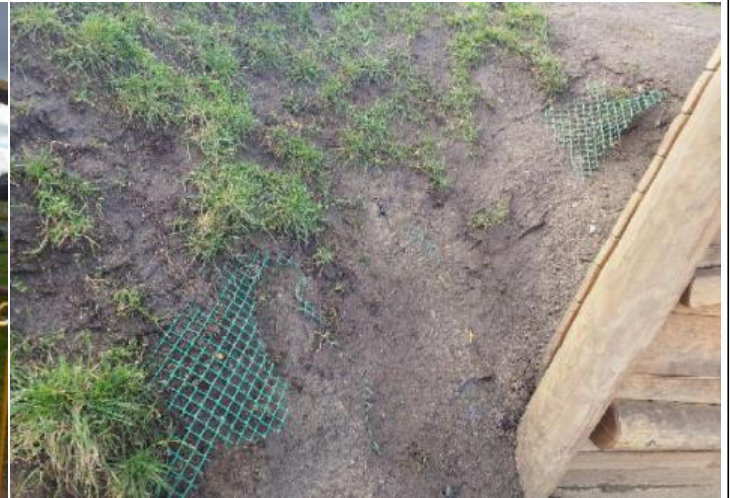
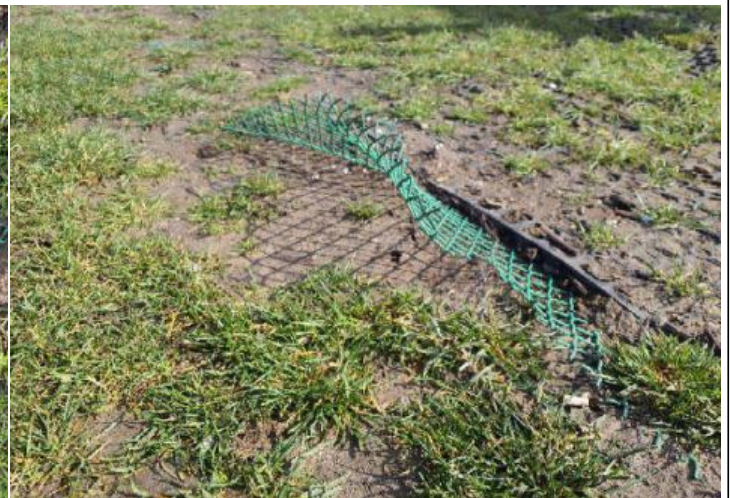
**Finding:** The safety surface is low and the membrane is exposed creating trip points throughout the site

**Action:** Remove or resecure the exposed membrane

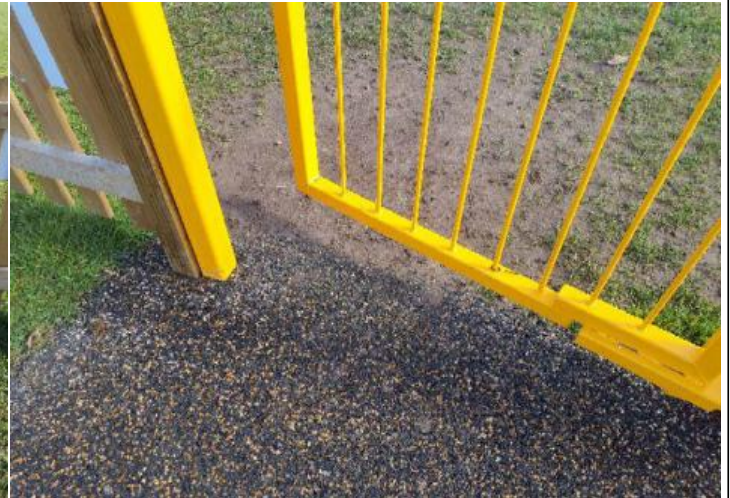
**Finding:** The area around the item has eroded and may become slippery

**Action:** Reinststate eroded area

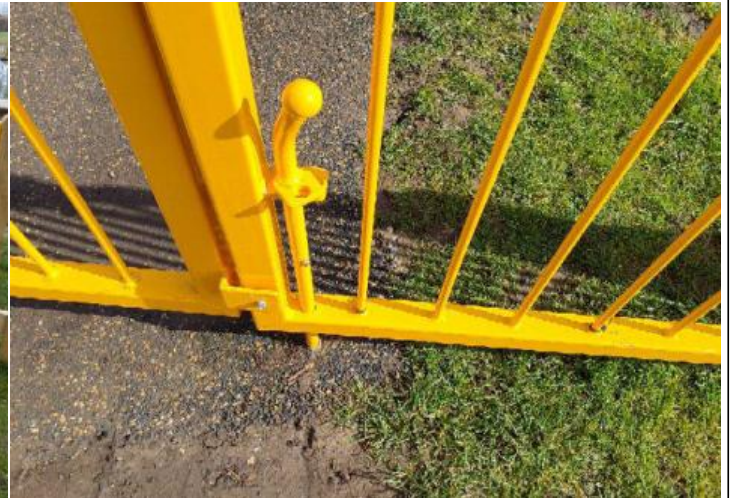
**Finding:** There is no padlock on the maintenance gate

**Action:** Provide a padlock to secure the gate

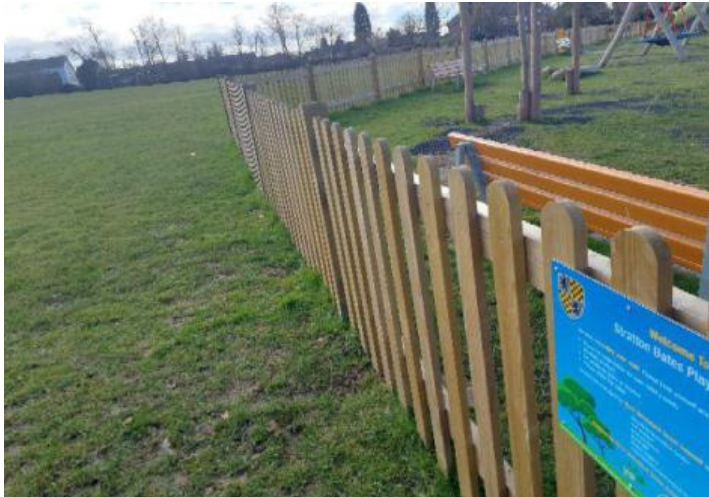
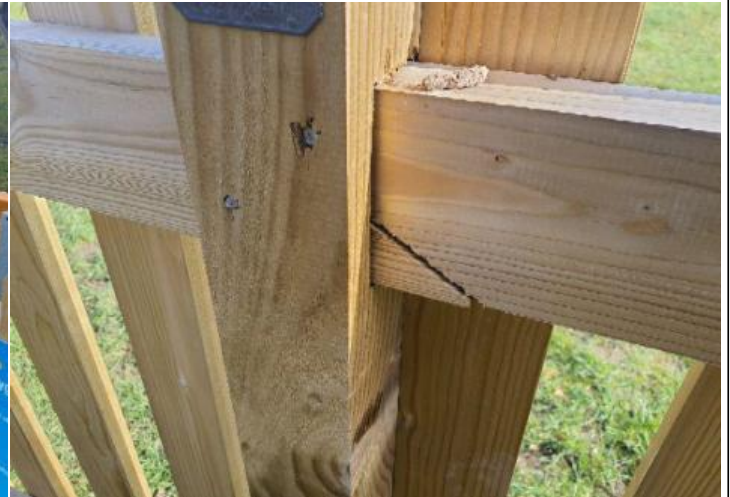
There is some damage to the fence sections - Monitor for any further deterioration and repair as required

**Finding:** There is some damage to the fence sections

**Action:** Monitor for any further deterioration and repair as required

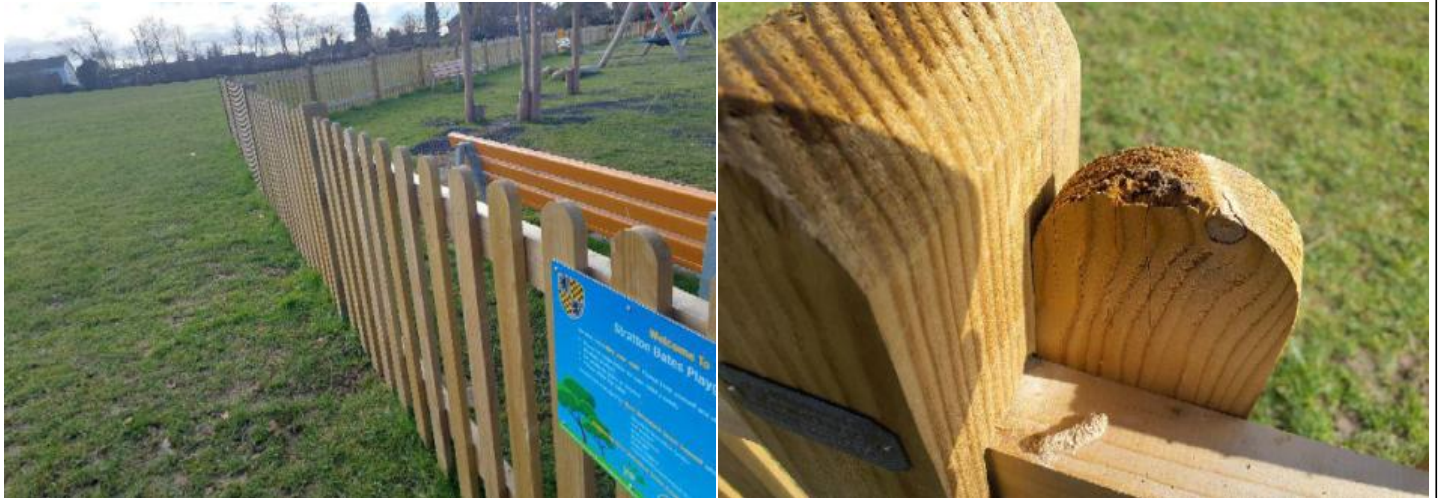
**Finding:** Parts of the timber are rough or splintered

**Action:** Remove all rough or sharp edges

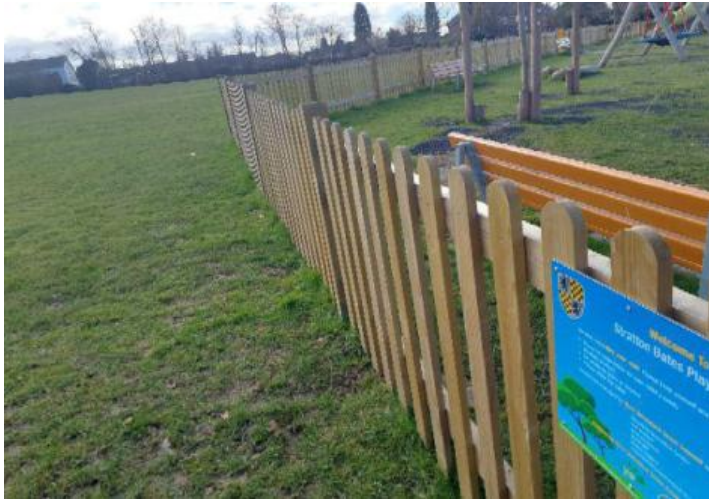
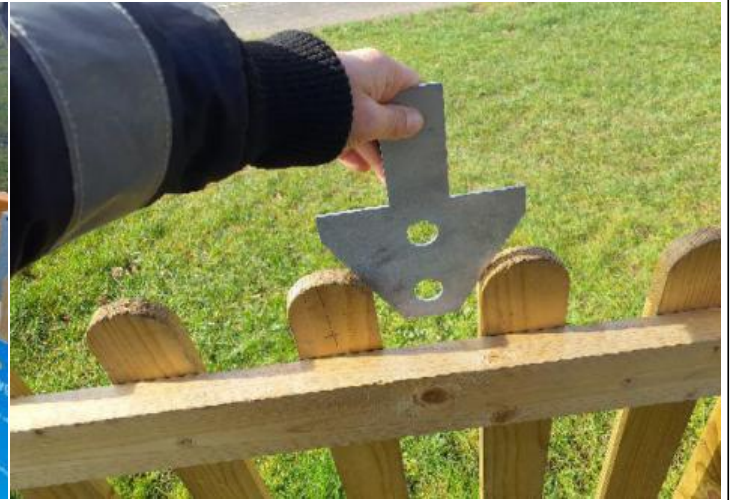
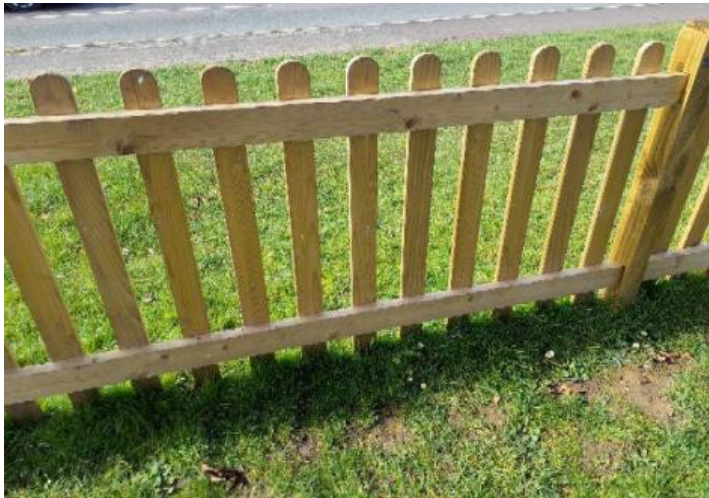
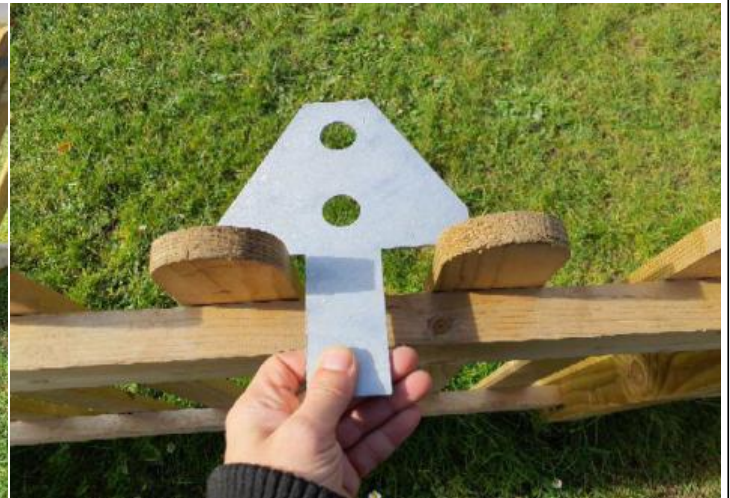
The item fails to meet the requirements of BS EN 1176 Part 1 4.2.7.2 for head and neck entrapment in the fence - No further action required

**Finding:** The item fails to meet the requirements of BS EN 1176 Part 1 4.2.7.2 for head and neck entrapment in the fence

**Action:** No further action required

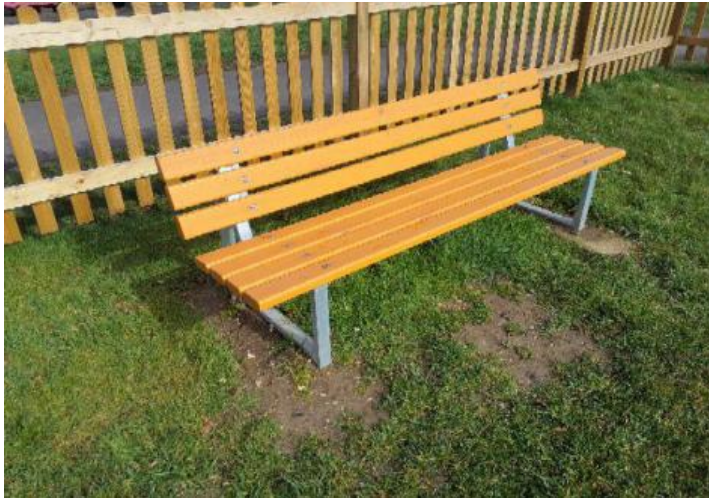
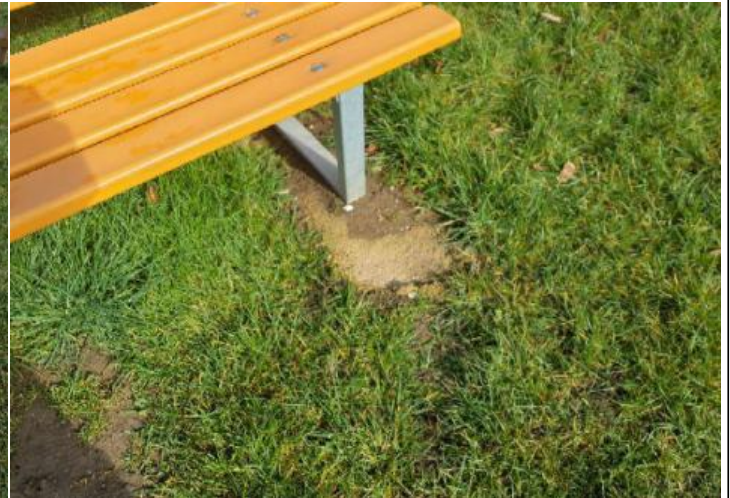
**Finding:** The surface has eroded and the foundations are exposed

**Action:** Reinststate surrounding surfaces to cover the foundations

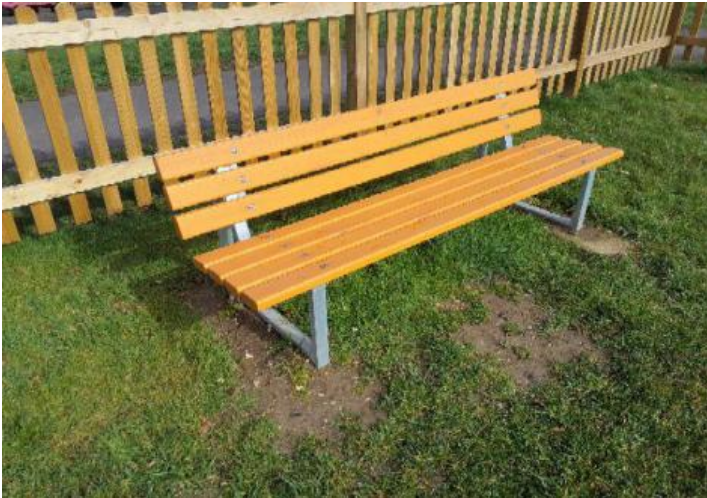
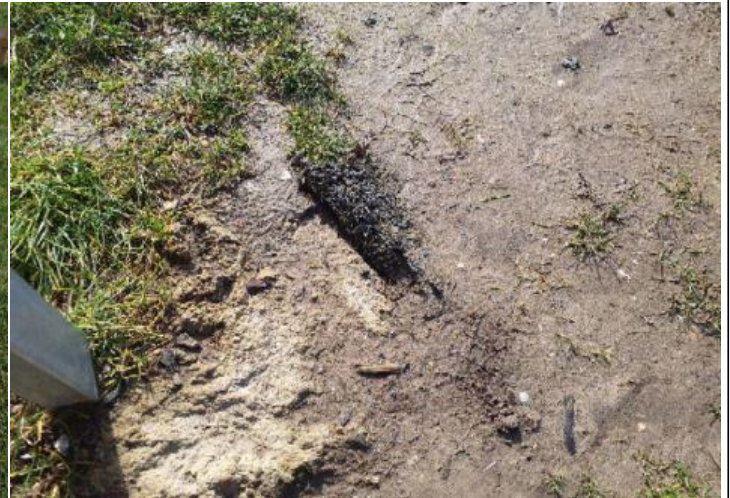
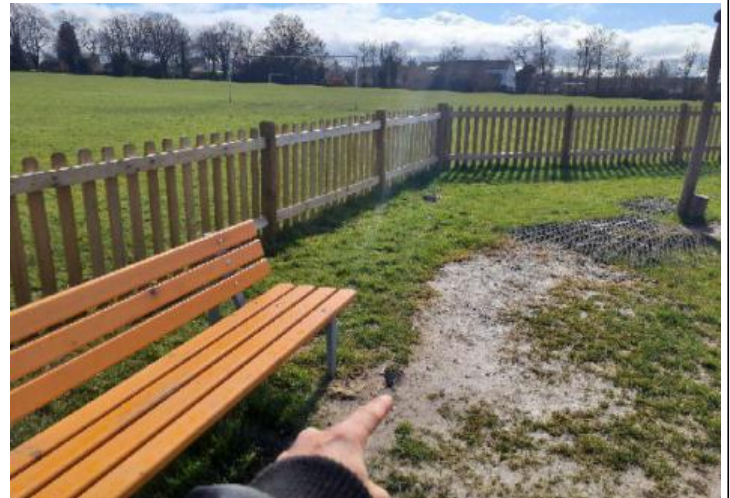
There are trip hazards present - Reinstate surrounding surfaces to level to remove the trip points

**Finding:** There are trip hazards present

**Action:** Reinstate surrounding surfaces to level to remove the trip points

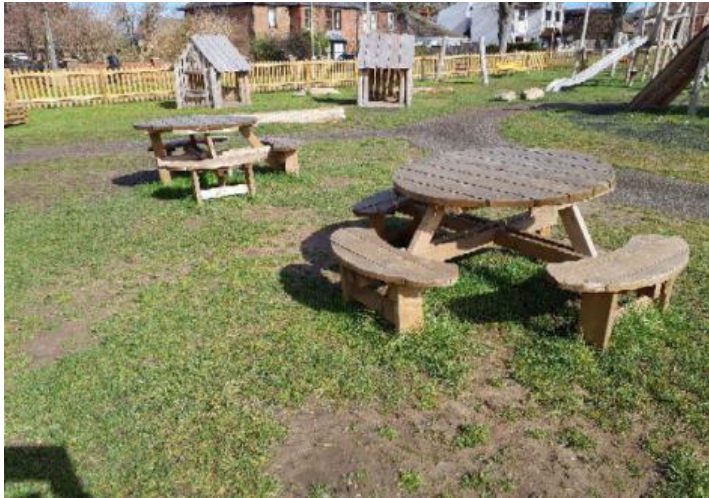
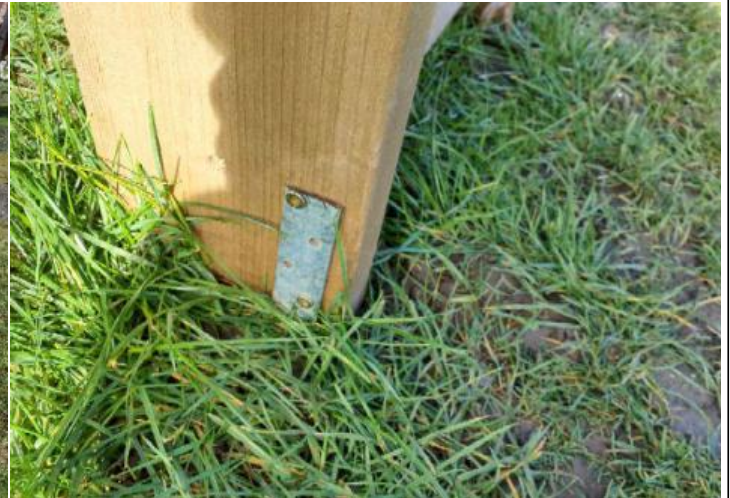
There is or are fixings missing on the item - Replace all missing fixings

**Finding:** There is or are fixings missing on the item

**Action:** Replace all missing fixings

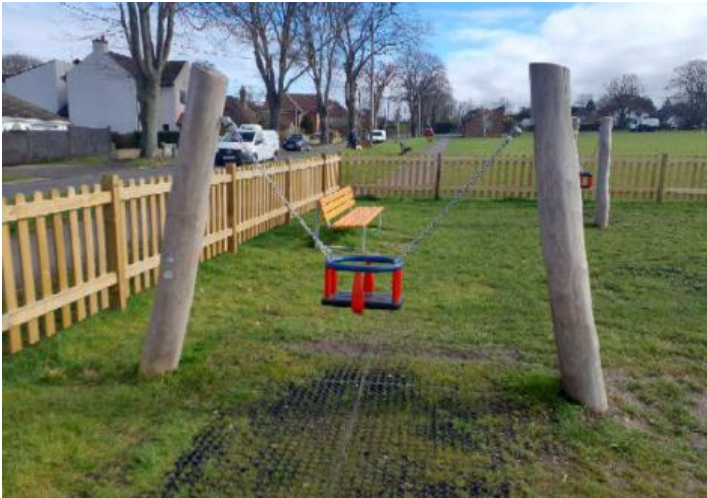
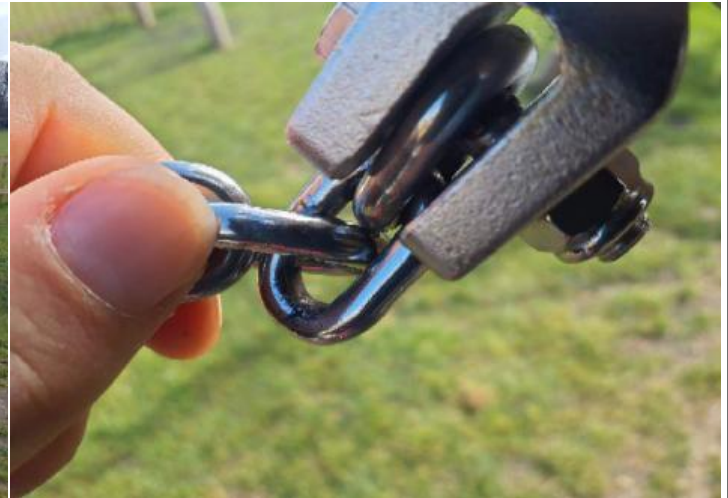
**Finding:** There is some notable evidence of chain wear  
**Action:** Monitor for any further deterioration and replace when 40% worn

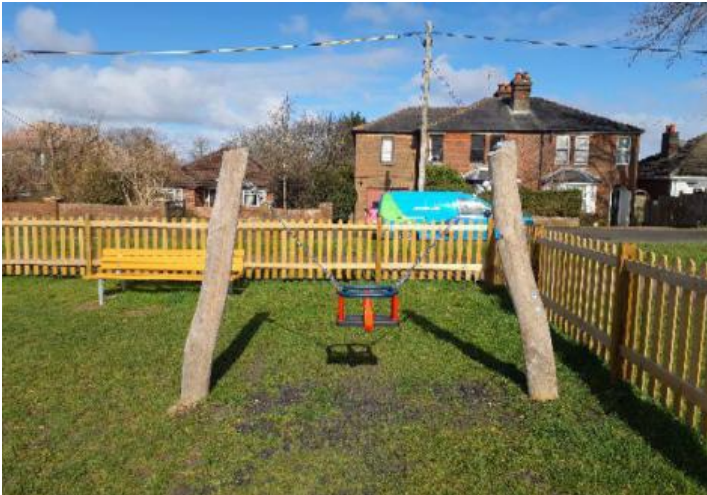
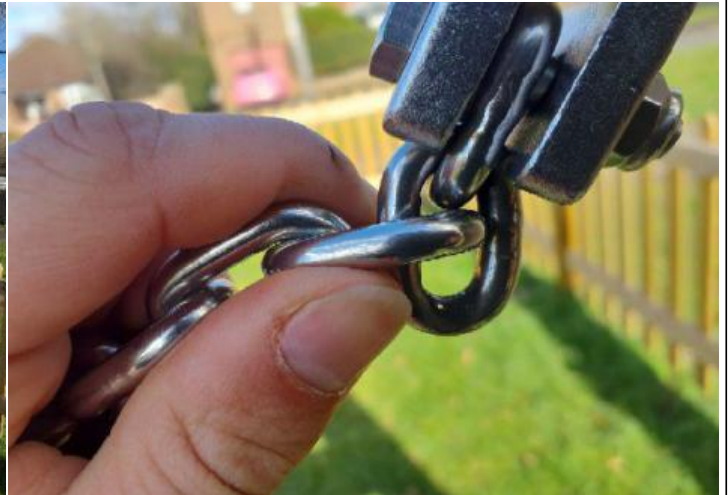
**Finding:** There is some notable evidence of chain wear

**Action:** Monitor for any further deterioration and replace when 40% worn

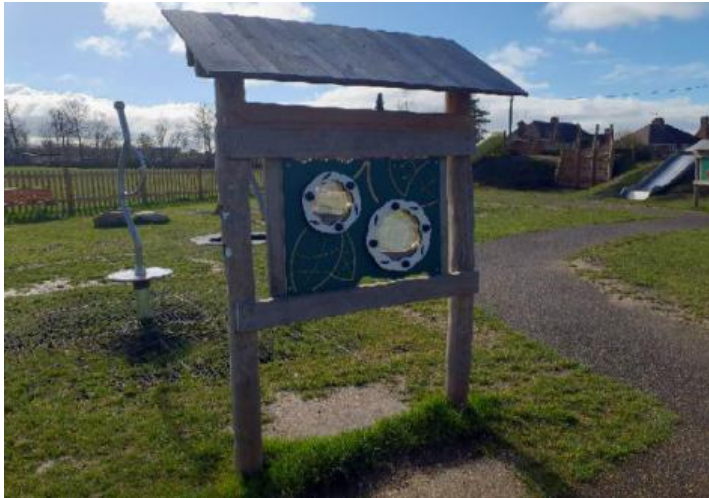
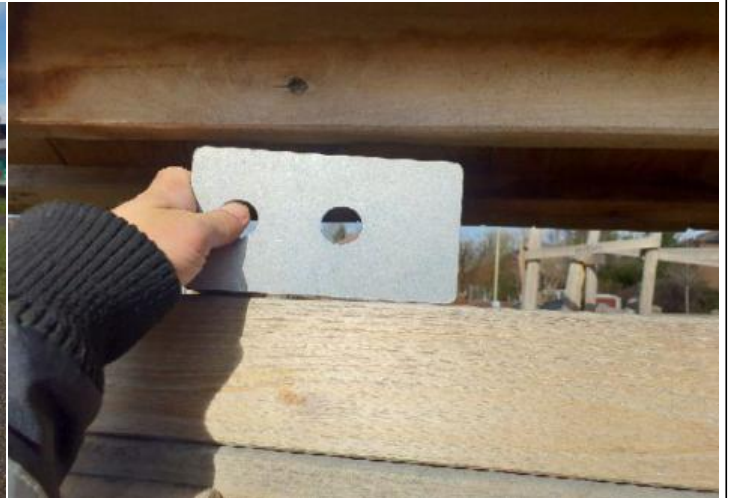
The item fails to meet the requirements of BS EN 1176 Part 1 4.2.7.2 for head and neck entrapment in the structure - Monitor - No remedial work recommended

**Finding:** The item fails to meet the requirements of BS EN 1176 Part 1 4.2.7.2 for head and neck entrapment in the structure

**Action:** Monitor - No remedial work recommended

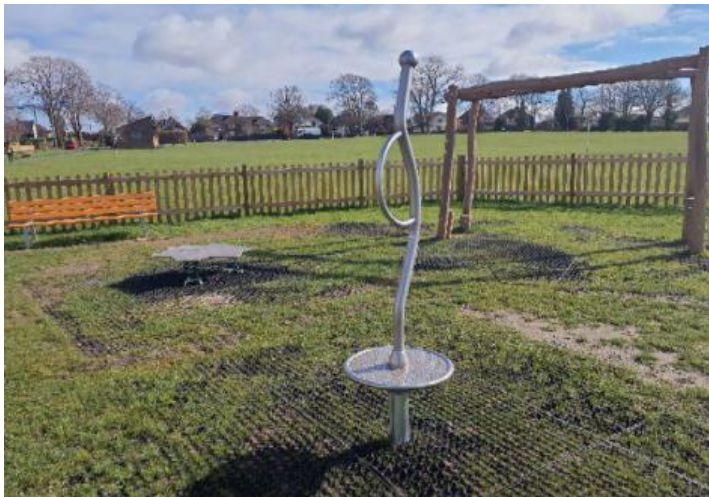
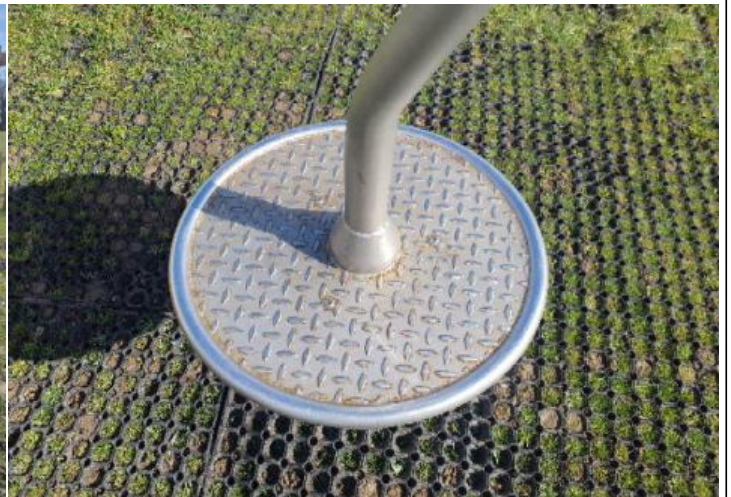
The bearing is showing signs of wear - Monitor for any further deterioration and replace as required

**Finding:** The bearing is showing signs of wear

**Action:** Monitor for any further deterioration and replace as required

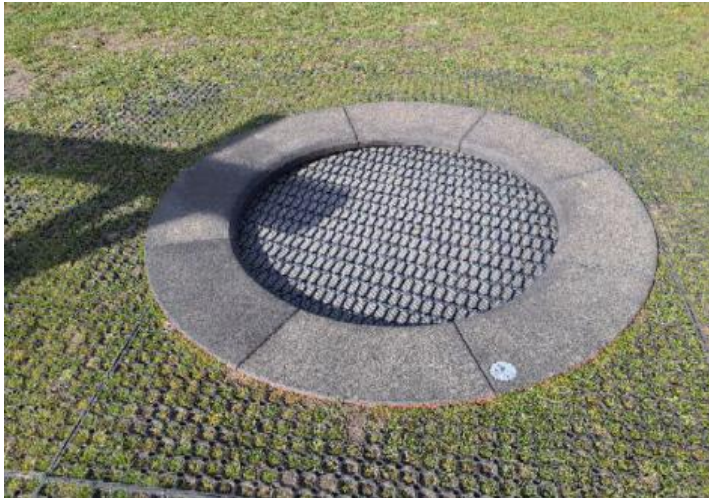
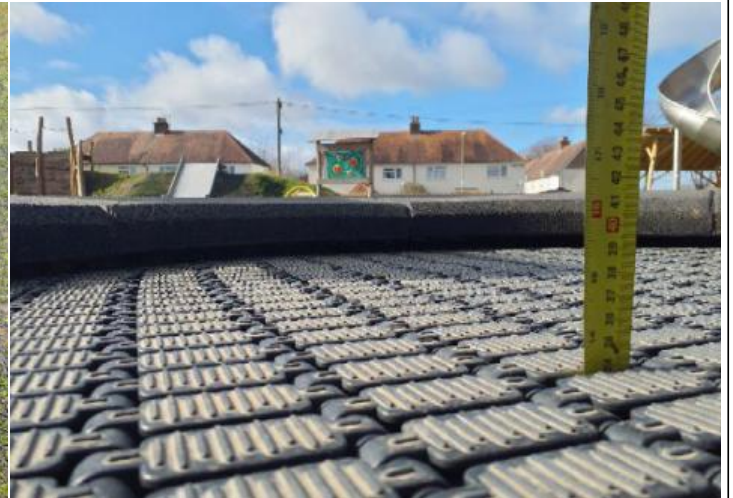
On site visits it is not possible to test the ground clearance of the Bouncing Facility bed as specified in BS EN 1176; ensure that the clearance between the Bouncing Facility Bed and the ground underneath is in accordance with the manufacturers recommendations (recorded nominal depth at time of inspection 340mm measured unloaded). - Refer to the manufacturers recommendations

**Finding:** On site visits it is not possible to test the ground clearance of the Bouncing Facility bed as specified in BS EN 1176; ensure that the clearance between the Bouncing Facility Bed and the ground underneath is in accordance with the manufacturers recommendations (recorded nominal depth at time of inspection 340mm measured unloaded).

**Action:** Refer to the manufacturers recommendations

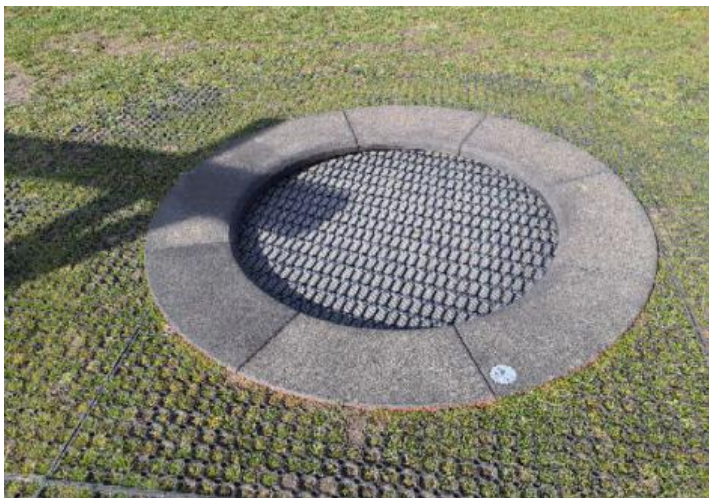
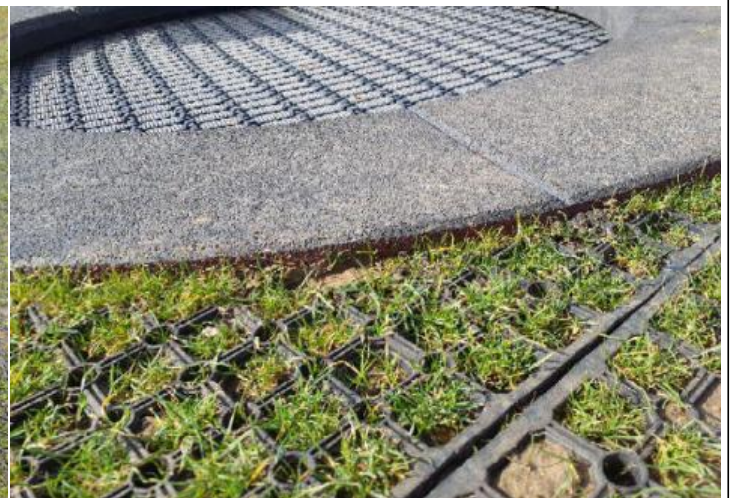
There are trip hazards at the edges of the surface - Reinstate surrounding surface levels to remove the trip points

**Finding:** There are trip hazards at the edges of the surface

**Action:** Reinstate surrounding surface levels to remove the trip points

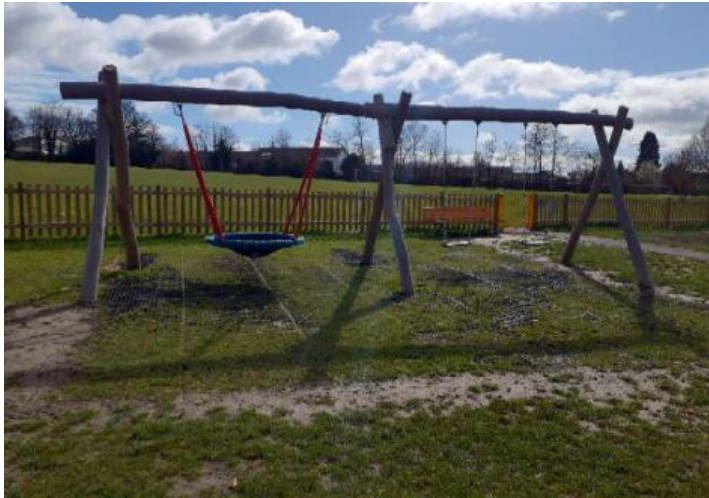
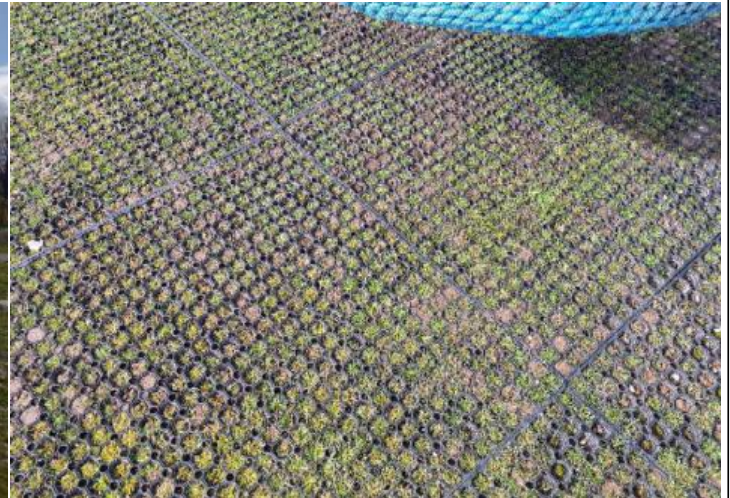
The grass mats are silted up and the soil is compacted; this may have an effect on the impact absorbing properties of the surface - Consider HIC testing impact absorbing properties to ensure the correct surface qualities are maintained for the equipment and replace as required

**Finding:** The grass mats are silted up and the soil is compacted; this may have an effect on the impact absorbing properties of the surface

**Action:** Consider HIC testing impact absorbing properties to ensure the correct surface qualities are maintained for the equipment and replace as required

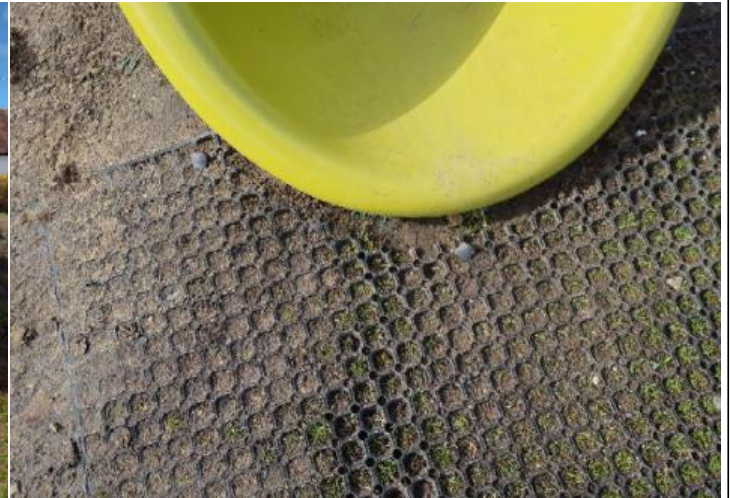
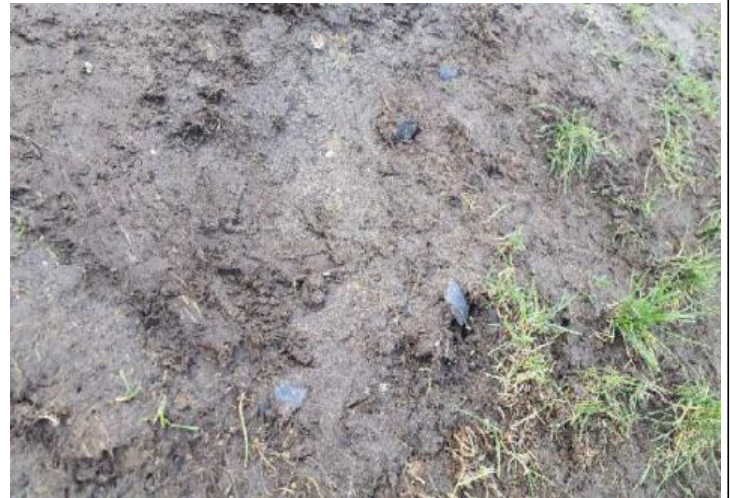
**Finding:** Fixing Pins have been installed in the impact areas of the grass mats  
**Action:** Remove pins from impact areas

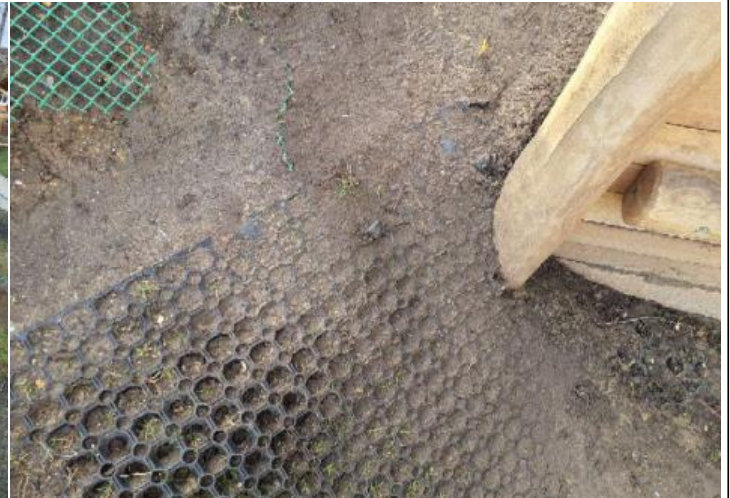
**Finding:** Fixing Pins have been installed in the impact areas **Action:** Remove pins from impact areas of the grass mats

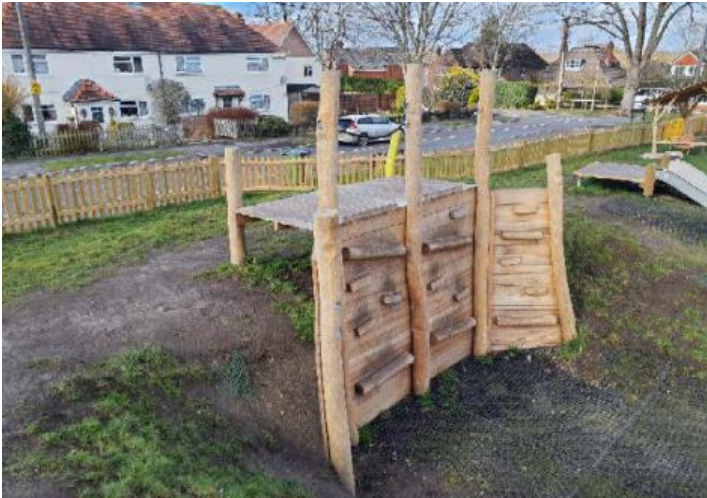
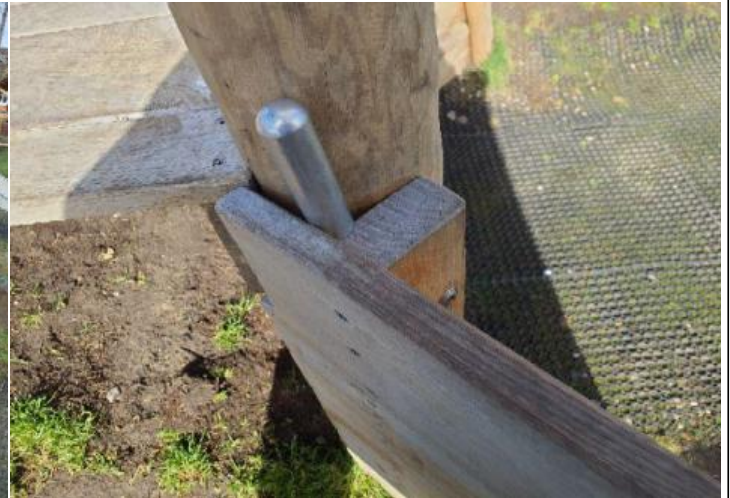
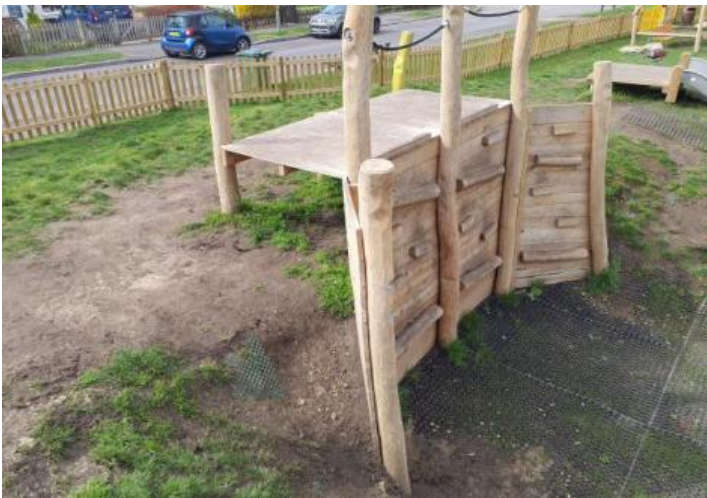
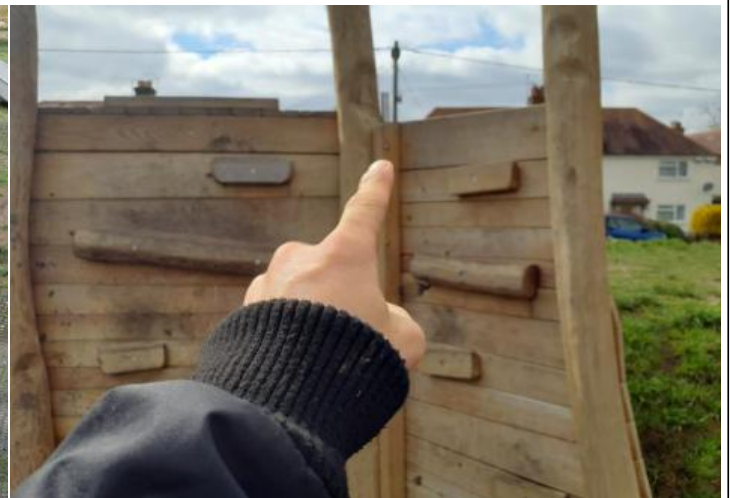
There is/are finger entrapment/s in the climbing wall and the item fails to meet the requirements of BS EN 1176 Part 1 4.2.7.6 Entrapment of fingers - Monitor - No remedial work recommended

**Finding:** There is/are finger entrapment/s in the climbing wall and the item fails to meet the requirements of BS EN 1176 Part 1 4.2.7.6 Entrapment of fingers

**Action:** Monitor - No remedial work recommended

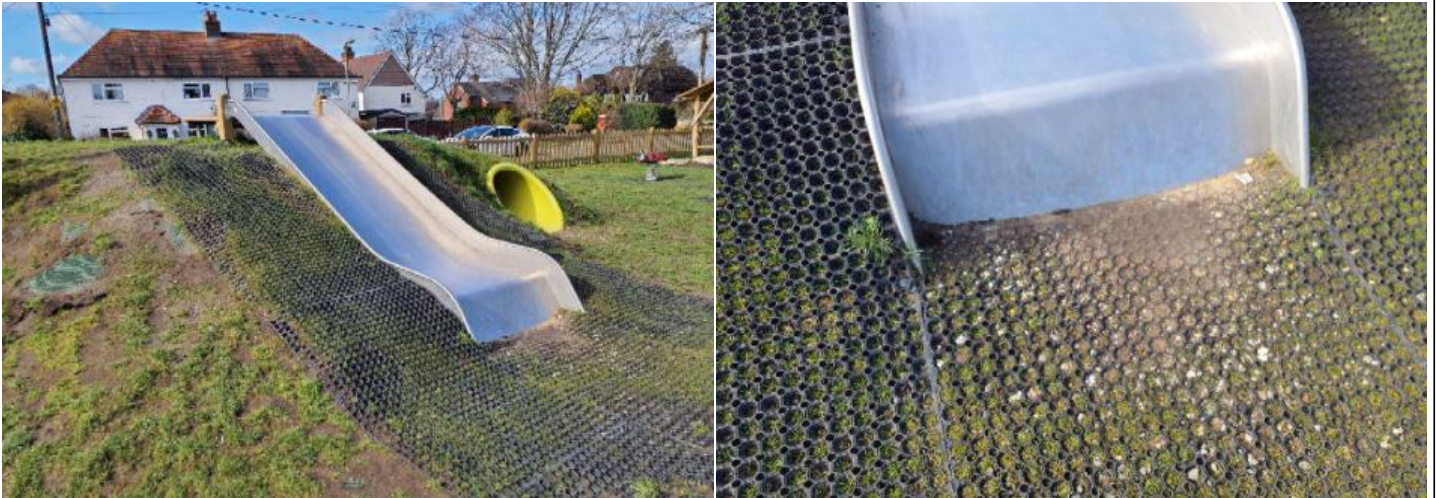
**Finding:** Fixing Pins have been installed in the impact areas **Action:** Remove pins from impact areas of the grass mats

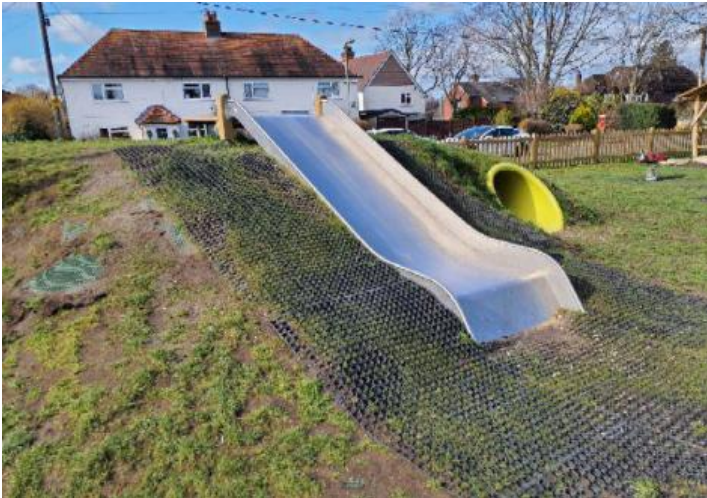
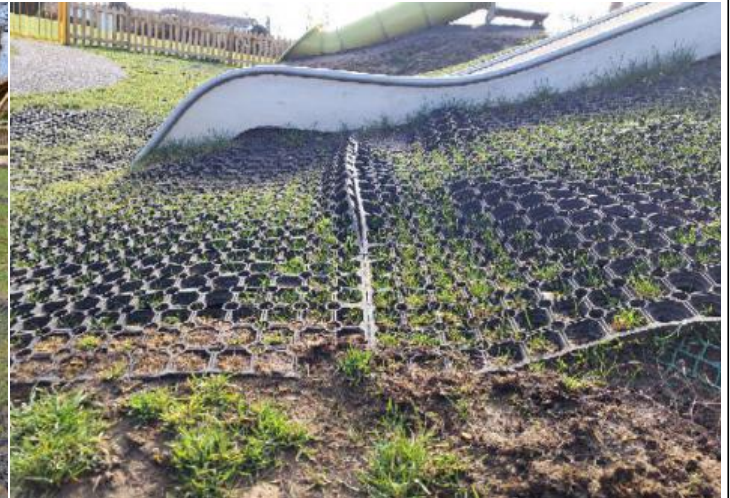
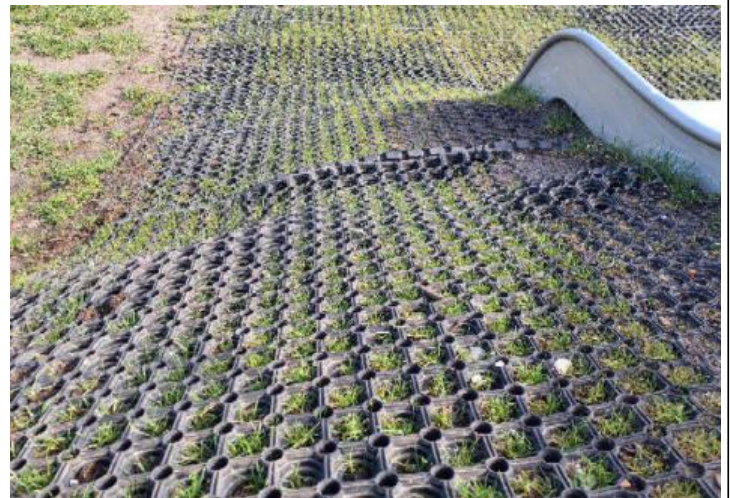
The grass matrix tiles have buckled in places, causing trip hazards - Provide additional ties or secure / reinstate surface

**Finding:** The grass matrix tiles have buckled in places, causing trip hazards

**Action:** Provide additional ties or secure / reinstate surface

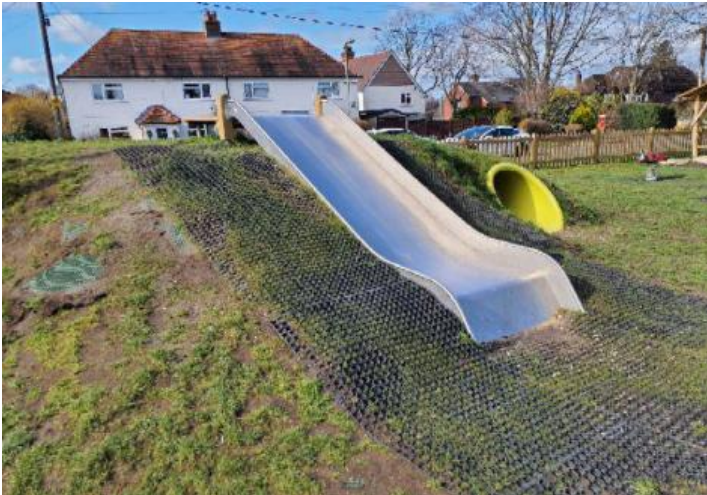
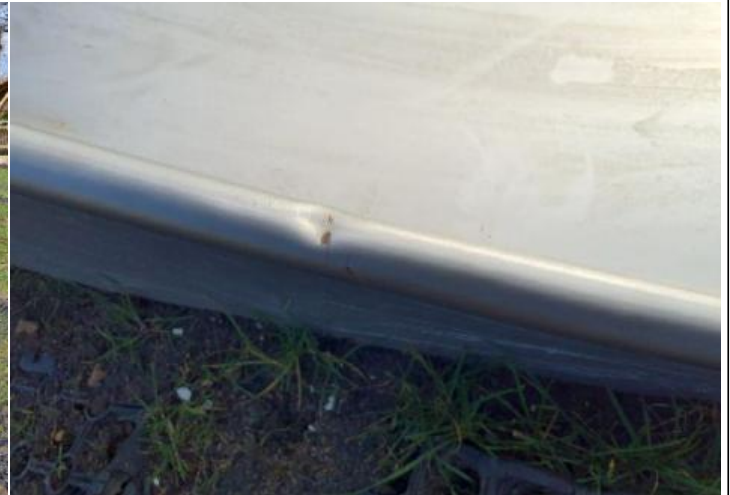
There are a number of dents in the slide surface - Monitor for any further deterioration and repair as required

**Finding:** There are a number of dents in the slide surface

**Action:** Monitor for any further deterioration and repair as required

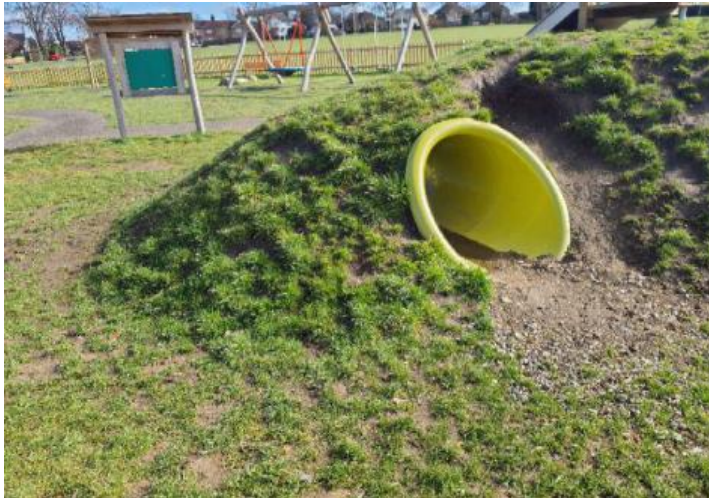
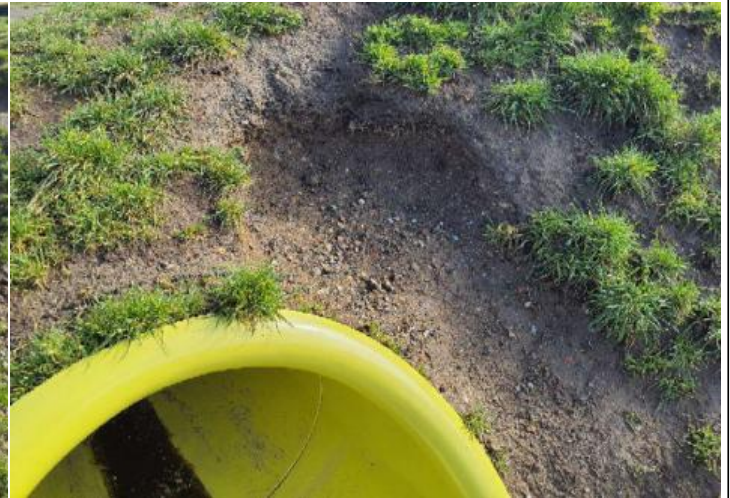
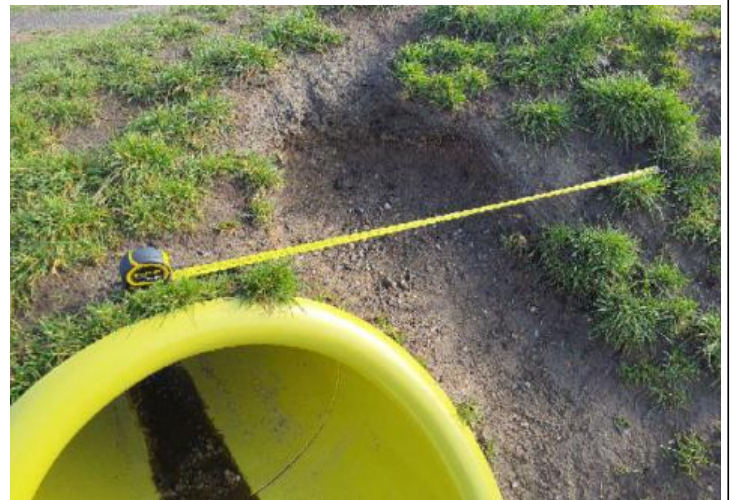
The surface has eroded in some areas and may be slippery in wet conditions - Reinstate the surface

**Finding:** The surface has eroded in some areas and may be slippery in wet conditions  
**Action:** Reinstate the surface

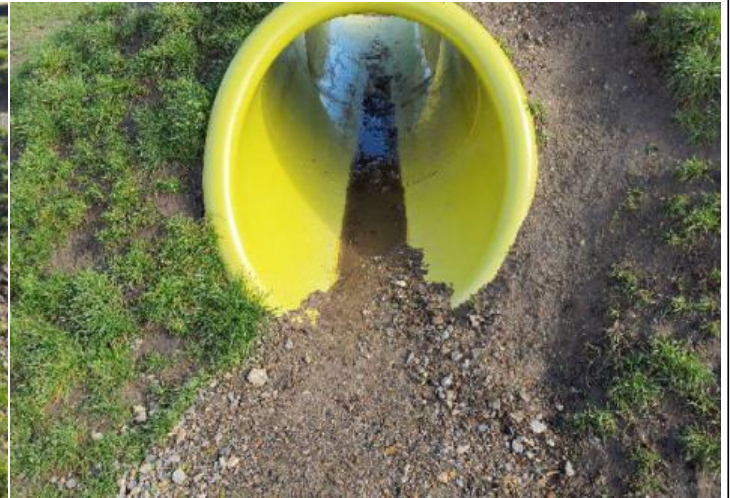
**Finding:** There is some water and dirt/debris on the surfacing

**Action:** Clean and maintain / Consider adding drainage

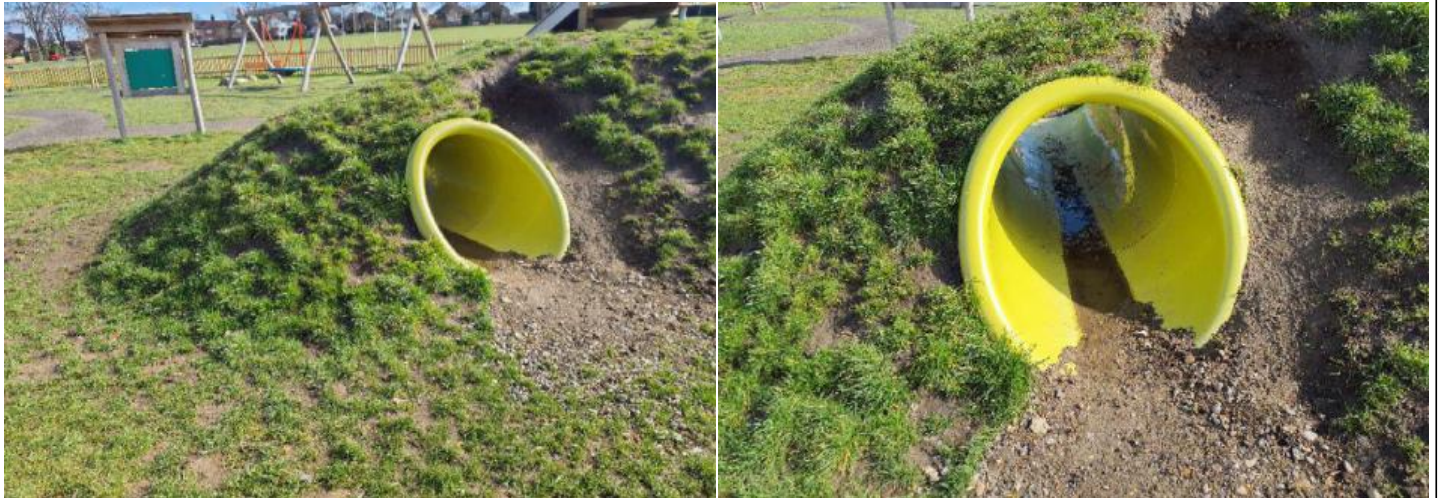
This design / configuration of tunnel mound is well established and has been successfully included in large quantities of playgrounds throughout the UK. Whilst the design does not fully meet the requirements of BS EN 1176 with regards to falls in excess of 600mm over the edge of the tunnel to the surface below, it has been risk assessed as fit for purpose and no changes are recommended to the design - Monitor - No remedial work recommended

**Finding:** This design / configuration of tunnel mound is well established and has been successfully included in large quantities of playgrounds throughout the UK. Whilst the design does not fully meet the requirements of BS EN 1176 with regards to falls in excess of 600mm over the edge of the tunnel to the surface below, it has been risk assessed as fit for purpose and no changes are recommended to the design

**Action:** Monitor - No remedial work recommended

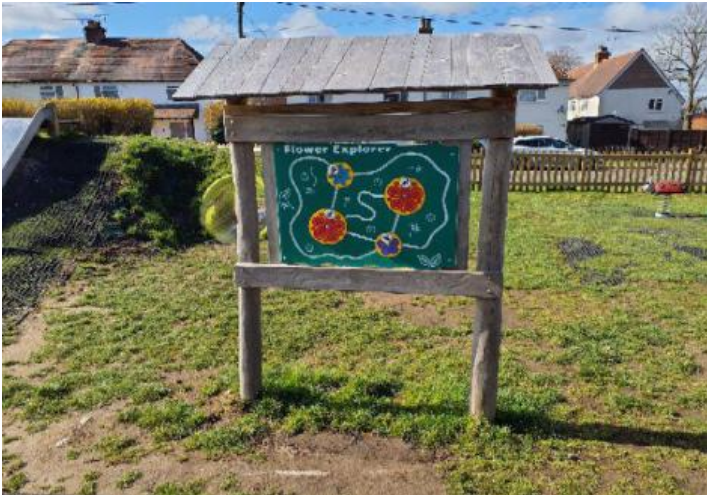
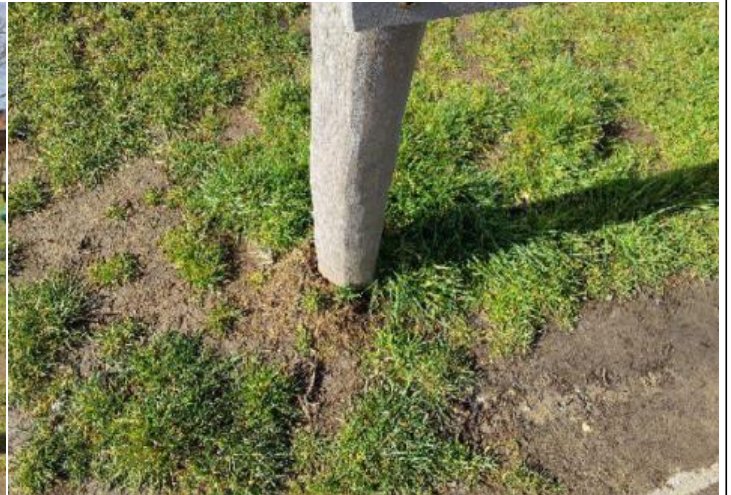
The item is slightly loose in its foundations - Monitor for any further deterioration and repair as required

**Finding:** The item is slightly loose in its foundations

**Action:** Monitor for any further deterioration and repair as required
