## Annual Inspection

Winchester City Council

Stratton Bates Recreation Ground (New Alresford)

Grange Road, Alresford, SO24 9HF

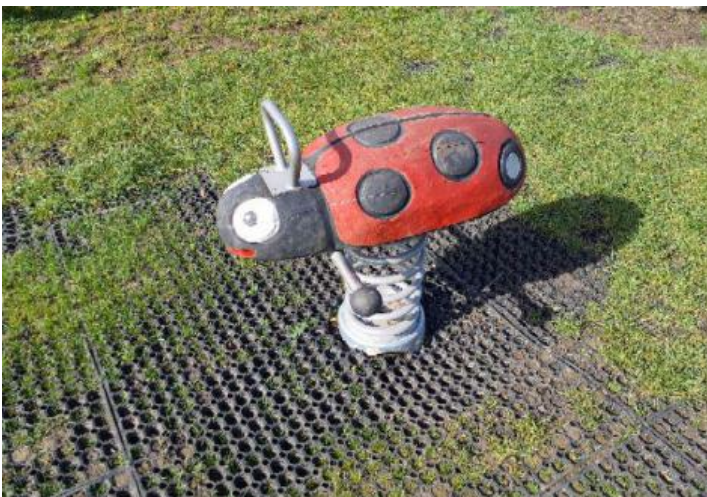
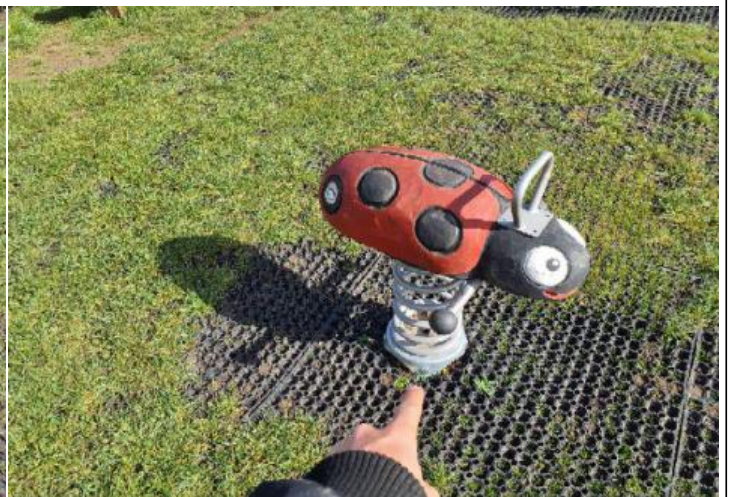
A number of fixing(s) have worked loose - Secure all loose fixings

**Finding:** A number of fixing(s) have worked loose

**Action:** Secure all loose fixings

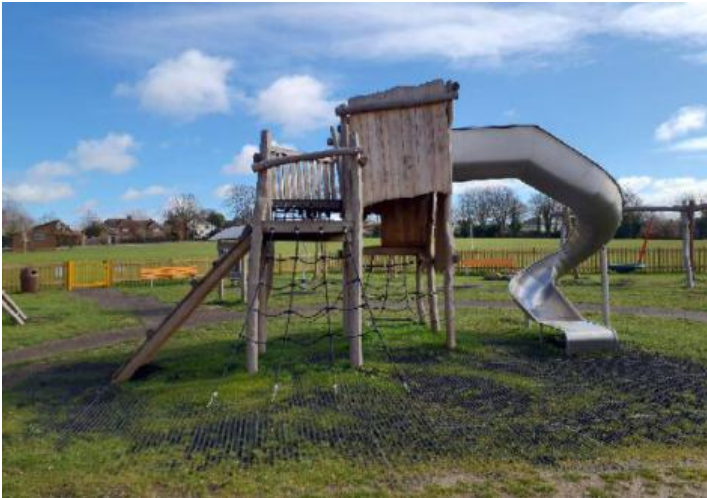
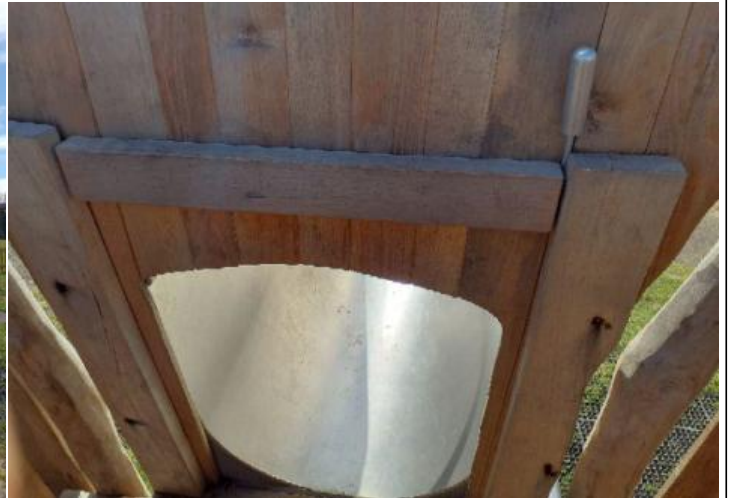
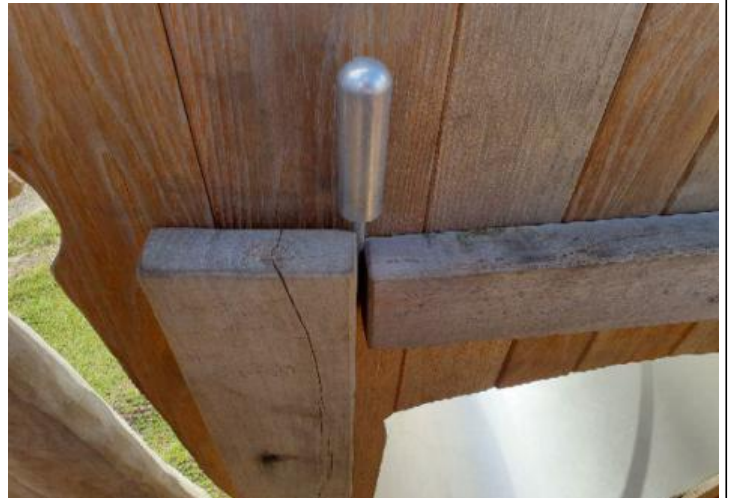
There is/are finger entrapment/s in the slide starting section and the item fails to meet the requirements of BS EN 1176 Part 1 4.2.7.6 Entrapment of fingers - Monitor - No remedial work recommended

**Finding:** There is/are finger entrapment/s in the slide starting section and the item fails to meet the requirements of BS EN 1176 Part 1 4.2.7.6 Entrapment of fingers

**Action:** Monitor - No remedial work recommended

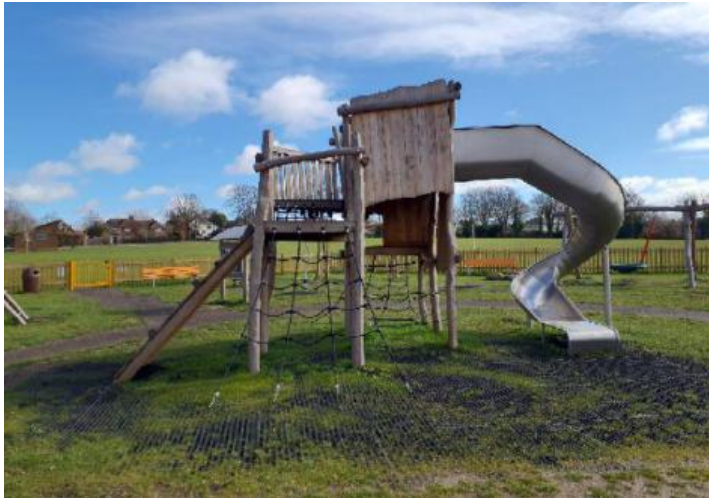
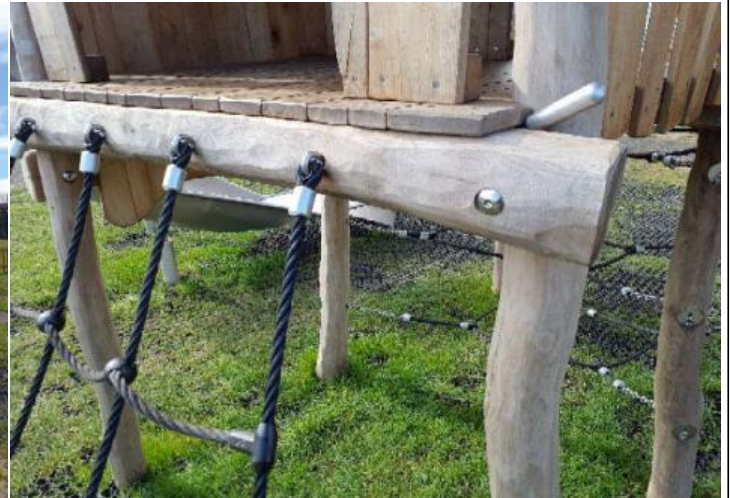
There is/are finger entrapment/s in the structure and the item fails to meet the requirements of BS EN 1176 Part 1 4.2.7.6 Entrapment of fingers - Monitor - No remedial work recommended

**Finding:** There is/are finger entrapment/s in the structure and the item fails to meet the requirements of BS EN 1176 Part 1 4.2.7.6 Entrapment of fingers

**Action:** Monitor - No remedial work recommended

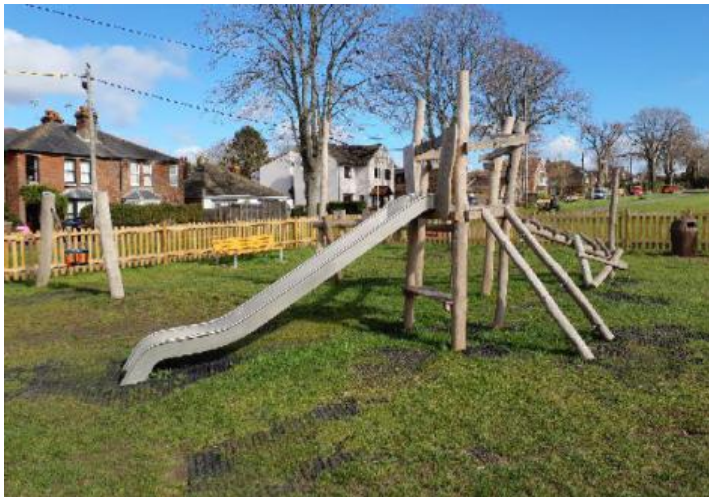
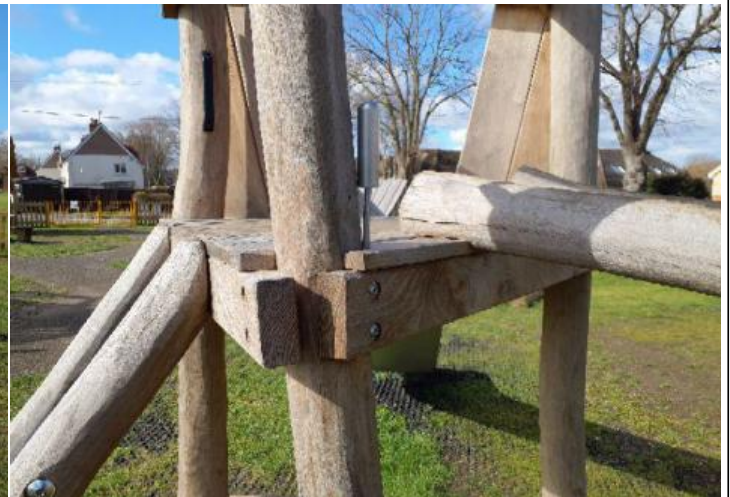
There is/are finger entrapment/s in the platform and the item fails to meet the requirements of BS EN 1176 Part 1 4.2.7.6 Entrapment of fingers - Monitor - No remedial work recommended

**Finding:** There is/are finger entrapment/s in the platform and the item fails to meet the requirements of BS EN 1176 Part 1 4.2.7.6 Entrapment of fingers

**Action:** Monitor - No remedial work recommended

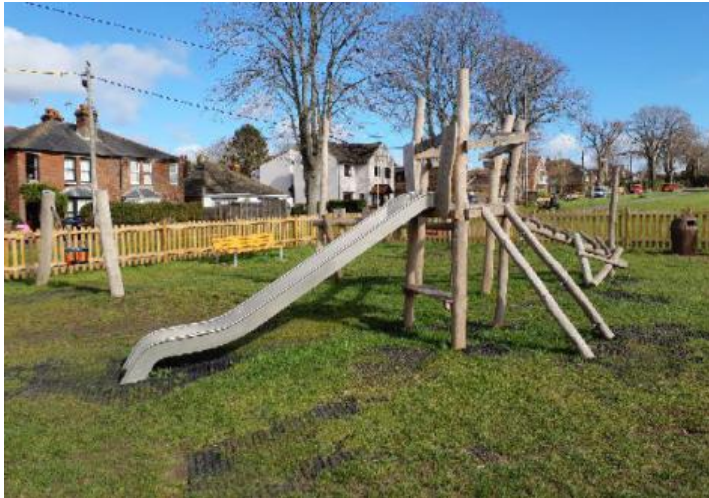
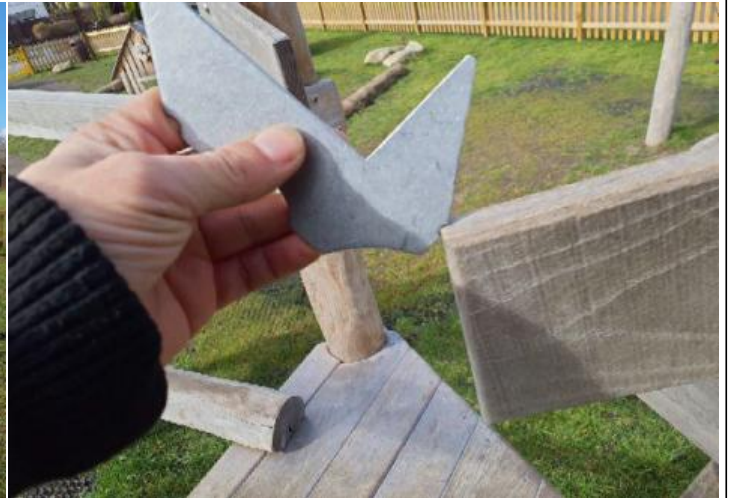
The item has exposed edges and corners with a radius of less than 3mm and fails the requirements of BS EN 1176 - Provide a 3mm radius to all exposed edges and corners

**Finding:** The item has exposed edges and corners with a radius of less than 3mm and fails the requirements of BS EN 1176  
**Action:** Provide a 3mm radius to all exposed edges and corners

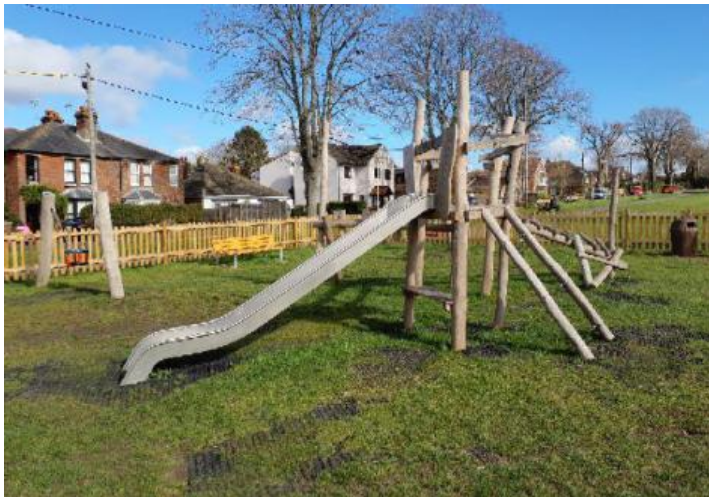
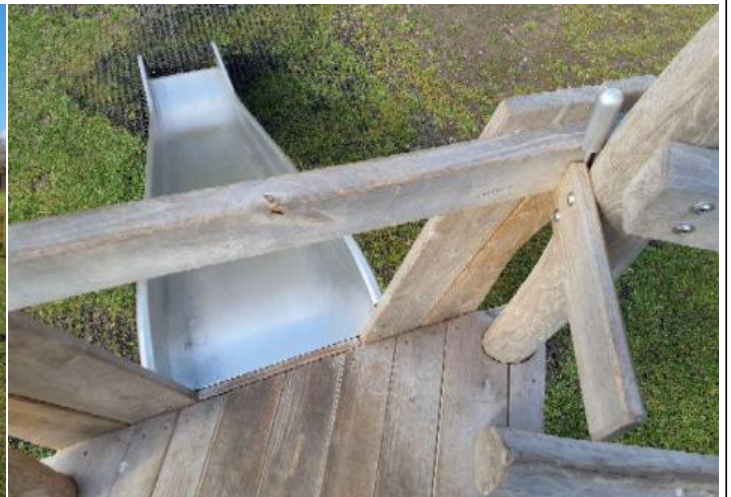
There is/are finger entrapment/s in the slide starting section and the item fails to meet the requirements of BS EN 1176 Part 1 4.2.7.6 Entrapment of fingers - Monitor - No remedial work recommended

**Finding:** There is/are finger entrapment/s in the slide starting section and the item fails to meet the requirements of BS EN 1176 Part 1 4.2.7.6 Entrapment of fingers  
**Action:** Monitor - No remedial work recommended

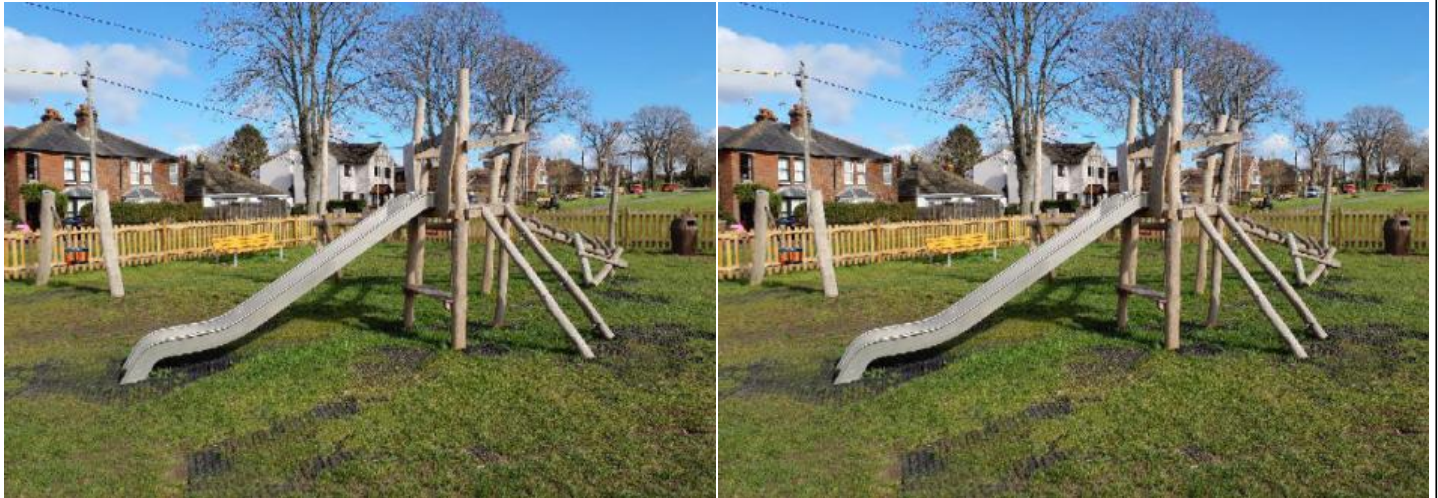
There is an opening in the barriers exceeding the width allowed (500mm) in BS EN 1176, and no guardrail has been provided; this is a low risk failure and no remedial action is required - Refer to the manufacturer

**Finding:** There is an opening in the barriers exceeding the width allowed (500mm) in BS EN 1176, and no guardrail has been provided; this is a low risk failure and no remedial action is required

**Action:** Refer to the manufacturer
