the **play inspection** company

Annual Inspection

Winchester City Council

Sun Hill Recreation Ground (New Alresford)

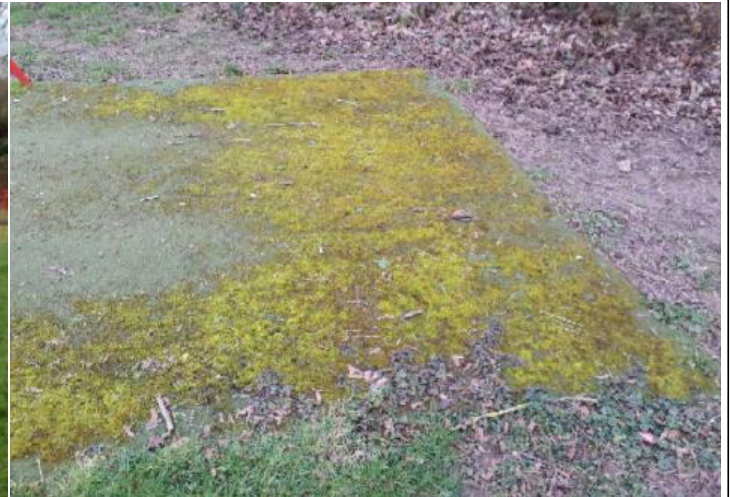
8 - Low Risk (Finding 1)

Item: Ancillary Items - Site General
Manufacturer: Owner/Operator
Risk Level: L - Low Risk
Surface: N/A

Finding: There is algae, silt or moss growth on the surface resulting in slippery conditions
Action: Clean and treat appropriately

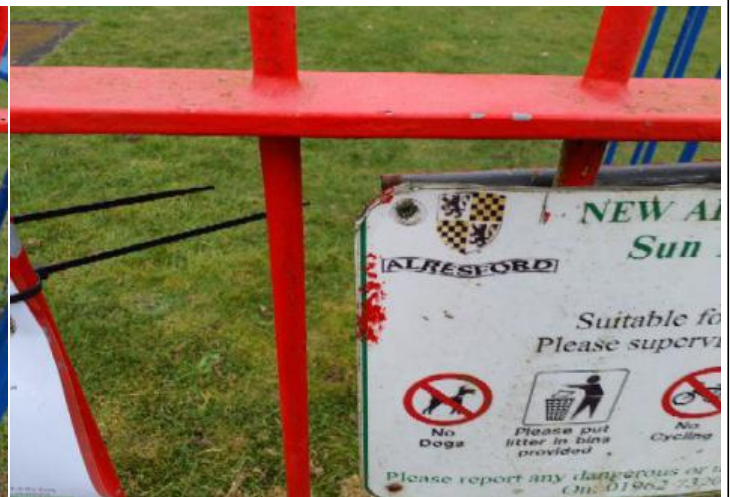
6 - Low Risk (Finding 1)

Item: Ancillary Items - Sign
Manufacturer: Not Identified
Risk Level: L - Low Risk
Surface: N/A

Finding: There is some damage to the item
Action: Monitor for any further deterioration and repair as required

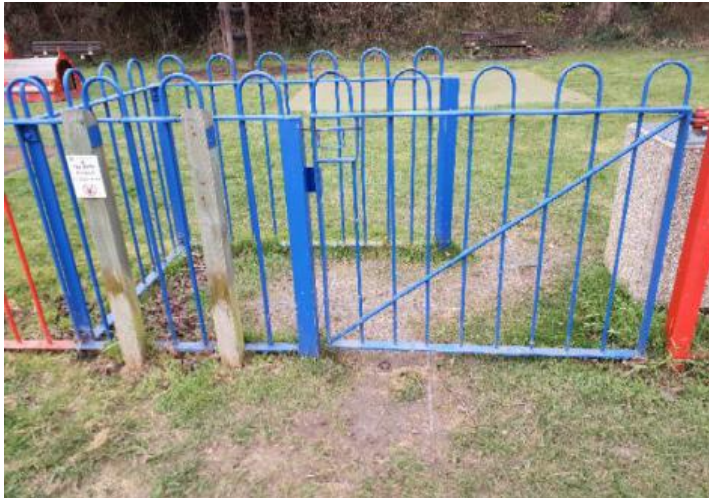
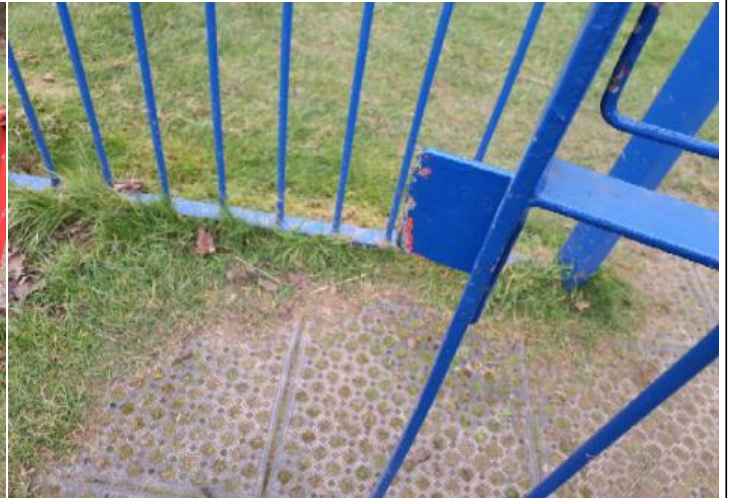
i 6 - Low Risk (Finding 1)

Item: Gates - Kissing Gate
Manufacturer: Not Identified

Finding: The rubber buffer is missing from the latch plate

Action: Replace rubber buffer

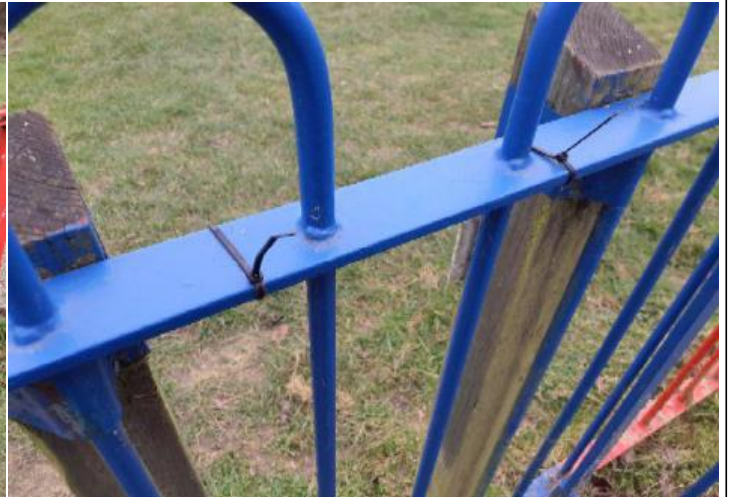
Item: Gates - Kissing Gate
Manufacturer: Not Identified

Finding: Cable ties have been used on the item and there are sharp projecting ends

Action: Remove if not required or replace with a more appropriate alternative fixing method if used as a fixing

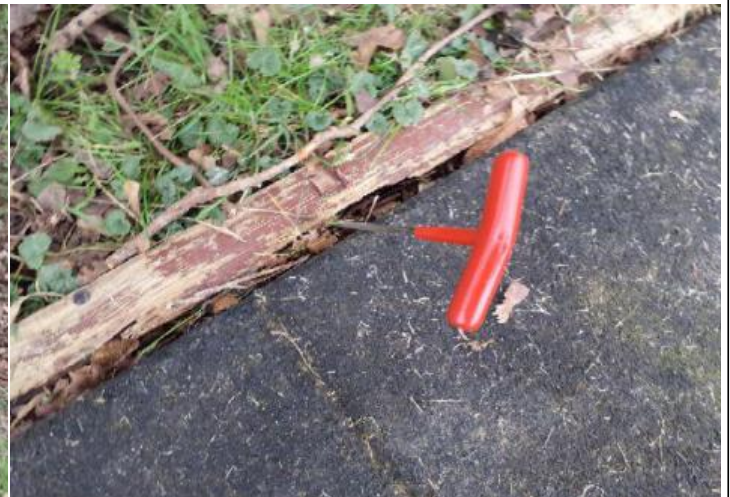
6 - Low Risk (Finding 2)

Item: Ancillary Items - Bench
Manufacturer: Not Identified
Risk Level: L - Low Risk
Surface: Grass

Finding: There is some evidence of rot in the timber
Action: Monitor for any further deterioration and replace as required

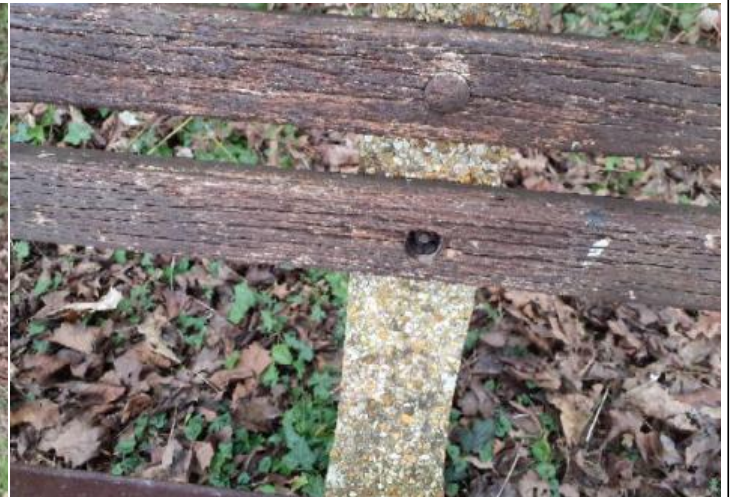
4 - Very Low Risk (Finding 3)

Item: Ancillary Items - Bench
Manufacturer: Not Identified
Risk Level: V - Very Low Risk
Surface: Grass

Finding: There is/are inserts missing
Action: Replace missing inserts

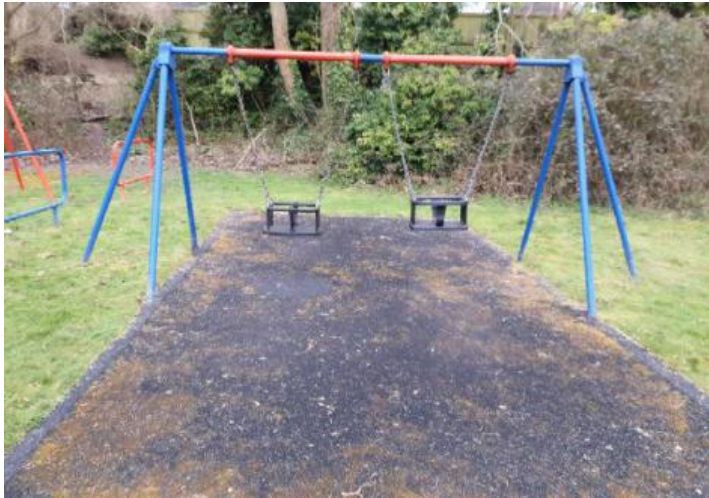
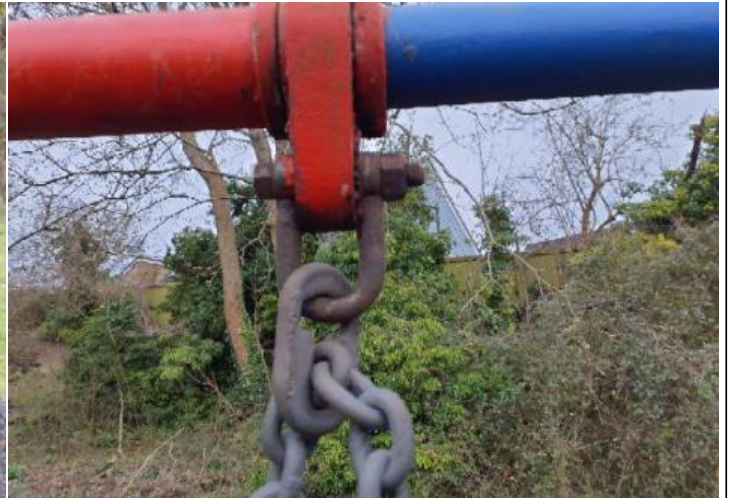
i 6 - Low Risk (Finding 1)

Item: Swings - 1 Bay 2 Seat (Cradle)
Manufacturer: Wicksteed Playgrounds

Finding: The shackles have been overtightened or seized transferring wear to the chain links below

Action: Loosen shackles to ensure free movement at the pivot

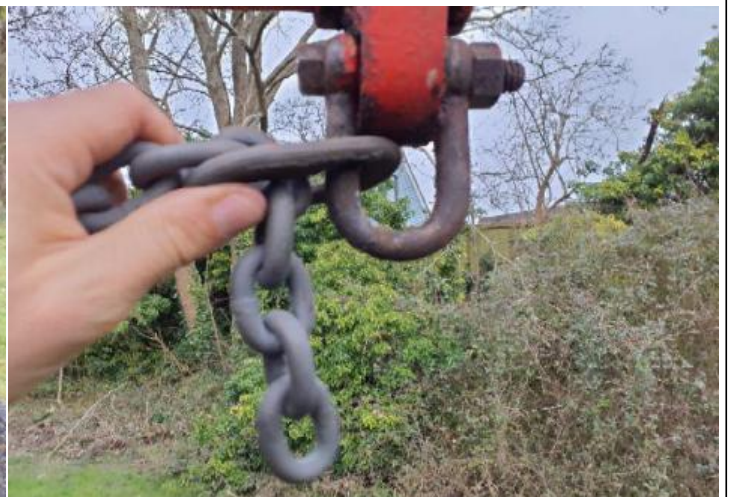
Item: Swings - 1 Bay 2 Seat (Cradle)
Manufacturer: Wicksteed Playgrounds

Finding: There is some wear to the shackles.

Action: Monitor for any further deterioration and replace when 40% worn

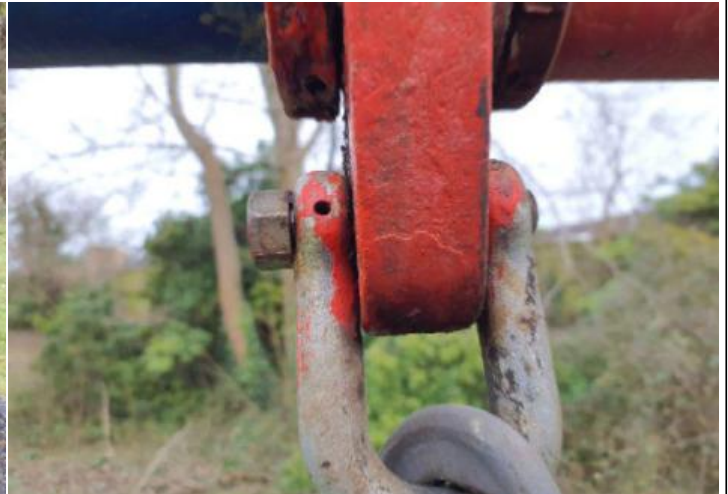
Item: Swings - 1 Bay 2 Seat (Cradle)
Manufacturer: Wicksteed Playgrounds

Finding: The split pins are missing from the shackles

Action: Insert split pins to secure the shackles

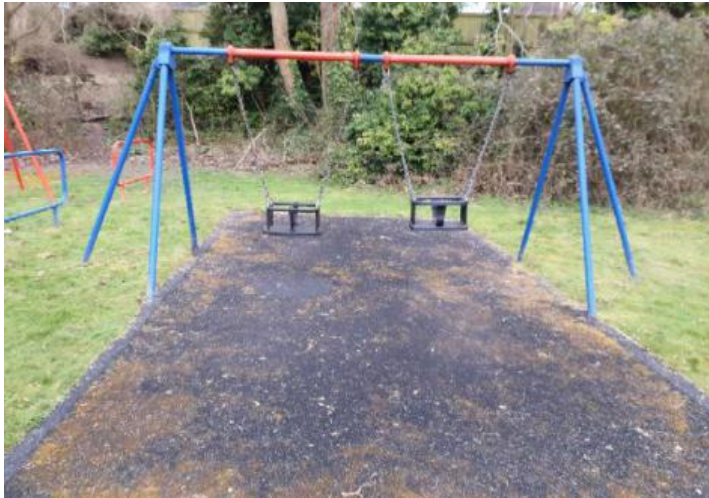
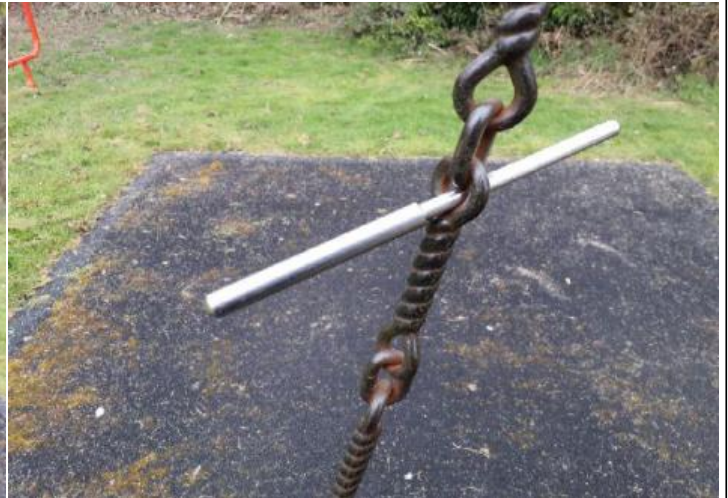
Item: Swings - 1 Bay 2 Seat (Cradle)
Manufacturer: Wicksteed Playgrounds

Finding: The connecting links are in excess of 8.6mm and less than 12mm and fail the requirements of BS EN 1176 Part 1; clause 4.2.13, Chains

Action: Monitor - No remedial work recommended

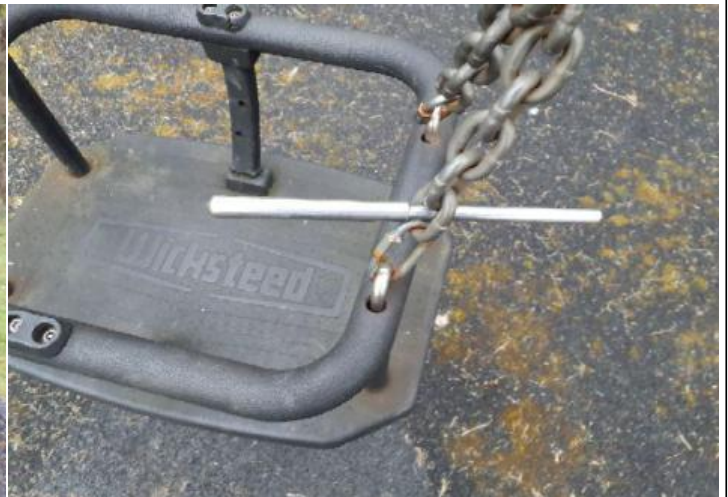
Item: Swings - 1 Bay 2 Seat (Cradle)
Manufacturer: Wicksteed Playgrounds

Finding: The chain openings are in excess of the 8.6mm as recommended by BS EN 1176

Action: Monitor - No remedial work recommended

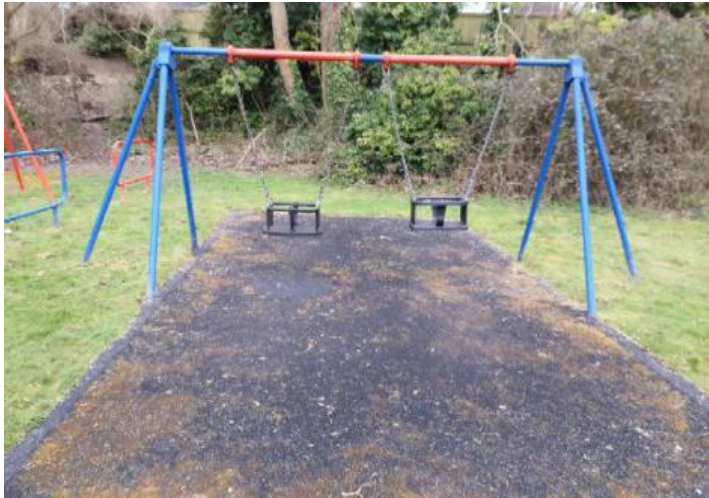
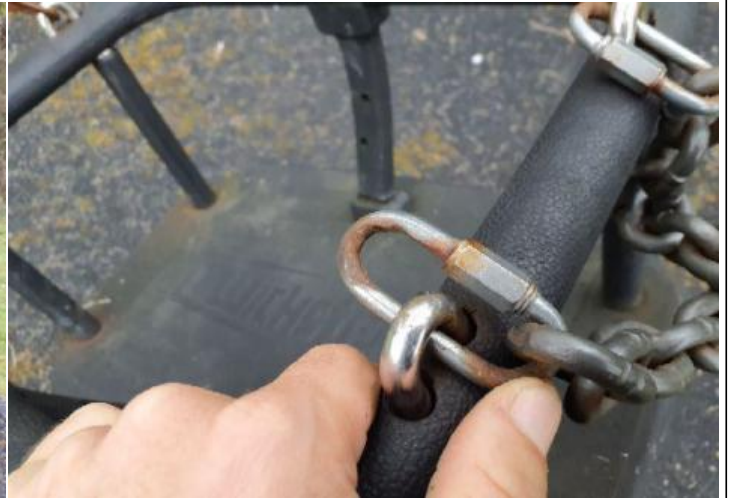
Finding: There is some notable evidence of connecting link wear

Action: Monitor for any further deterioration and replace when 40% worn

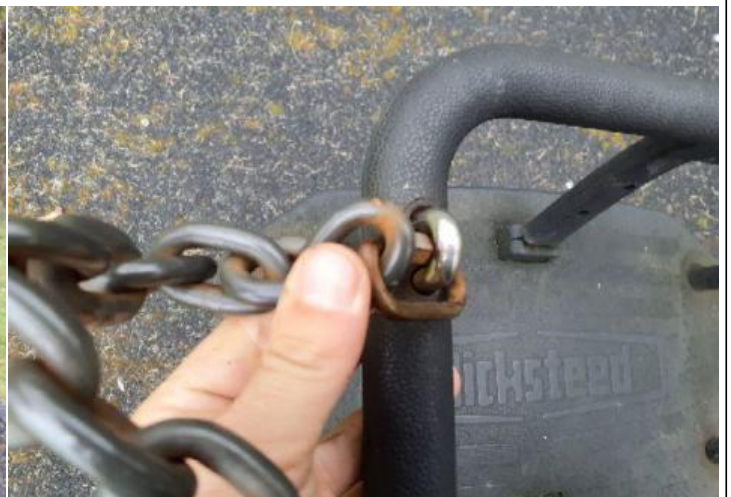
Finding: There is some notable evidence of chain wear

Action: Monitor for any further deterioration and replace when 40% worn

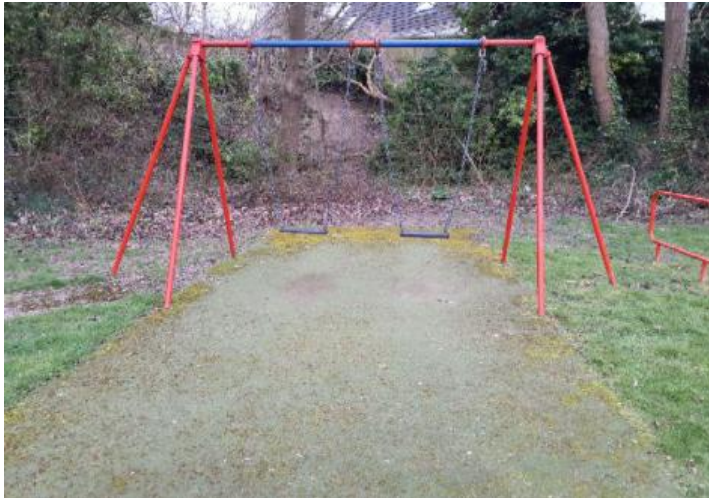
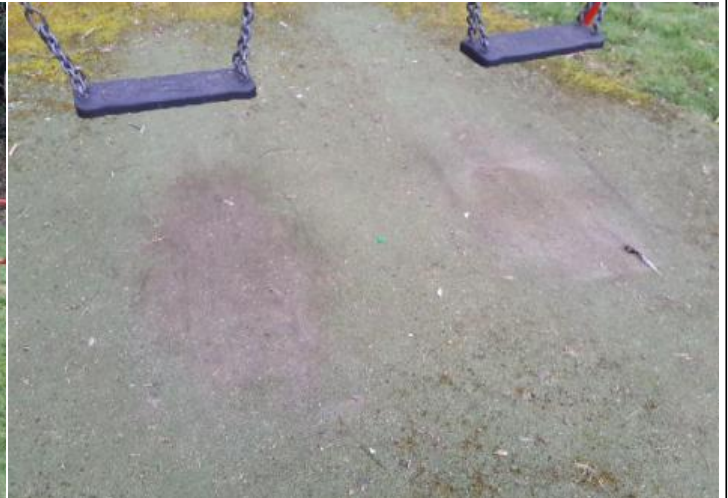
Finding: The safety surface around the area is beginning to wear

Action: Monitor for any further deterioration and repair as required

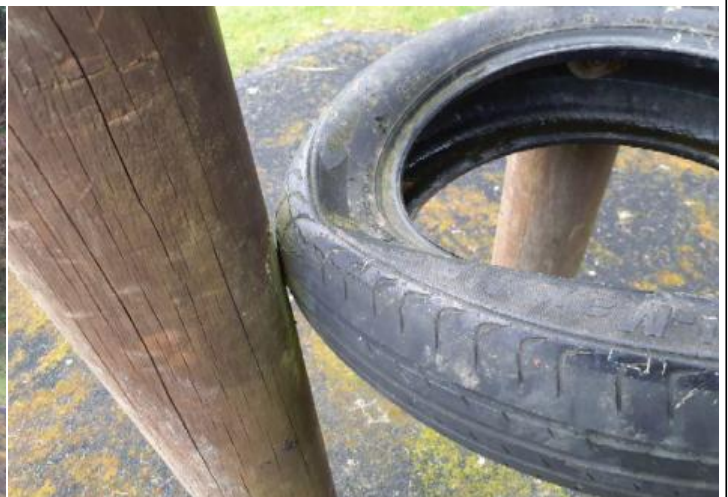
Finding: The tyres are losing their integrity

Action: Replace as required

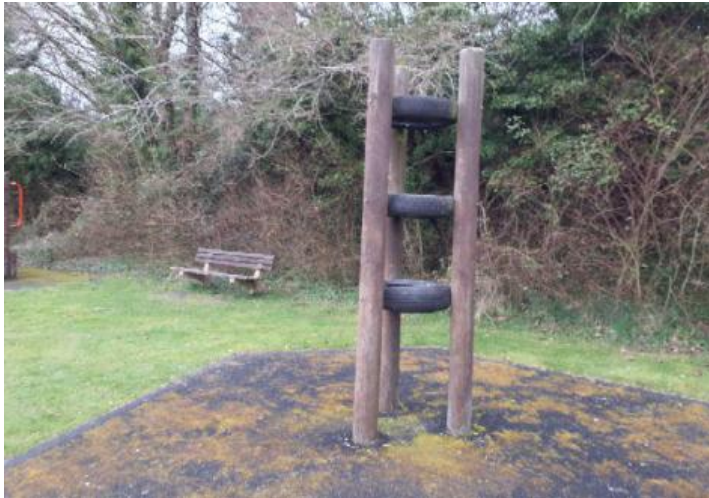
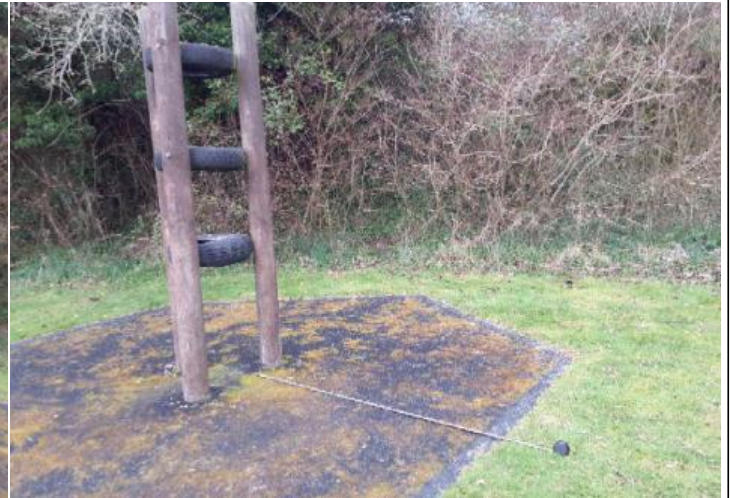
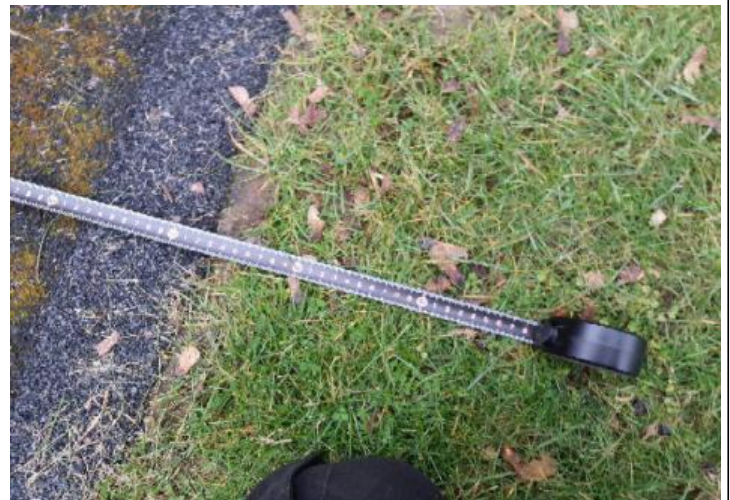
Finding: The surfacing dimensions are short and do not meet with the requirements of the current applicable standard

Action: Monitor - no remedial action recommended

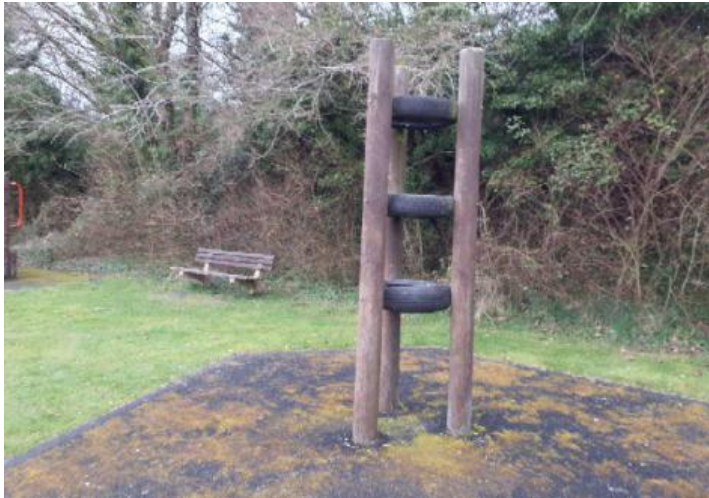
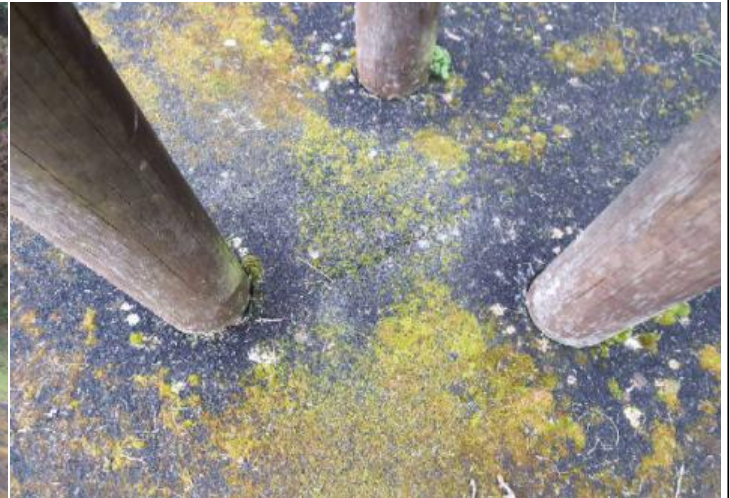
Finding: There is some minor damage to the surface

Action: Monitor for any further deterioration and repair as required

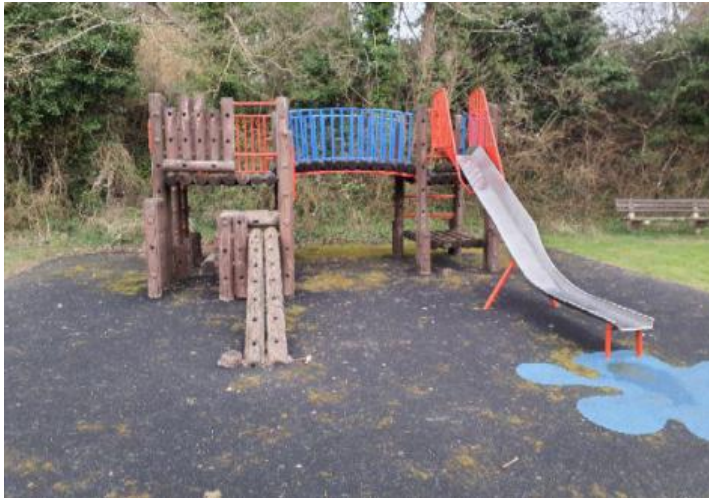
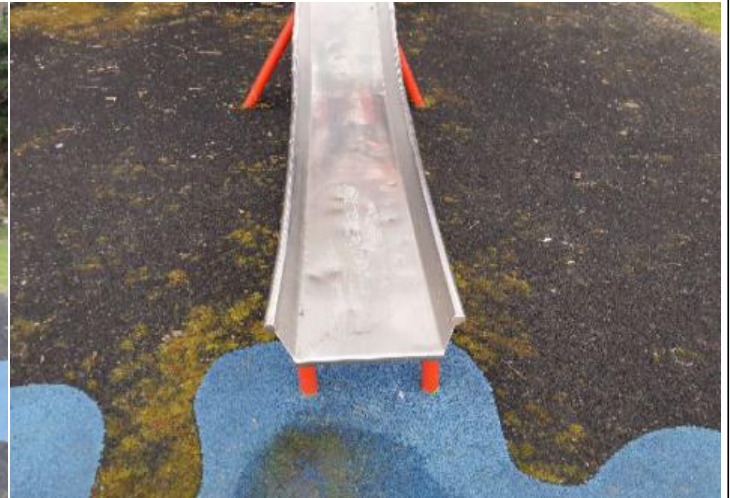
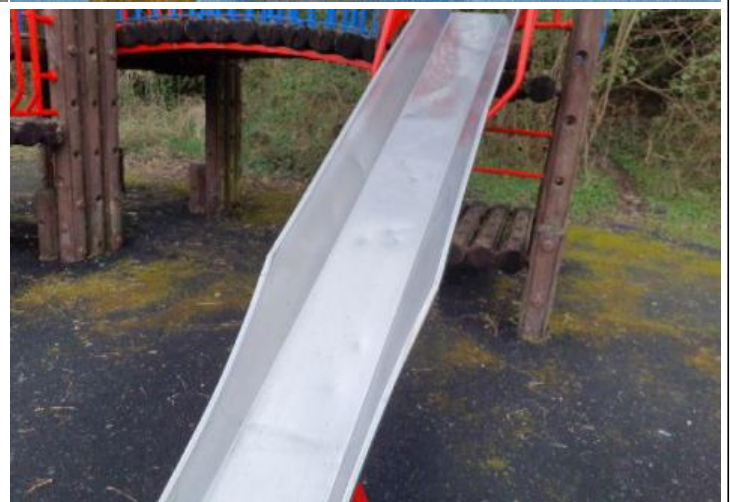
Finding: There are a number of dents in the slide surface

Action: Monitor for any further deterioration and repair as required

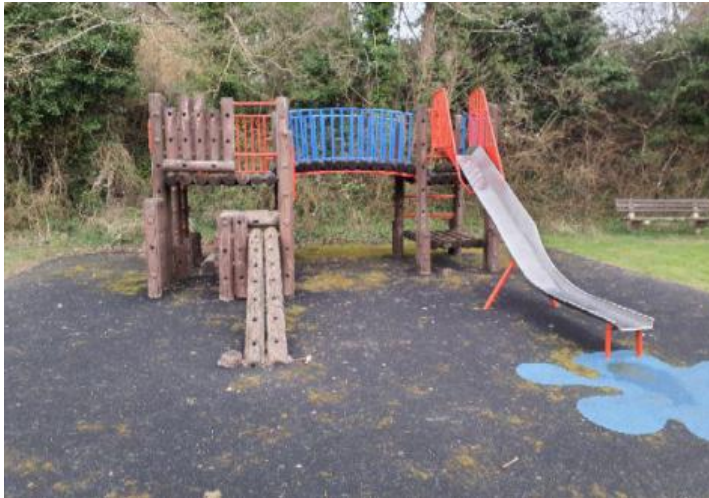
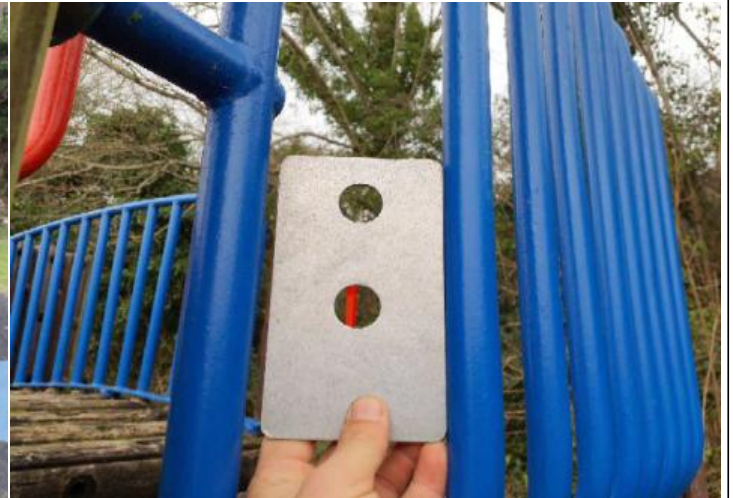
Finding: The item fails to meet the requirements of BS EN 1176 Part 1 4.2.7.2 head and neck entrapment in the barriers and/or steps

Action: Monitor - No remedial work recommended

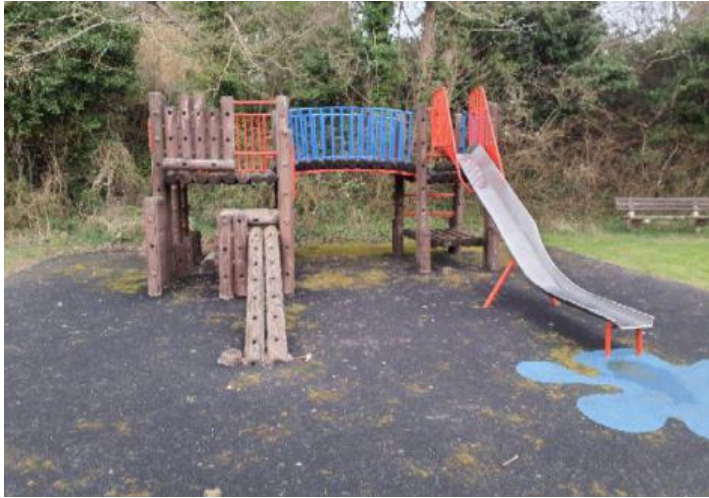
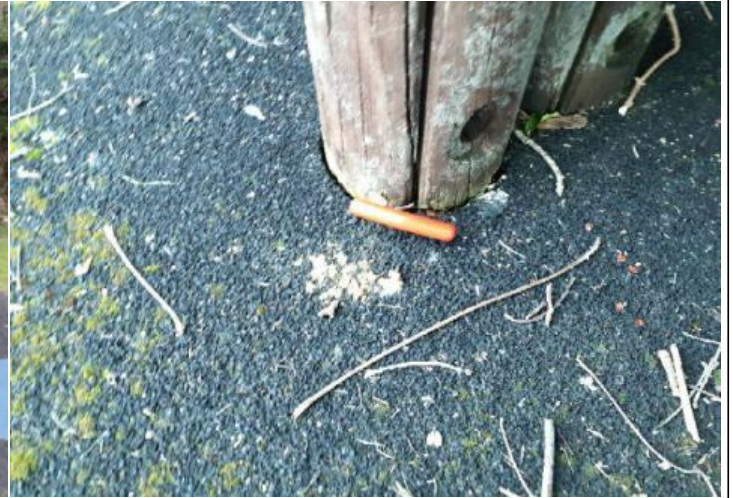
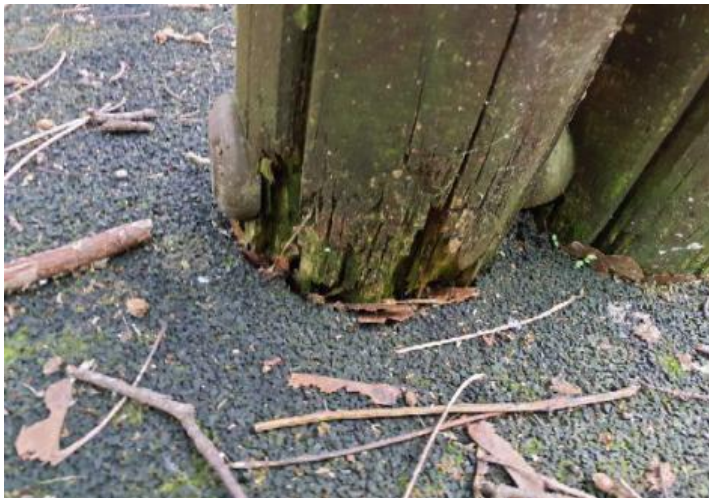
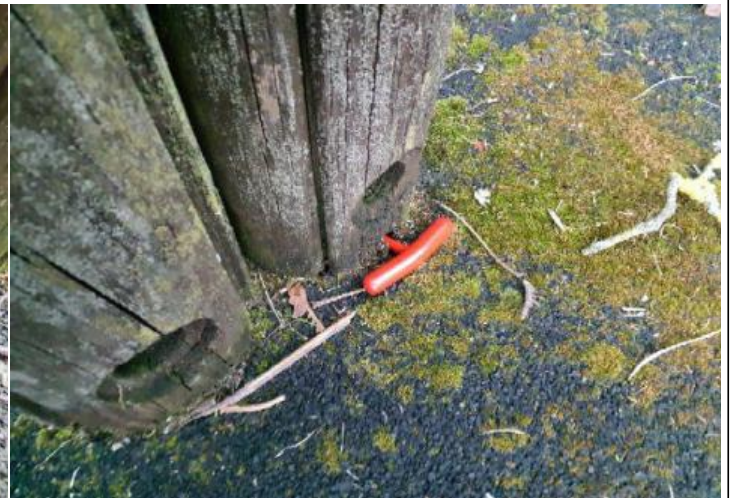
Risk Level: M - Moderate Risk
Surface: Wet Pour

Finding: The inspector is unable to ascertain if there are metal feet below ground supporting the timber posts, if there are not, then the majority of timber posts on the structure appear to have rotted

Action: Investigate further and replace all affected timbers

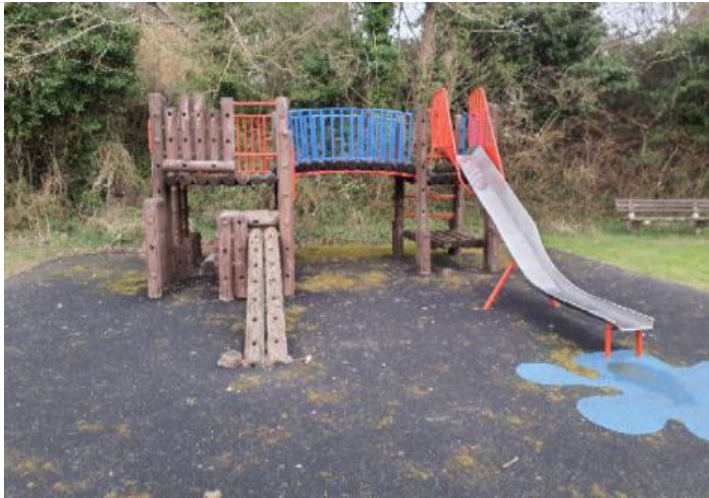
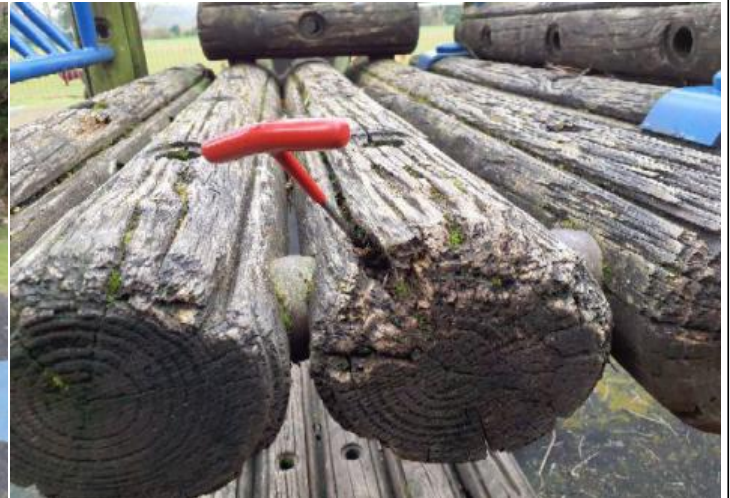
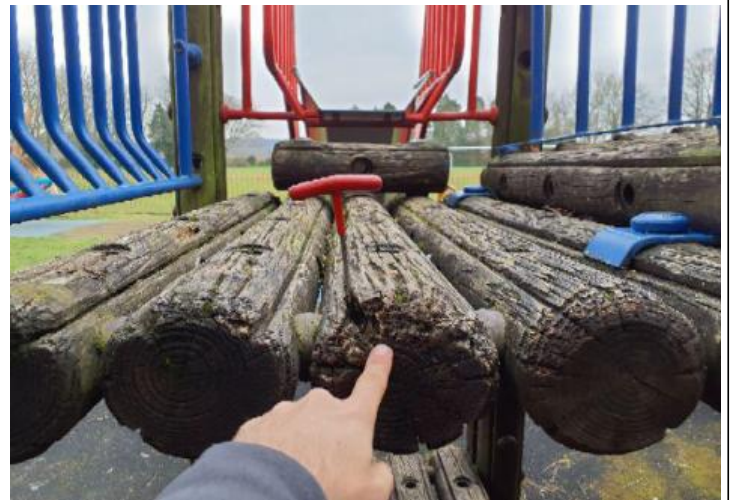
Finding: There are areas or parts of the timber on the structure that have rotted

Action: Replace all affected timbers

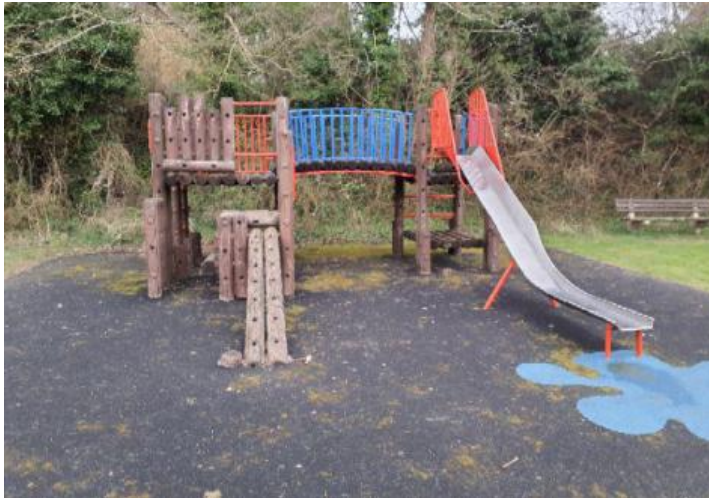
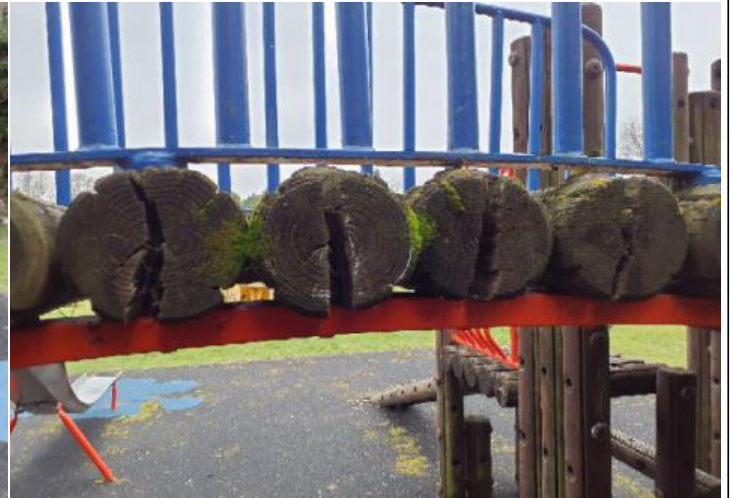
Finding: There are splits in the timber running through fixing points and creating some instability in the structure
Action: Replace all affected timber parts

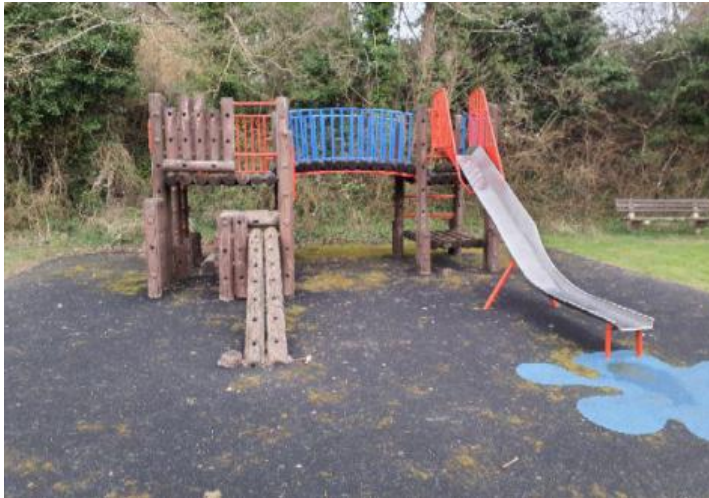
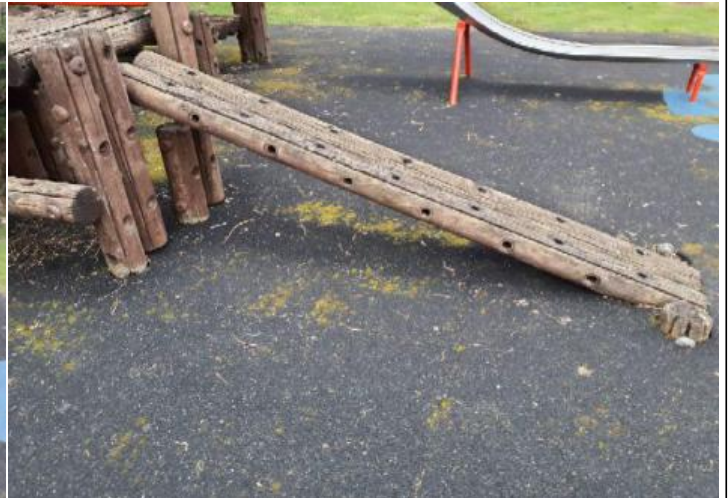
Finding: The access ramp height is greater than 600mm and the angle of ascent is less than 38 degrees. Barriers or guardrails are required to comply with the requirements BS EN 1176

Action: Monitor - No remedial work recommended

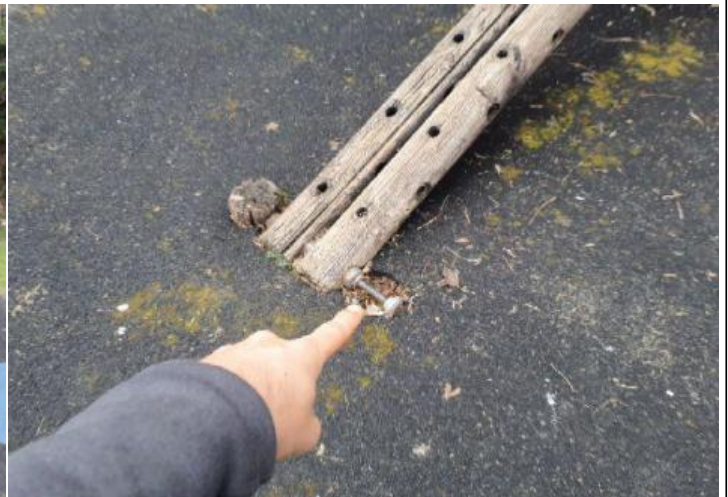
Finding: The item has missing component(s) leaving a trip hazard

Action: Replace missing components

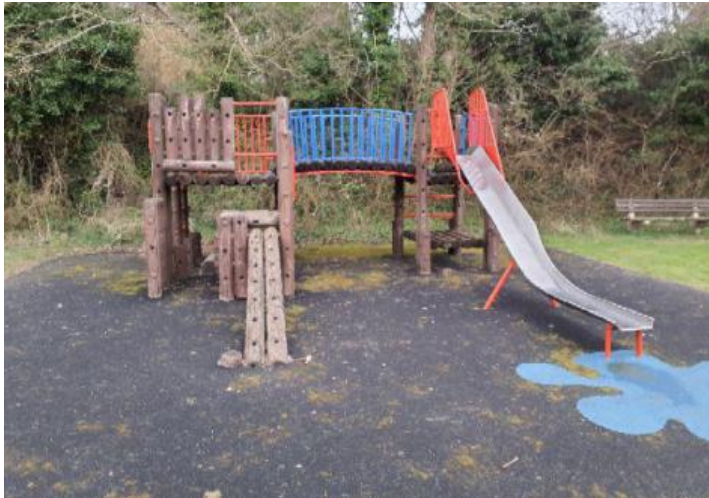
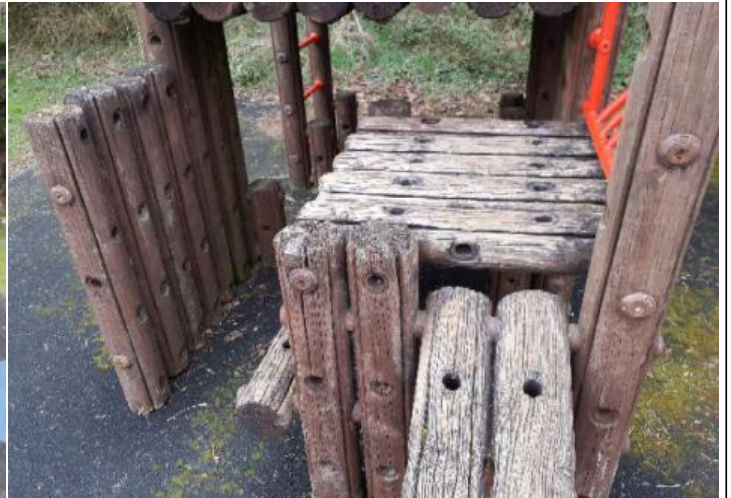
Finding: The unit is easily accessible and should have the appropriate barriers installed to meet the requirements of BS EN 1176 Part 1 as the height of the unit exceeds 600mm

Action: Monitor - No remedial work recommended

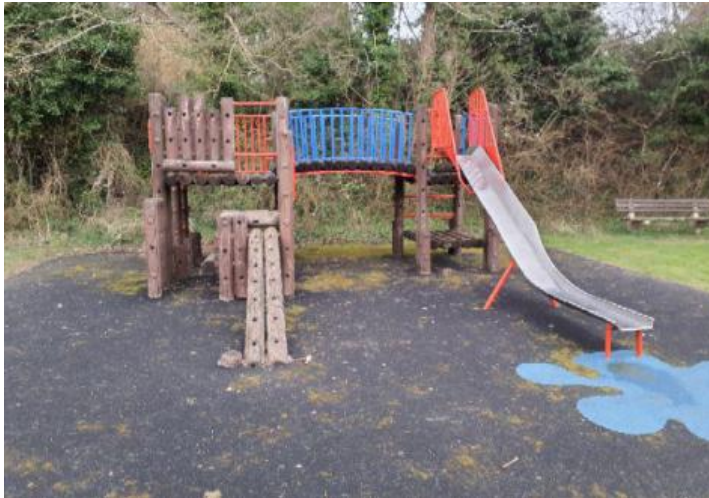
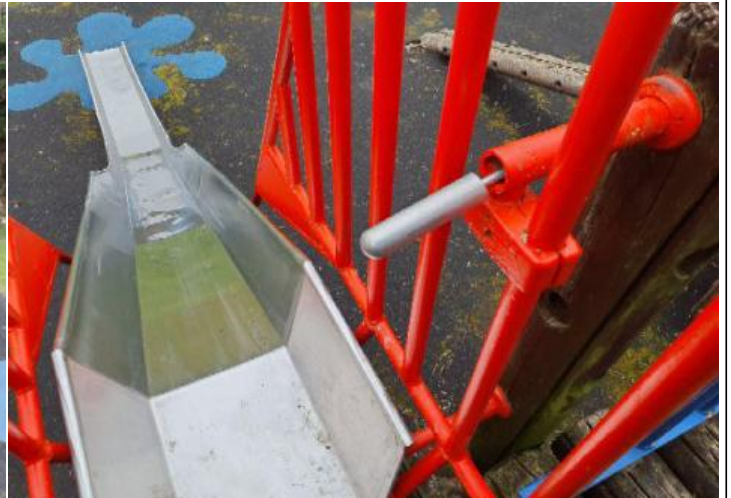
Finding: There is/are finger entrapment/s in the slide starting section and the item fails to meet the requirements of BS EN 1176 Part 1 4.2.7.6 Entrapment of fingers

Action: Monitor - No remedial work recommended

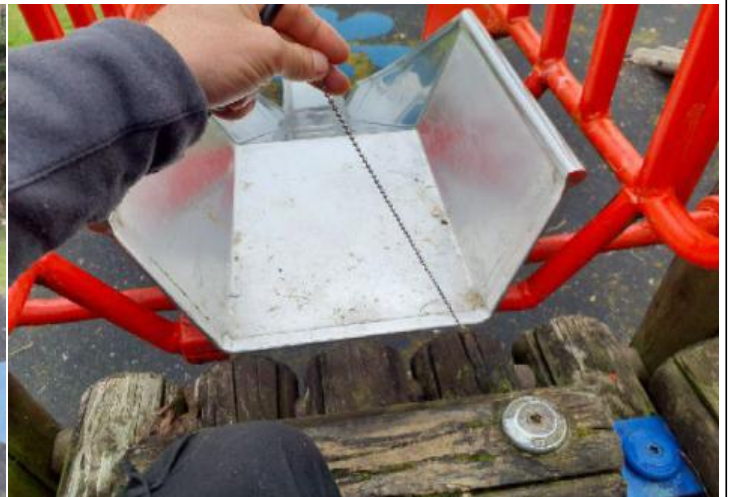
Finding: There is / are toggle entrapment/s present in contravention of the recommendations set out in BS EN 1176 Part 3

Action: Monitor - no remedial work recommended

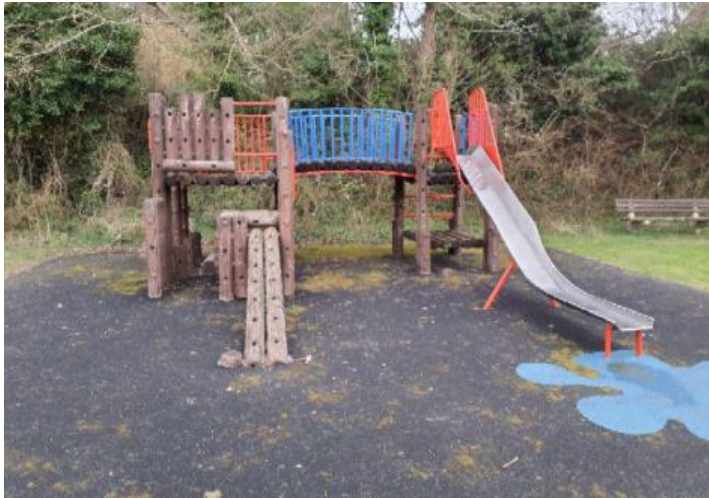
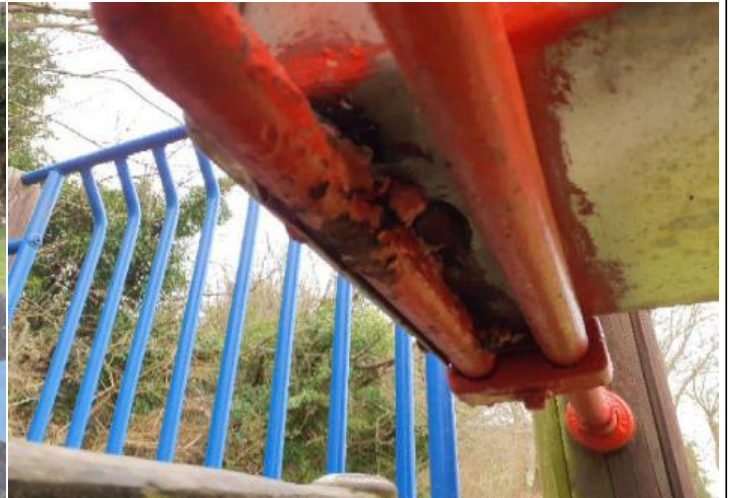
Finding: The paintwork on this item has been damaged or worn exposing the metal underneath which is rusting / corroding

Action: Treat affected areas and repaint

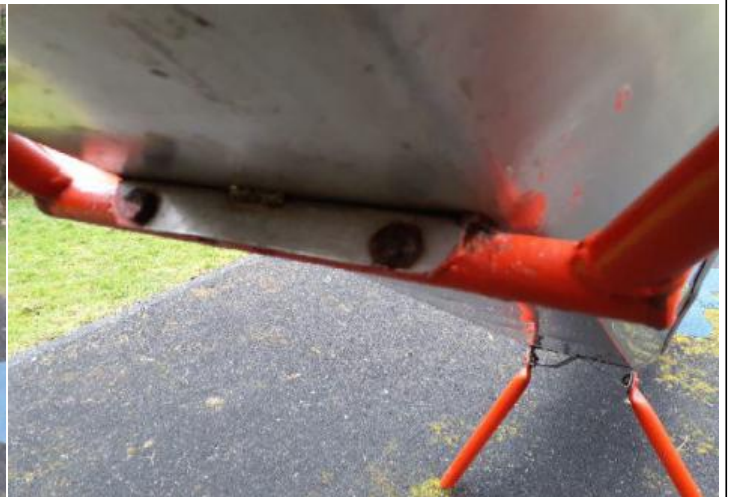
Finding: The fixings have corroded excessively

Action: Replace all corroded fixings

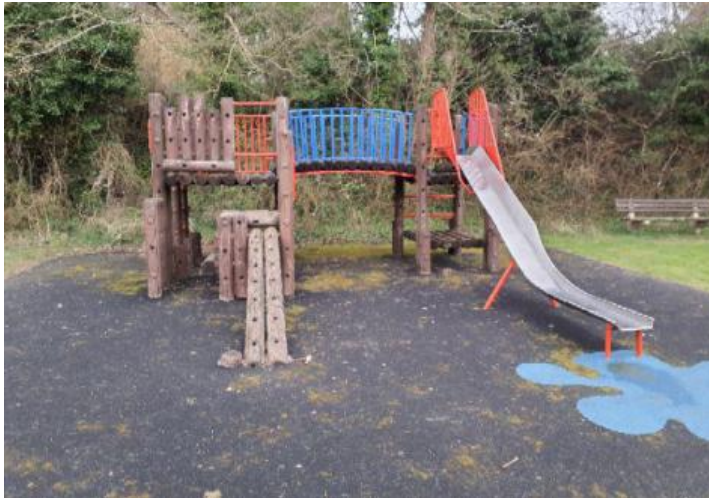
Finding: NOTE: This item is coming towards to, or is at the end of its shelf life
Action: Consider removal and replacement of this item

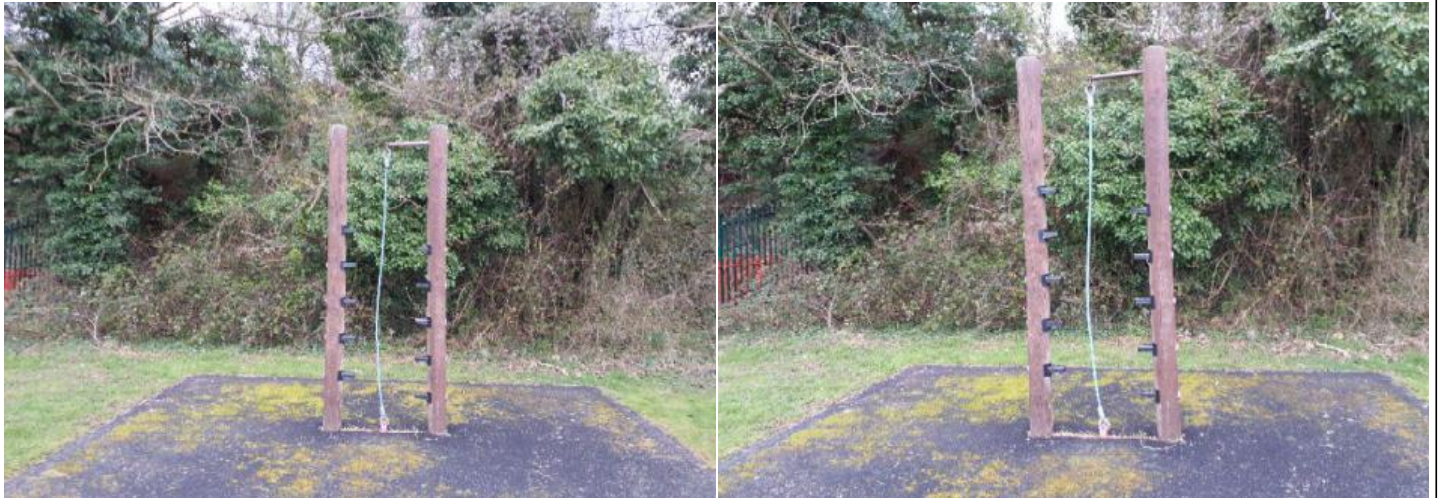
Finding: This item of equipment relies on a single post, or a line of posts, for stability and extra care needs to be taken with equipment of this nature to avoid the potential for catastrophic failure; it has been checked at the time of inspection however its important that particular attention is applied on all interim inspections

Action: Ensure that regular detailed inspections are undertaken to assess for rot, corrosion and general stability

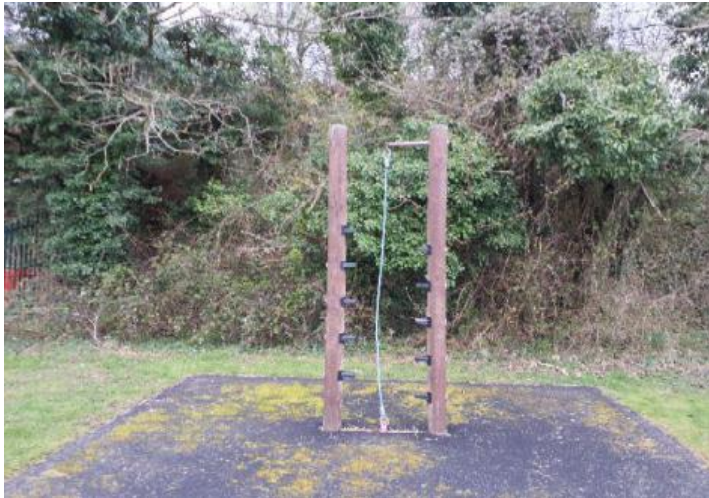
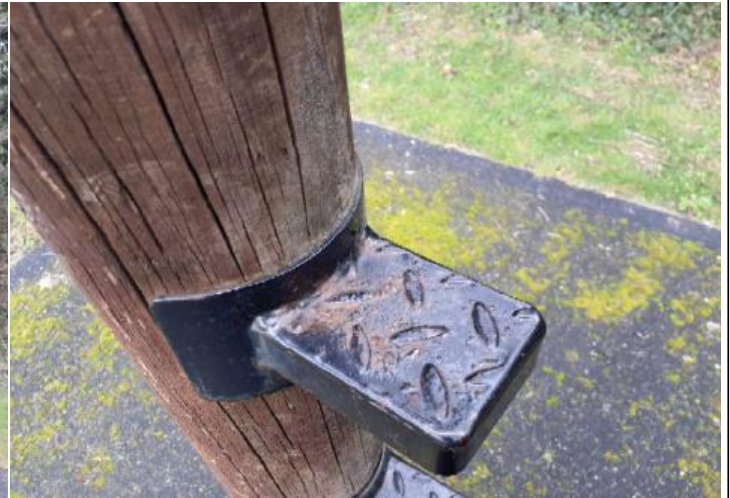
Finding: The paintwork on this item has been damaged or worn exposing the metal underneath which is rusting / corroding

Action: Treat affected areas and repaint

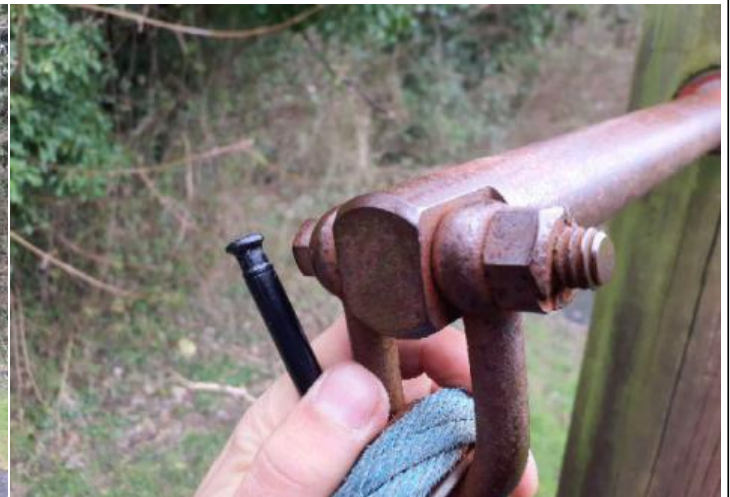
Finding: There is surface corrosion / rust present on the item

Action: Consider treating the item

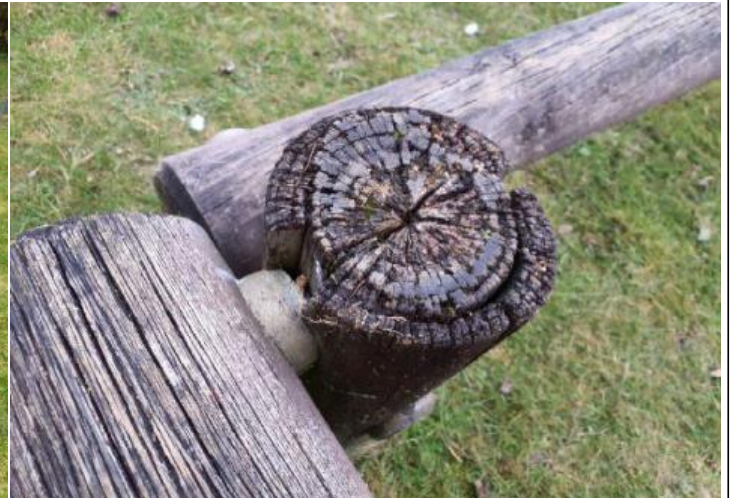
Finding: There is some damage to the item

Action: Monitor for any further deterioration and repair as required

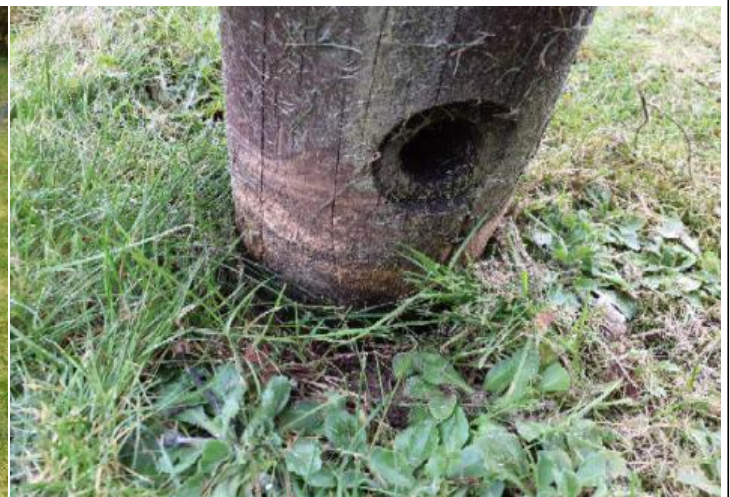
Finding: There is some strimmer / machinery damage apparent on the posts, this can penetrate the preservative applied to the timber and accelerate the rotting process

Action: Monitor for any deterioration (rot) and replace as required

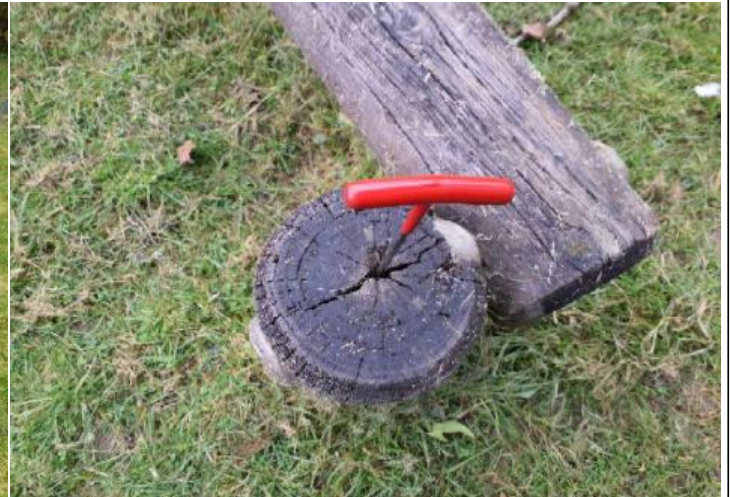
Finding: There is some evidence of rot in the timber

Action: Monitor for any further deterioration and replace as required
