the **play inspection** company

Annual Inspection

Winchester City Council

Sun Hill Recreation Ground (New Alresford)

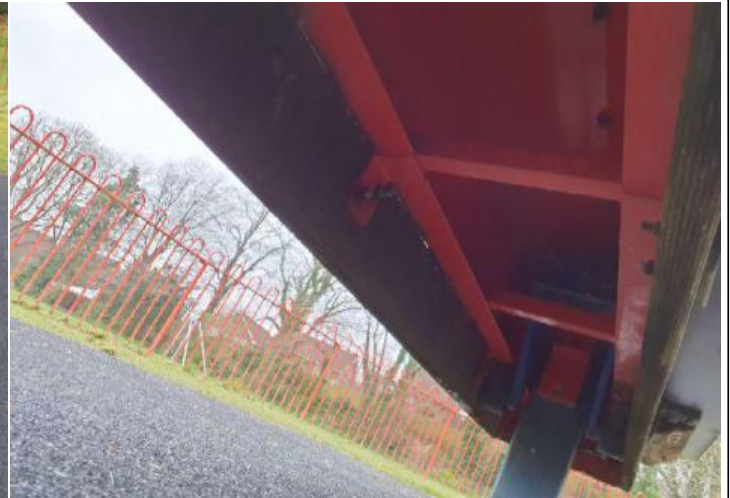
Finding: There is no gaiter protection for accessible moving parts (possible shear trap) as recommended in BS EN 1176 Part 1; 4.2.6 Moving Parts

Action: Monitor - No remedial work recommended

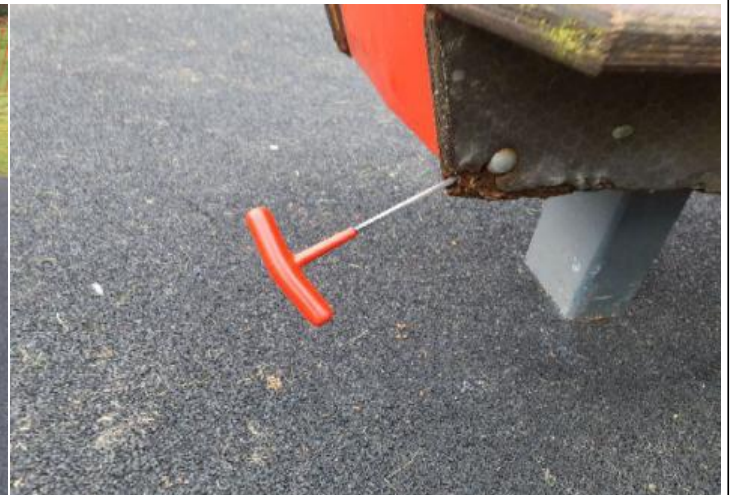
Finding: There is some evidence of rot in the timber

Action: Monitor for any further deterioration and replace as required

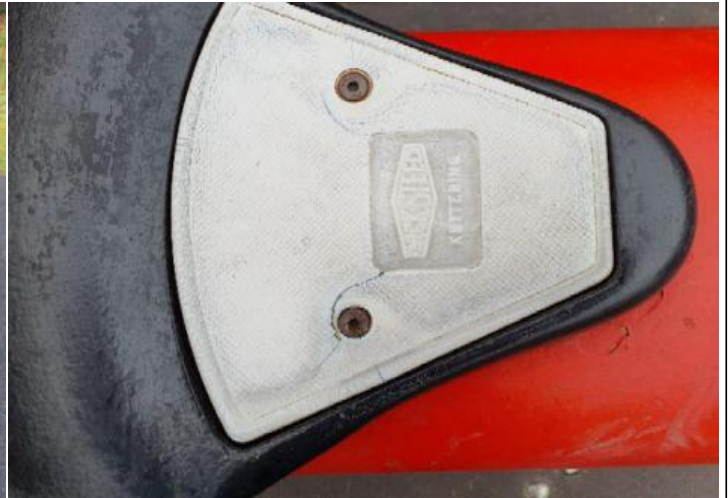
Finding: There is some damage to the item

Action: Monitor for any further deterioration and repair as required

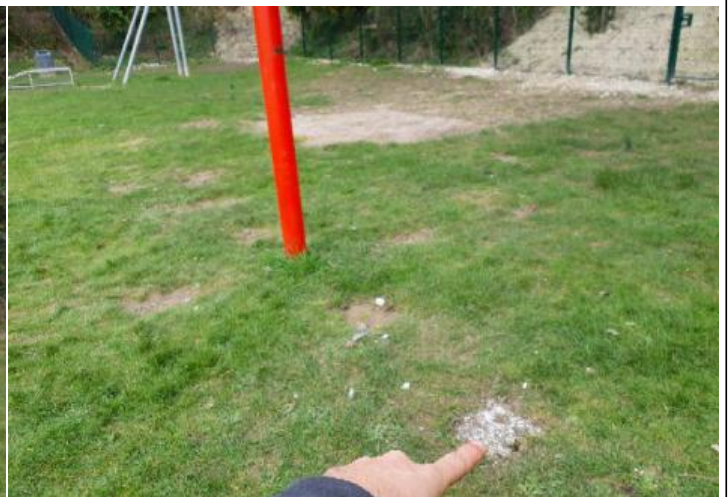
Finding: The surface has eroded and the foundations are exposed

Action: Reinststate surrounding surfaces to cover the foundations

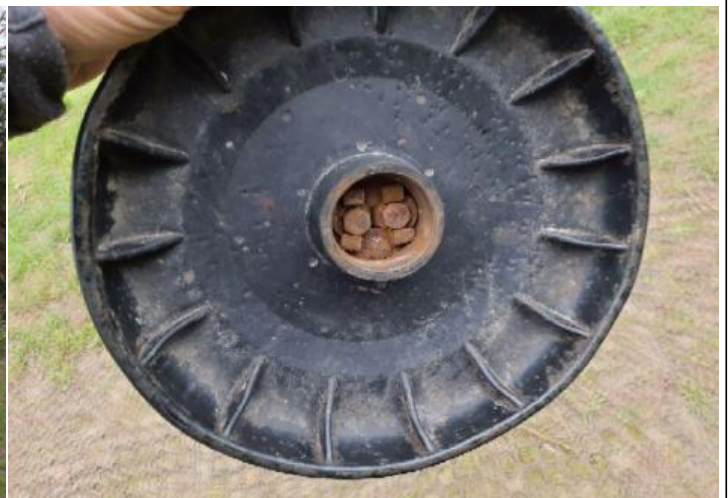
Finding: The seat connection cannot be inspected without dismantling the seat

Action: Dismantle the seat to inspect the seat connection for wear

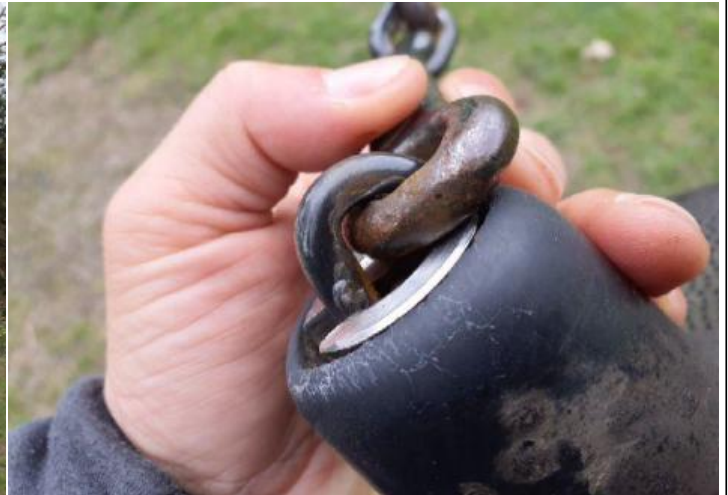
Finding: There is some notable evidence of chain wear

Action: Monitor for any further deterioration and replace when 40% worn

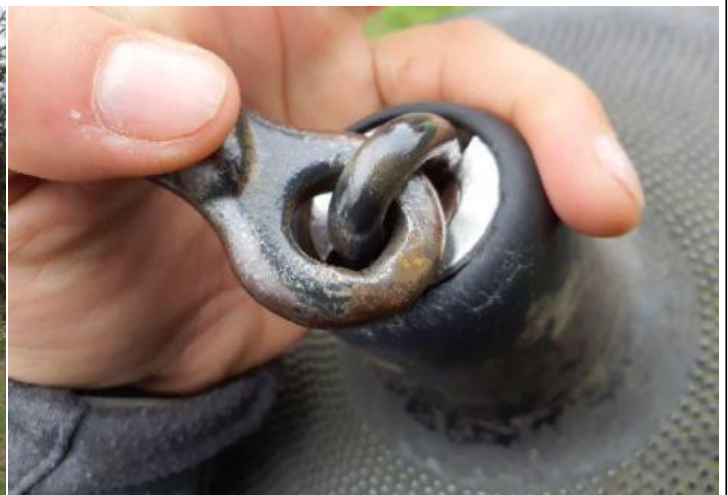
Finding: The connecting lugs are showing signs of wear

Action: Monitor for any further deterioration and repair as required

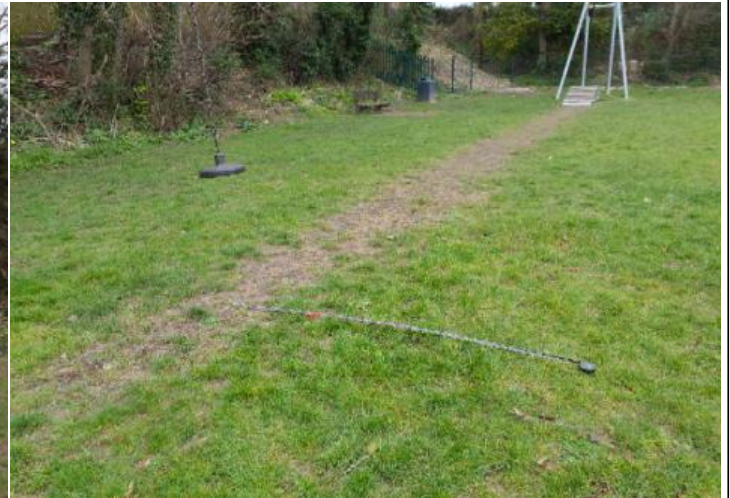
Finding: The item of equipment has a fall height exceeding 1.50 metres (1.7m) and grass has been provided as a safety surface, in contravention of the applicable standard (NOTE - Well maintained grass is only suitable for fall heights of upto 1.50m)
Action: Monitor - no remedial action recommended

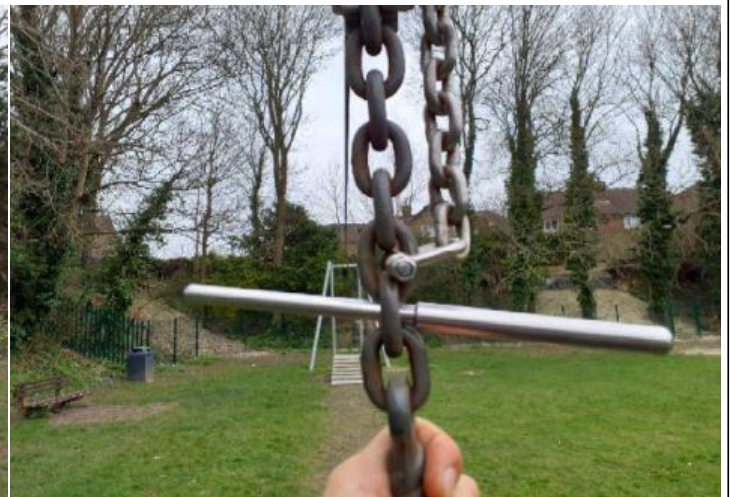
i 5 - Very Low Risk (Finding 9)

Finding: The chain openings are in excess of the 8.6mm as recommended by BS EN 1176
Action: Monitor - No remedial work recommended

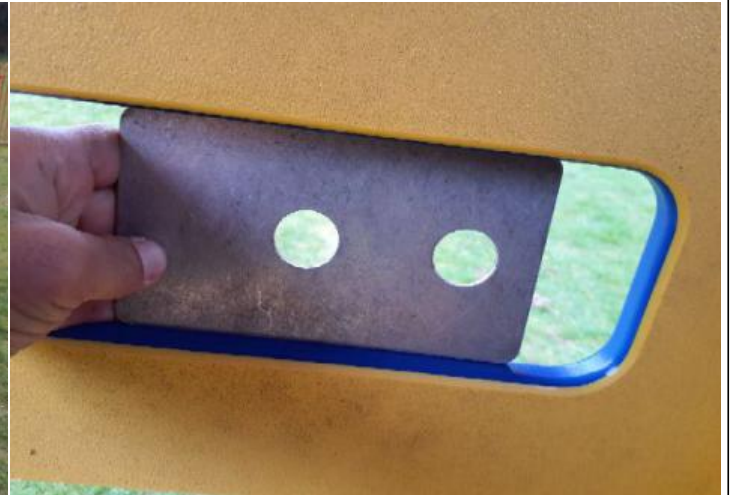
Finding: The item fails to meet the requirements of BS EN 1176 Part 1 4.2.7.2 head and neck entrapment in the barriers and/or steps
Action: Monitor - No remedial work recommended

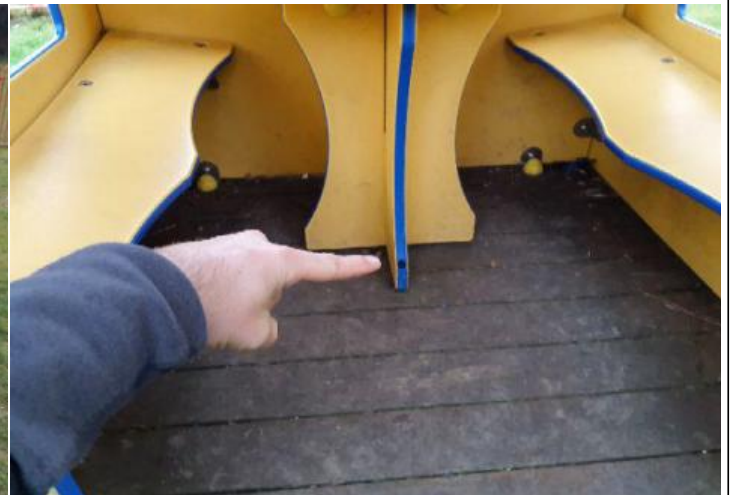
i 6 - Low Risk (Finding 2)

Finding: A number of fixing(s) have worked loose
Action: Secure all loose fixings

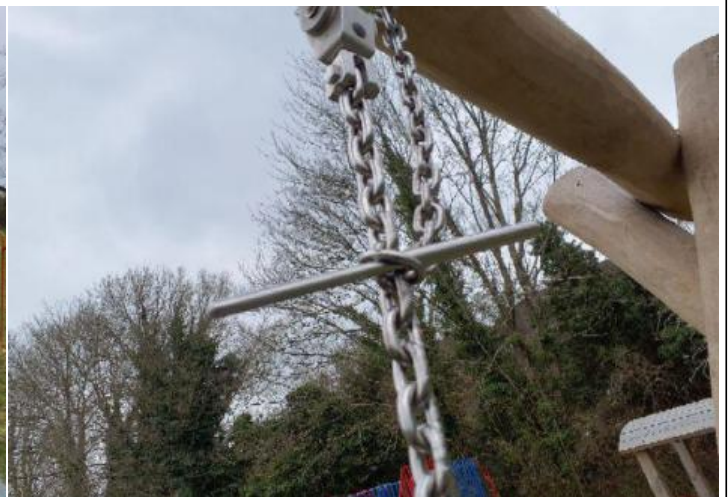
Finding: The connecting links are in excess of 8.6mm and less than 12mm and fail the requirements of BS EN 1176 Part 1; clause 4.2.13, Chains

Action: Monitor - No remedial work recommended
