Annual Inspection

Winchester City Council

Stratton Bates Recreation Ground (New Alresford)

Inspected: 11-March-2024 - 13:44 by Dom Park (RPII Annual Inspector)

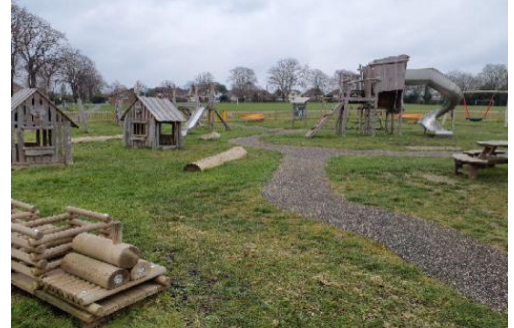
The area around the item has eroded and may become slippery - Reinstate eroded area

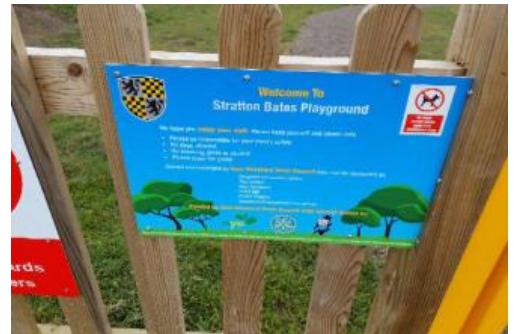
This item is satisfactory - no work required -

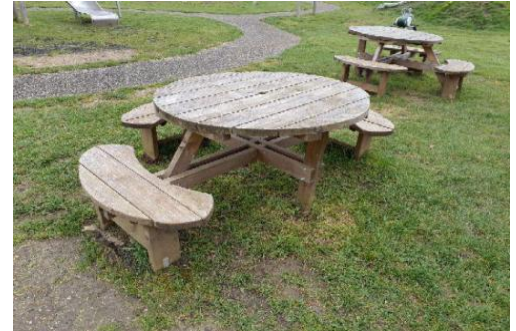
There is or are fixings missing on the item - Replace all missing fixings

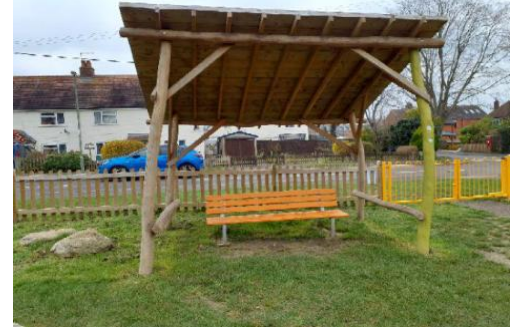
The surface has eroded and the foundations are exposed - Reinstate surrounding surfaces to cover the foundations

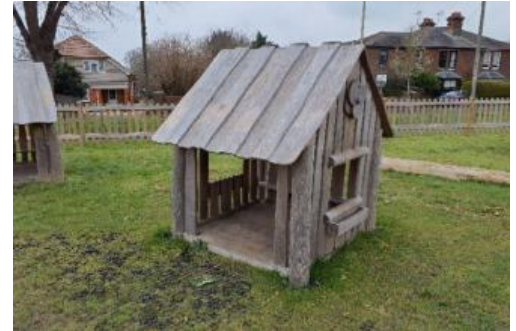
This item is satisfactory - no work required -

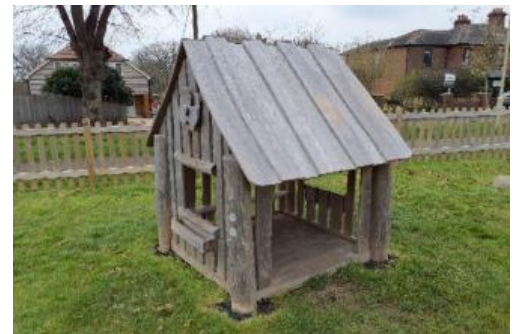
This item is satisfactory - no work required -

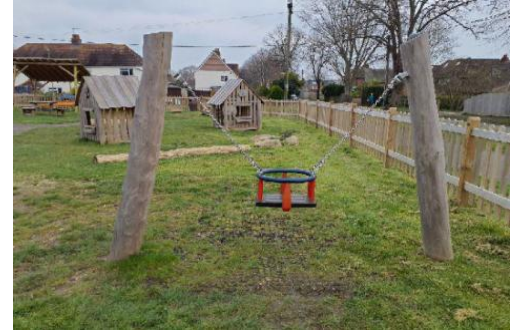
This design of swing joint has been known to fail on the weld connecting the joint to the threaded stud - We would recommend that the joint be dismantled and checked on a regular basis or consulting with manufacturer on whether a Secondary Safety Device can be fitted

There is some notable evidence of chain wear - Monitor for any further deterioration and replace when 40% worn

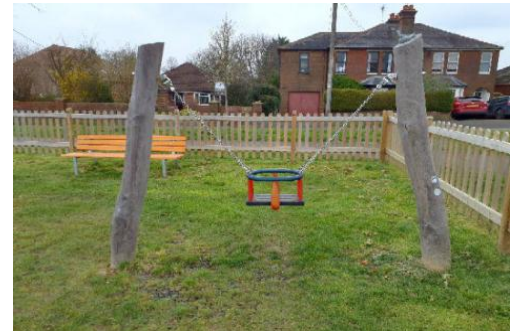
This design of swing joint has been known to fail on the weld connecting the joint to the threaded stud - We would recommend that the joint be dismantled and checked on a regular basis or consulting with manufacturer on whether a Secondary Safety Device can be fitted

There is some notable evidence of chain wear - Monitor for any further deterioration and replace when 40% worn

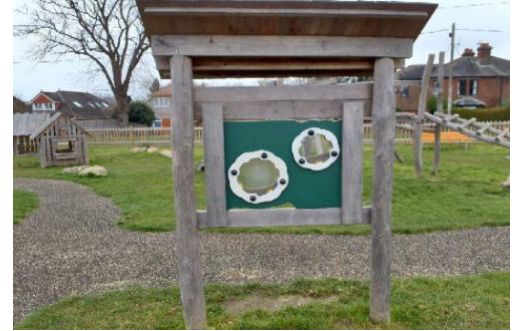
The item fails to meet the requirements of BS EN 1176 Part 1 4.2.7.2 for head and neck entrapment in the structure - Monitor - No remedial work recommended

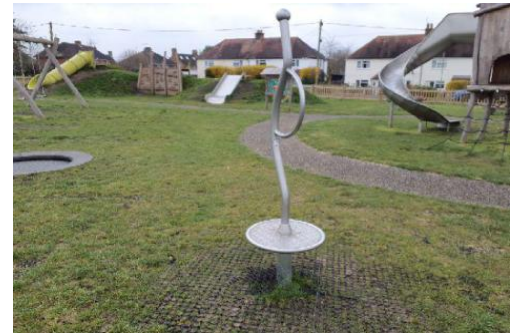
The bearing is showing signs of wear - Monitor for any further deterioration and replace as required

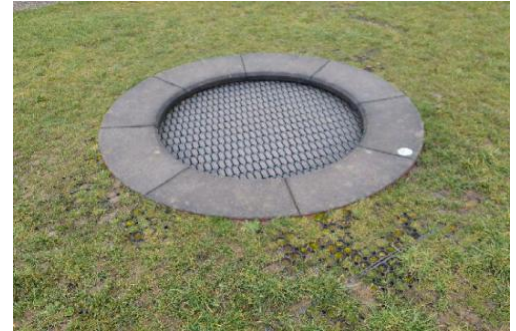
On site visits it is not possible to test the ground clearance of the Bouncing Facility bed as specified in BS EN 1176; ensure that the clearance between the Bouncing Facility Bed and the ground underneath is in accordance with the manufacturers recommendations (recorded nominal depth at time of inspection 330mm measured unloaded). - Refer to the manufacturers recommendations

There are trip hazards present - Reinstate surrounding surfaces to level to remove the trip points

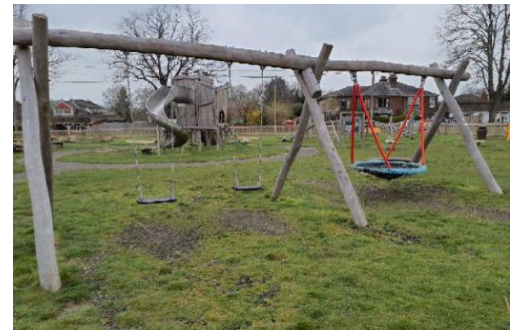
The chain openings are in excess of the 8.6mm as recommended by BS EN 1176 - Monitor - No remedial work recommended

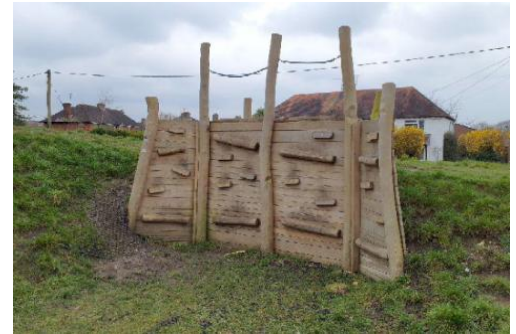
There is an opening in the barriers exceeding the width allowed (500mm) in BS EN 1176, this is a low risk failure and no remedial action is required - Monitor - No remedial work recommended

The unit is easily accessible and should have the appropriate barriers installed to meet the requirements of BS EN 1176 Part 1 as the height of the unit exceeds 600mm - Monitor - No remedial work recommended

There is/are finger entrapment/s in the structure and the item fails to meet the requirements of BS EN 1176 Part 1 4.2.7.6 Entrapment of fingers - Monitor - No remedial work recommended

The ropes/nets are worn/damaged in places - Monitor for any further deterioration and repair or replace as required

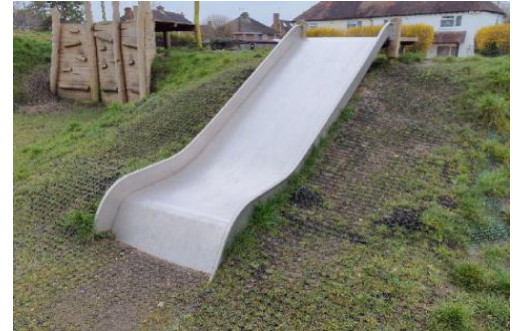
The grass matrix tiles have buckled in places, causing trip hazards - Provide additional ties or secure / reinstate surface

There are unused fixing holes on the item - Replace as required

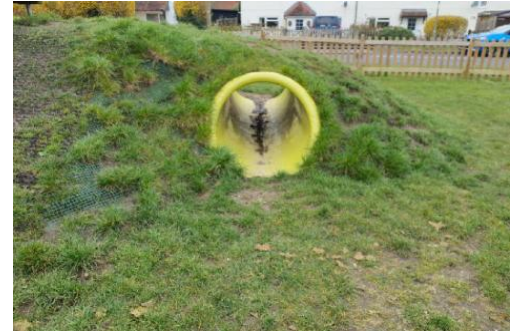
This design / configuration of tunnel mound is well established and has been successfully included in large quantities of playgrounds throughout the UK. Whilst the design does not fully meet the requirements of BS EN 1176 with regards to falls in excess of 600mm over the edge of the tunnel to the surface below, it has been risk assessed as fit for purpose in this regard and no changes are recommended to the design unless otherwise stated in additional findings - Monitor - No remedial work recommended

The edges of the grass mat surface are raised / lifting above the surrounding surface - Tuck in or pin edges of grass mats as per the API Code of Practice to remove trip hazards

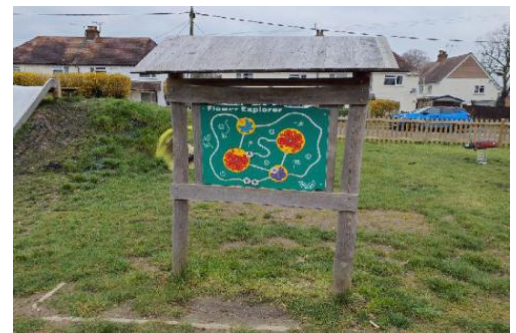
The item is slightly loose in its foundations - Monitor for any further deterioration and repair as required

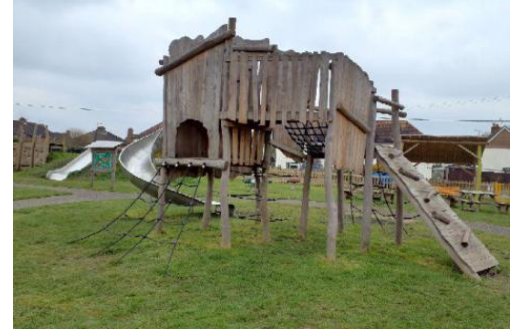
There is/are finger entrapment/s in the structure and the item fails to meet the requirements of BS EN 1176 Part 1 4.2.7.6 Entrapment of fingers - Monitor - No remedial work recommended

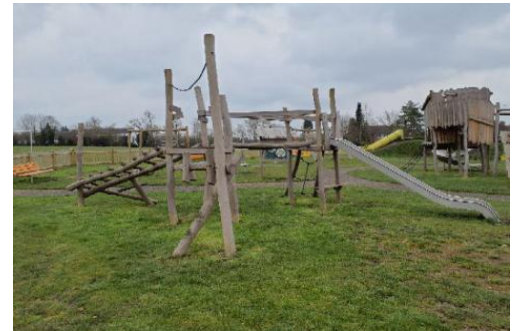
There is an opening in the barriers exceeding the width allowed (500mm) in BS EN 1176, and no guardrail has been provided; this is a low risk failure and no remedial action is required - Refer to the manufacturer

There is/are finger entrapment/s in the slide starting section and the item fails to meet the requirements of BS EN 1176 Part 1 4.2.7.6 Entrapment of fingers - Monitor - No remedial work recommended

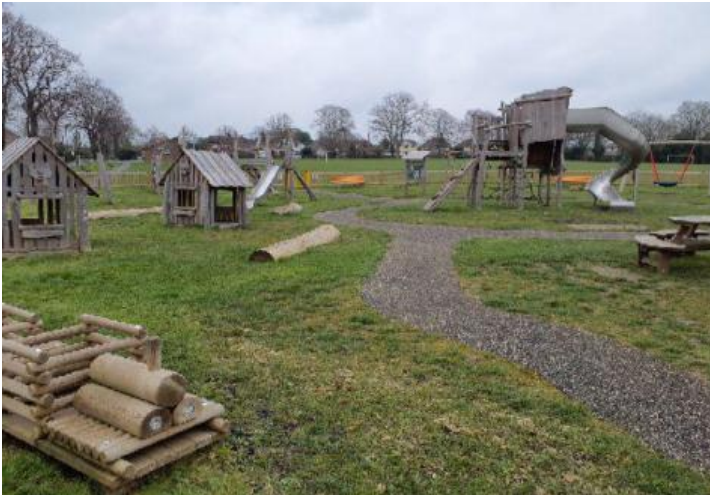
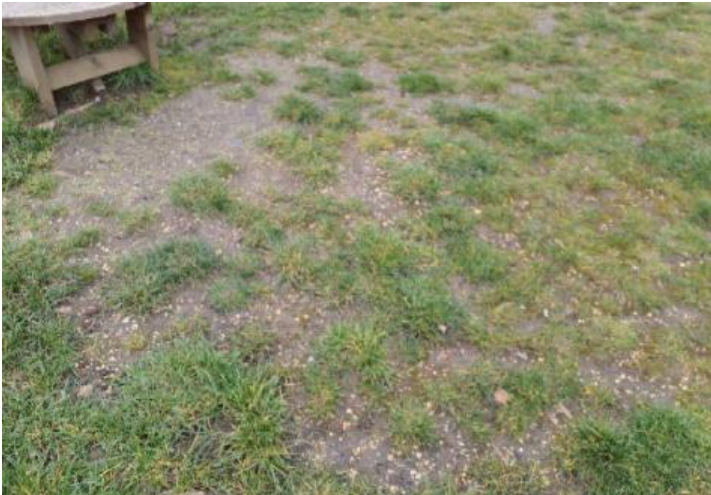
Item:	Ancillary Items - Site General	Risk Level:	L - Low Risk
Manufacturer:	Owner/Operator	Surface:	N/A

Finding: The area around the item has eroded and may become slippery

Action: Reinstate eroded area

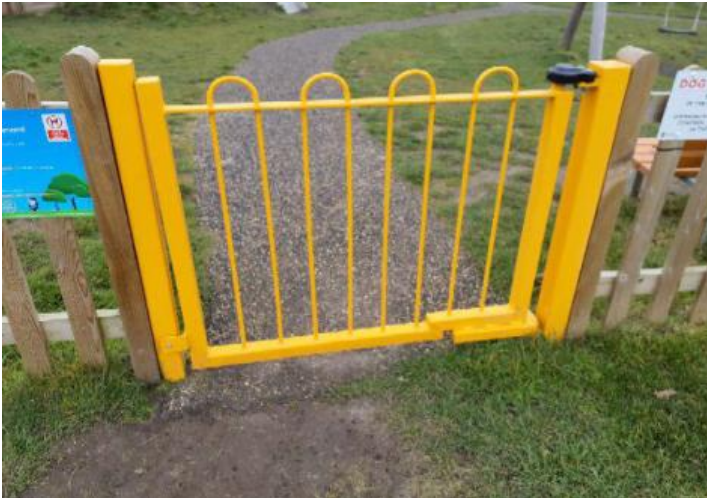
Item: Gates - Gate - Self Closing
Manufacturer: Not Identified

Finding: There are openings that are less than 12mm that could trap or crush fingers

Action: Provide a 12mm gap throughout full range of motion at both sides of gate

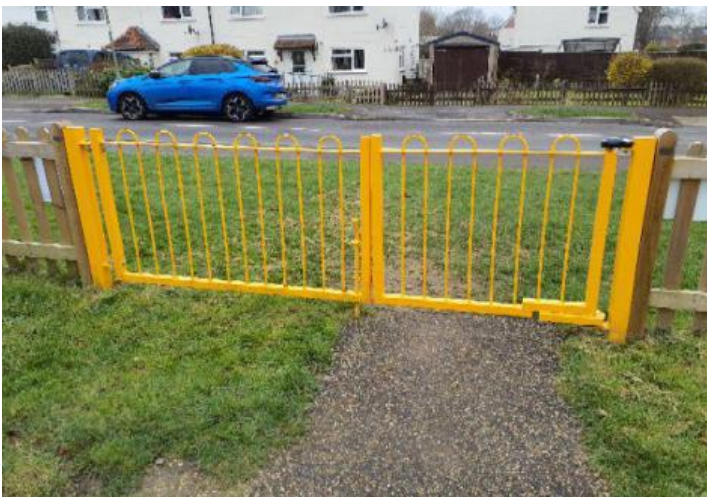
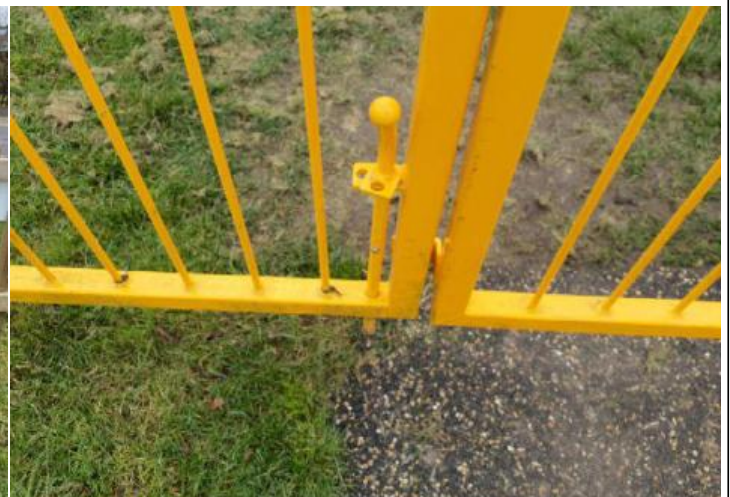
Item: Gates - Gate - Combination
Manufacturer: Not Identified

Finding: The maintenance gate was correctly padlocked at the time of inspection, however this means that the inspector was unable to fully assess the gate

Action: Ensure that there are 12mm gaps throughout the full range of motion on gate/s and between leaves where relevant

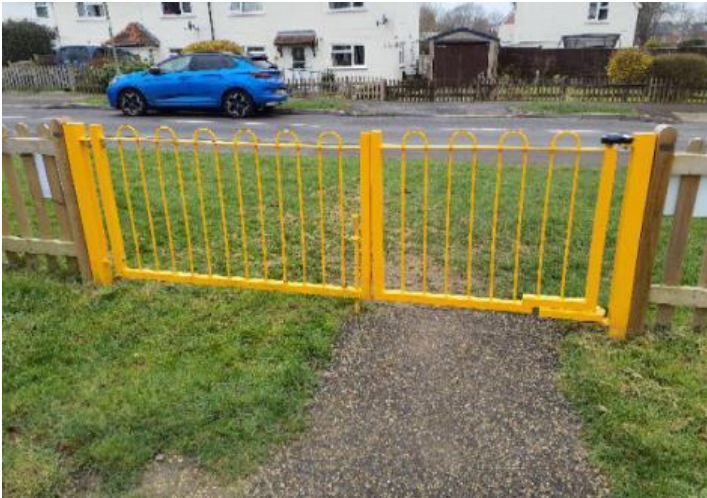
Item: Gates - Gate - Combination
Manufacturer: Not Identified

Finding: There are openings that are less than 12mm that could trap or crush fingers

Action: Provide a 12mm gap throughout full range of motion at both sides of gate

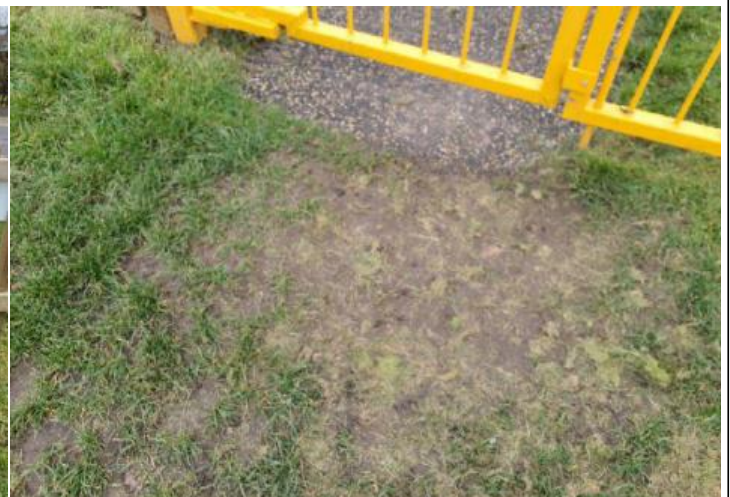
Item: Gates - Gate - Combination
Manufacturer: Not Identified

Finding: The area around the item has eroded and may become slippery

Action: Reinstate eroded area

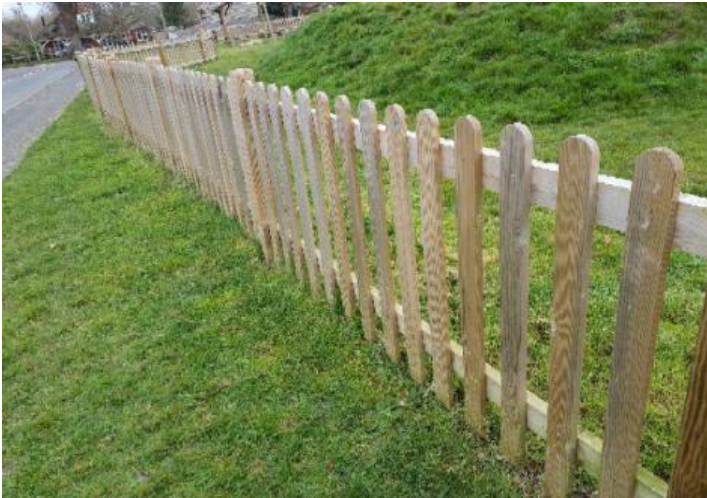
Item: Fences - Fencing - Timber
Manufacturer: Jacksons Fencing

Finding: There is a potential head and neck entrapment in the fence

Action: No further action required

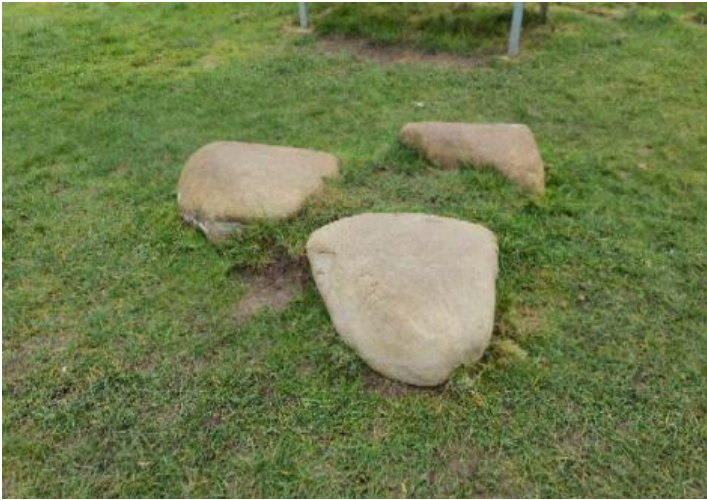
Item: Ancillary Items - Boulders
Manufacturer: Natural Feature

Finding: There is weed / vegetation growth on, between, or around the edges of the surfacing
Action: Remove weed / vegetation growth

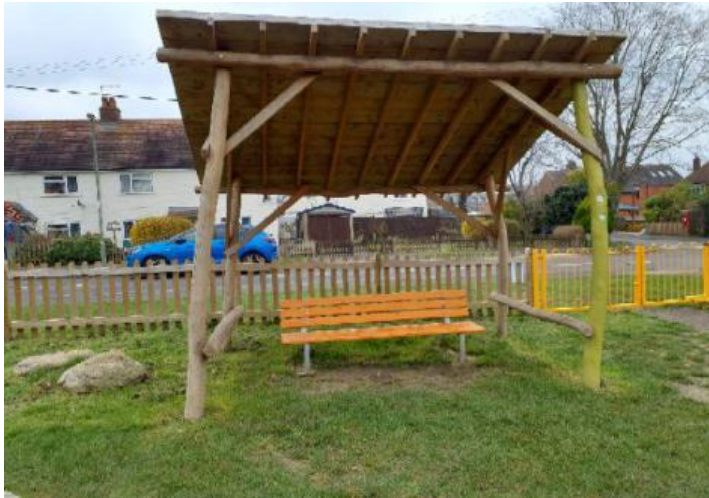
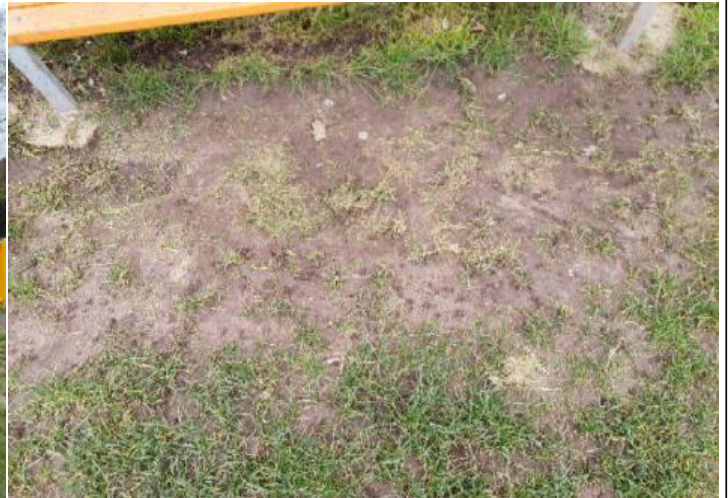
Item: Ancillary Items - Shelter
Manufacturer: Eibe Play Ltd

Finding: The area around the item has eroded and may become slippery

Action: Reinststate eroded area

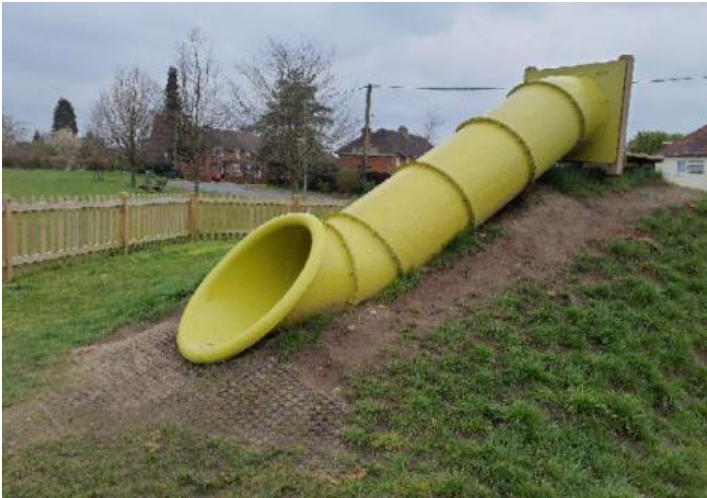
Item: Other - Tube Slide
Manufacturer: Eibe Play Ltd

Finding: Fixing Pins have been installed in the impact areas of the grass mats
Action: Remove pins from impact areas

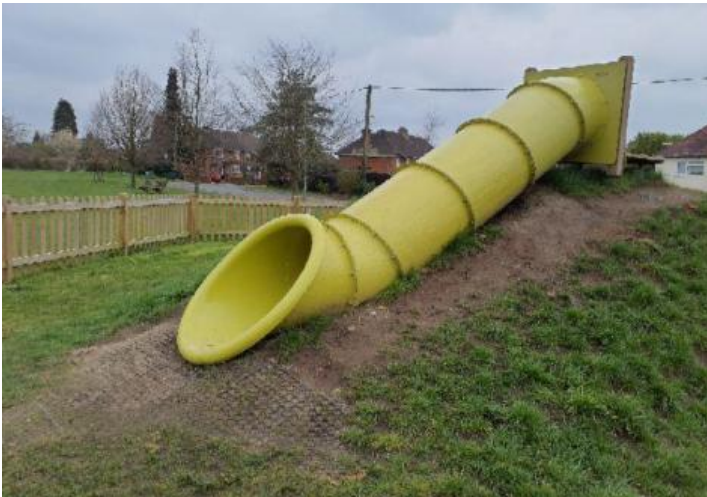
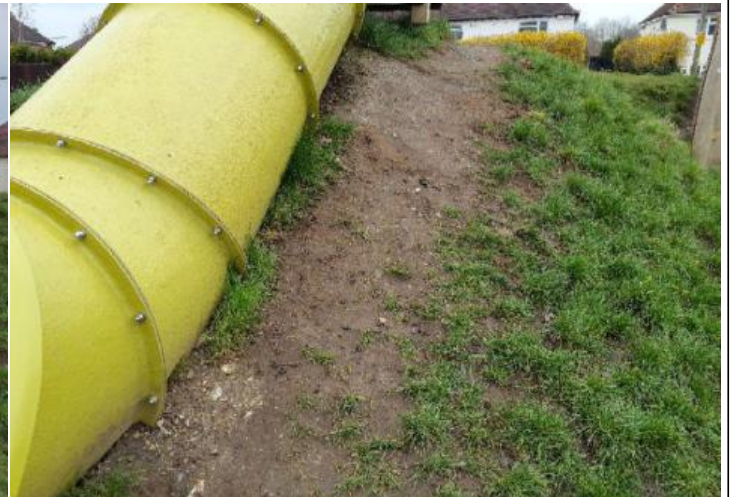
Item: Other - Tube Slide
Manufacturer: Eibe Play Ltd

Finding: The area around the item has eroded and may become slippery
Action: Reinstate eroded area

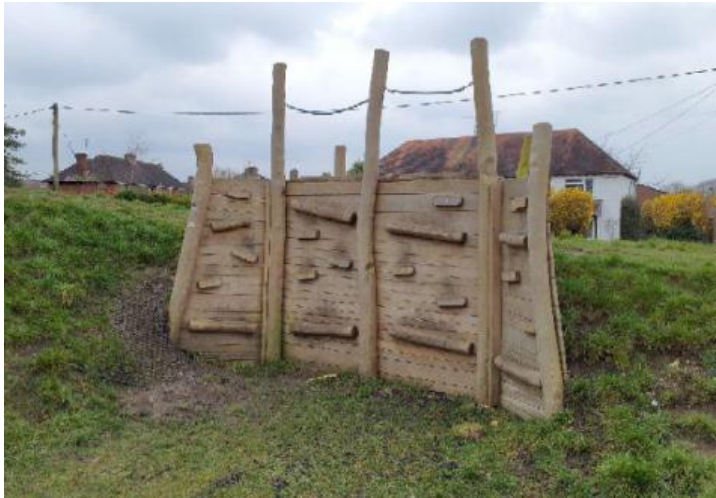
Item: Activity Equipment - Climbing Wall
Manufacturer: Eibe Play Ltd

Finding: Fixing Pins have been installed in the impact areas **Action:** Remove pins from impact areas of the grass mats

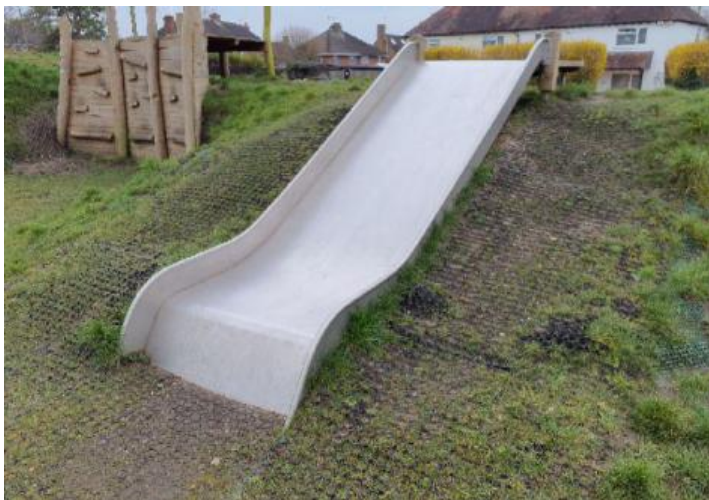
Item: Other - Embankment Slide
Manufacturer: Eibe Play Ltd

Finding: Fixing Pins have been installed in the impact areas of the grass mats

Action: Remove pins from impact areas

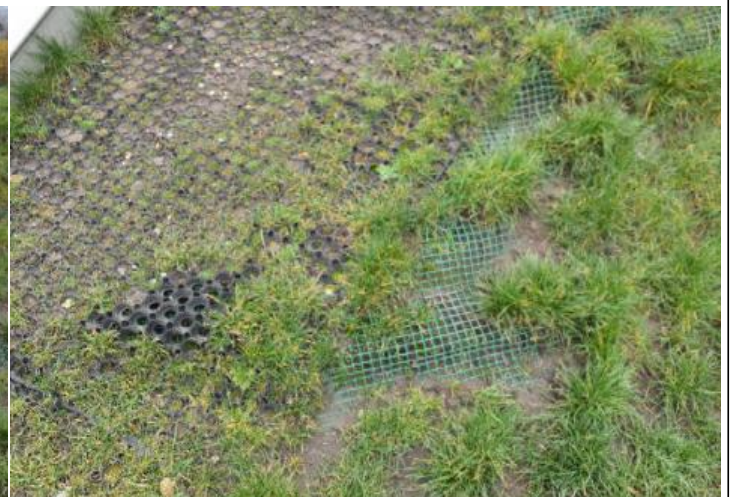
Item: Other - Embankment Slide
Manufacturer: Eibe Play Ltd

Finding: The safety surface is low and the membrane is exposed creating trip points

Action: Remove or resecure the exposed membrane and top up the surface to the correct level

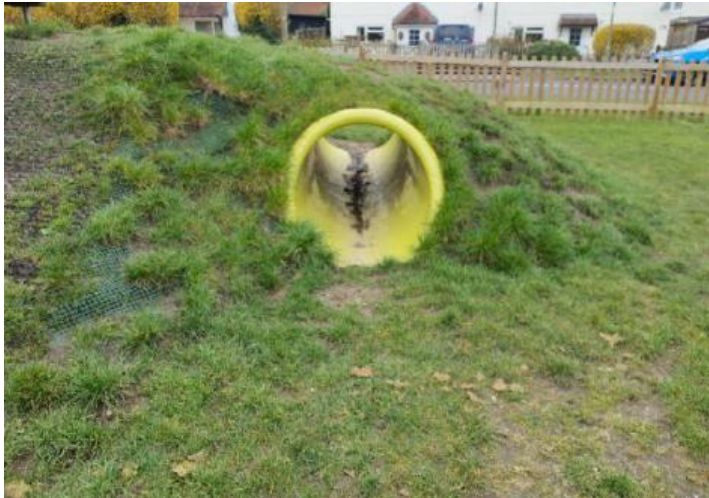
Item: Other - Tunnel Mound
Manufacturer: Eibe Play Ltd
Risk Level: L - Low Risk
Surface: Grass

Finding: The area around the item has eroded and may become slippery

Action: Reinststate eroded area

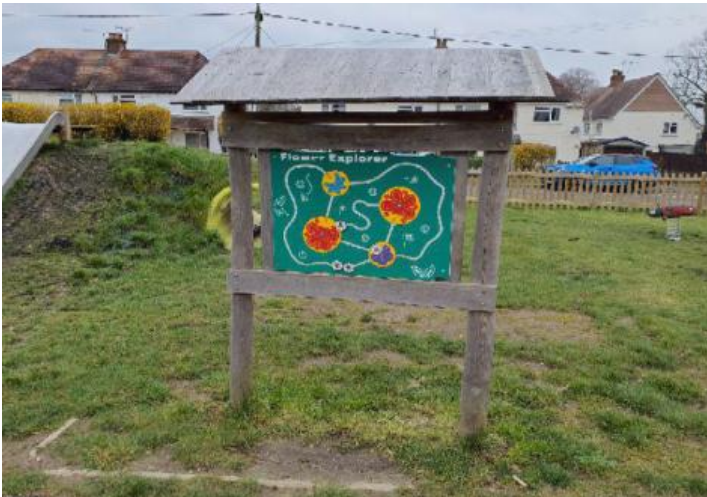
Item: Other - Play Panel
Manufacturer: Eibe Play Ltd

Finding: The area around the item has eroded and may become slippery

Action: Reinstate eroded area

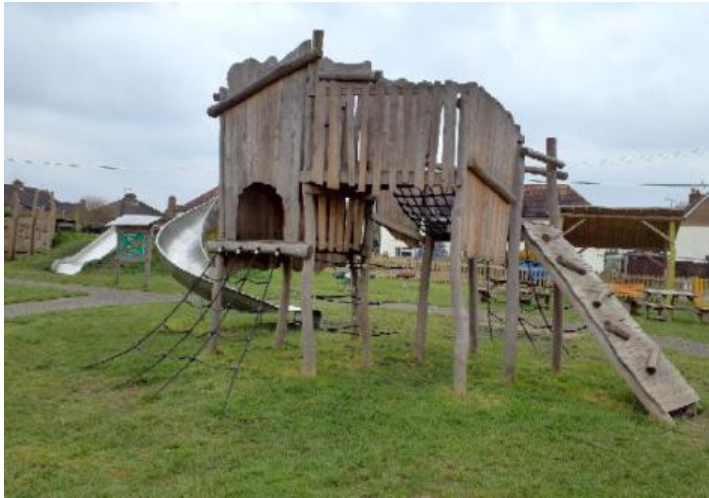
Item: Activity Equipment - Multi Play (Junior)
Manufacturer: Eibe Play Ltd

Finding: There are gaps opening between the grass mat tiles

Action: Provide additional ties or secure / reinstate surface

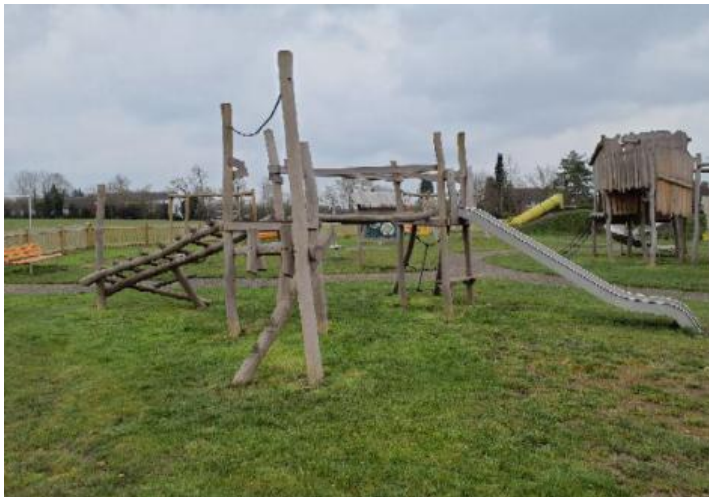
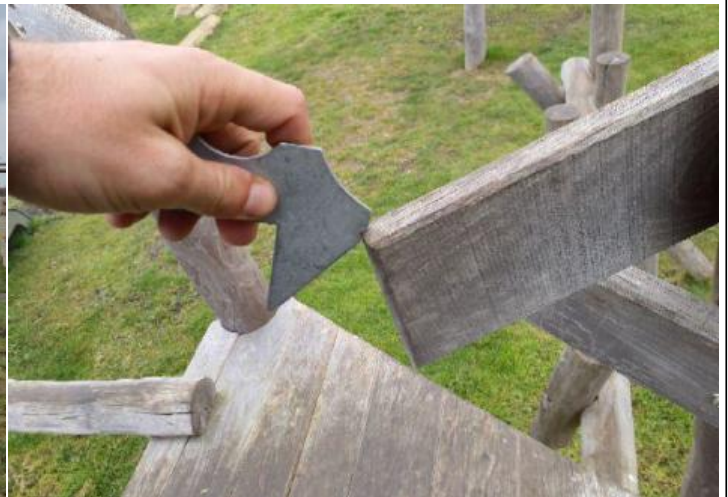
Item: Activity Equipment - Multi Play (Junior)
Manufacturer: Eibe Play Ltd

Finding: The item has exposed edges and corners that are sharp, or with a radius of less than 3mm, and does not meet the requirements of BS EN 1176 Part 1 - 4.2.5

Action: Provide a 3mm radius to all exposed edges and corners, or remove sharp edge
