## Annual Inspection

Winchester City Council

Stratton Bates Recreation Ground (New Alresford)

Grange Road, Alresford, SO24 9HF

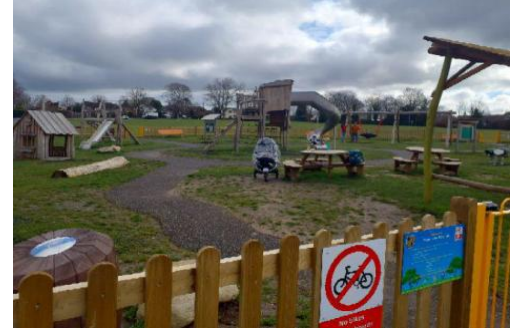
**Item:** Site General  
**Manufacturer:** Owner/Operator  
**Surface Type:** N/A  
**Item Quantity:** 1  
**Equipment Compliance:** N/A  
**Surface Area Compliance:** N/A

The area around the item has eroded and may become slippery - Reinstate eroded area

The surface has eroded and the foundations are exposed - Reinstate surrounding surfaces to cover the foundations

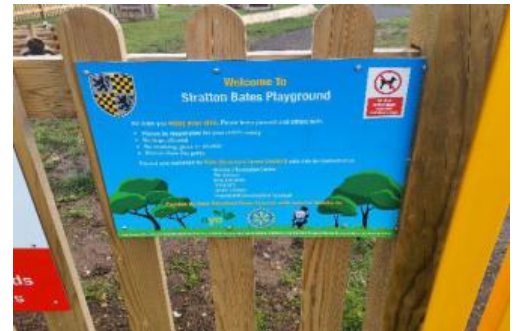
**Item:** Sign  
**Manufacturer:** Owner/Operator  
**Surface Type:** N/A  
**Item Quantity:** 1  
**Equipment Compliance:** N/A  
**Surface Area Compliance:** N/A

This item is satisfactory - no work required -

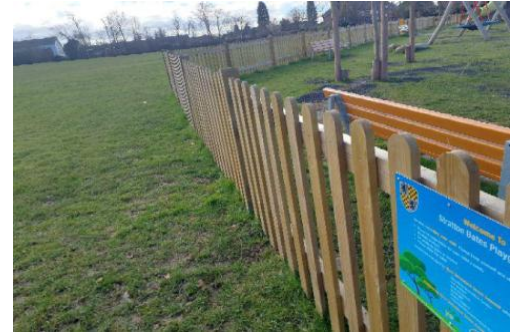
**Item:** Fencing - Timber  
**Manufacturer:** Jacksons Fencing  
**Surface Type:** Grass  
**Item Quantity:** 1  
**Equipment Compliance:** N/A  
**Surface Area Compliance:** N/A

There is some damage to the fence sections - Monitor for any further deterioration and repair as required

The item fails to meet the requirements of BS EN 1176 Part 1 4.2.7.2 for head and neck entrapment in the fence - No further action required

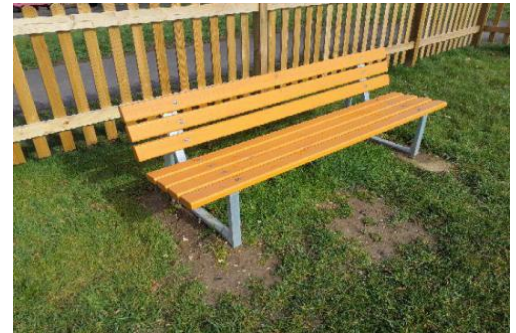
**Item:** Bench  
**Manufacturer:** Not Identified  
**Surface Type:** Grass  
**Item Quantity:** 5  
**Equipment Compliance:** N/A  
**Surface Area Compliance:** N/A

The surface has eroded and the foundations are exposed - Reinstate surrounding surfaces to cover the foundations

There are trip hazards present - Reinstate surrounding surfaces to level to remove the trip points

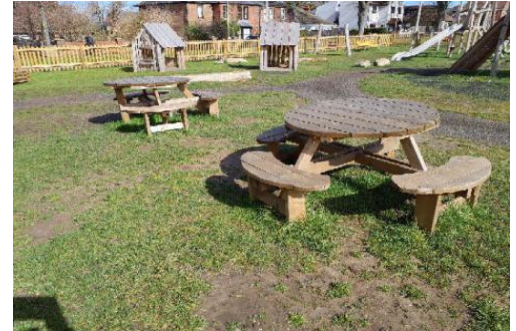
**Item:** Picnic Table  
**Manufacturer:** Not Identified  
**Surface Type:** Grass  
**Item Quantity:** 2  
**Equipment Compliance:** N/A  
**Surface Area Compliance:** N/A

There is or are fixings missing on the item - Replace all missing fixings

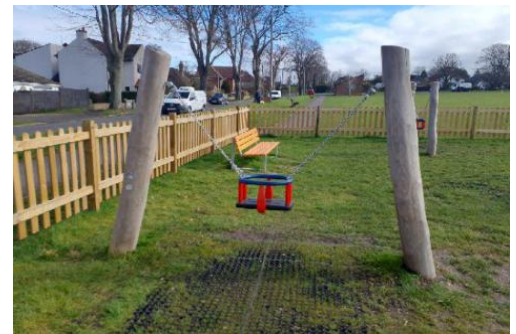
**Item:** 1 Bay 1 Seat (Cradle) - Type 1  
**Manufacturer:** Eibe Play Ltd  
**Surface Type:** Grass Matrix Tiles  
**Item Quantity:** 1  
**Equipment Compliance:** Yes  
**Surface Area Compliance:** Yes

There is some notable evidence of chain wear - Monitor for any further deterioration and replace when 40% worn

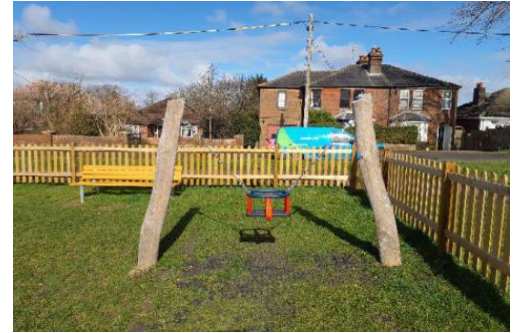
**Item:** 1 Bay 1 Seat (Cradle) - Type 1  
**Manufacturer:** Eibe Play Ltd  
**Surface Type:** Grass Matrix Tiles  
**Item Quantity:** 1  
**Equipment Compliance:** Yes  
**Surface Area Compliance:** Yes

There is some notable evidence of chain wear - Monitor for any further deterioration and replace when 40% worn

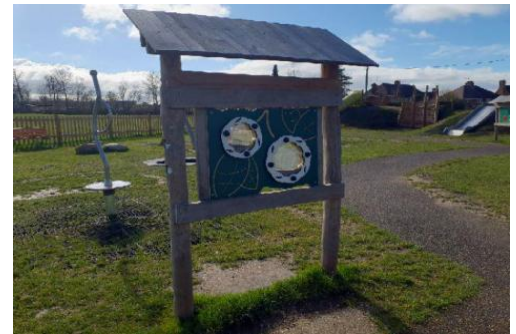
**Item:** Play Panel  
**Manufacturer:** Eibe Play Ltd  
**Surface Type:** Grass  
**Item Quantity:** 1  
**Equipment Compliance:** No  
**Surface Area Compliance:** N/A

The item fails to meet the requirements of BS EN 1176 Part 1 4.2.7.2 for head and neck entrapment in the structure - Monitor - No remedial work recommended

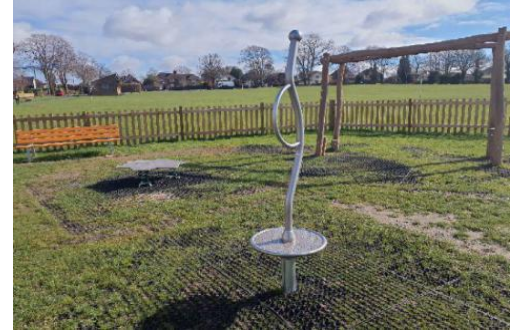
**Item:** Spinning Pole  
**Manufacturer:** Not Identified  
**Surface Type:** Grass Matrix Tiles  
**Item Quantity:** 1  
**Equipment Compliance:** Yes  
**Surface Area Compliance:** Yes

The bearing is showing signs of wear - Monitor for any further deterioration and replace as required

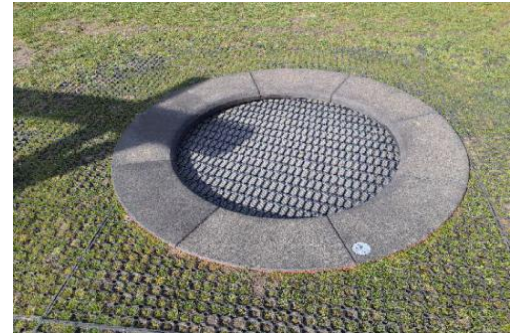
**Item:** Bouncing Facility  
**Manufacturer:** Seilfabrik Ullmann  
**Surface Type:** Grass Matrix Tiles  
**Item Quantity:** 1  
**Equipment Compliance:** Yes  
**Surface Area Compliance:** Yes

On site visits it is not possible to test the ground clearance of the Bouncing Facility bed as specified in BS EN 1176; ensure that the clearance between the Bouncing Facility Bed and the ground underneath is in accordance with the manufacturers recommendations (recorded nominal depth at time of inspection 340mm measured unloaded). - Refer to the manufacturers recommendations

There are trip hazards at the edges of the surface - Reinstate surrounding surface levels to remove the trip points

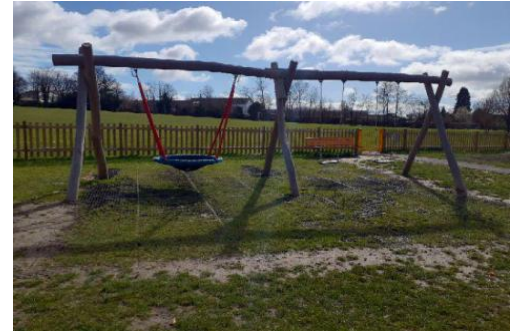
**Item:** 2 Bay 2 Flat 1 Basket Seat  
**Manufacturer:** Eibe Play Ltd  
**Surface Type:** Grass Matrix Tiles  
**Item Quantity:** 1  
**Equipment Compliance:** Yes  
**Surface Area Compliance:** Yes

The grass mats are silted up and the soil is compacted; this may have an effect on the impact absorbing properties of the surface - Consider HIC testing impact absorbing properties to ensure the correct surface qualities are maintained for the equipment and replace as required

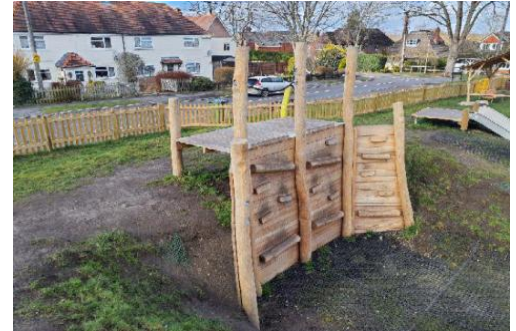
**Item:** Climbing Wall  
**Manufacturer:** Eibe Play Ltd  
**Surface Type:** Grass Matrix Tiles  
**Item Quantity:** 1  
**Equipment Compliance:** No  
**Surface Area Compliance:** Yes

There is/are finger entrapment/s in the climbing wall and the item fails to meet the requirements of BS EN 1176 Part 1 4.2.7.6 Entrapment of fingers - Monitor - No remedial work recommended

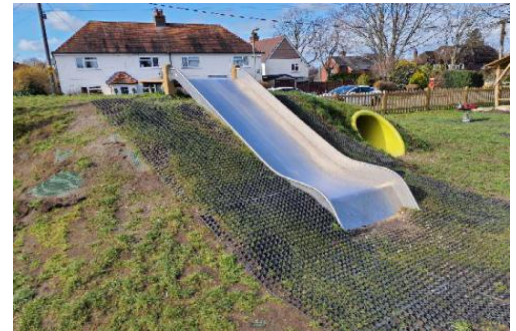
**Item:** Embankment Slide  
**Manufacturer:** Eibe Play Ltd  
**Surface Type:** Grass Matrix Tiles  
**Item Quantity:** 1  
**Equipment Compliance:** Yes  
**Surface Area Compliance:** Yes

The grass matrix tiles have buckled in places, causing trip hazards - Provide additional ties or secure / reinstate surface

There are a number of dents in the slide surface - Monitor for any further deterioration and repair as required

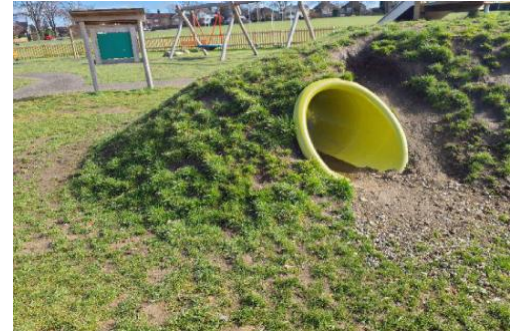
**Item:** Tunnel Mound  
**Manufacturer:** Eibe Play Ltd  
**Surface Type:** Grass  
**Item Quantity:** 1  
**Equipment Compliance:** No  
**Surface Area Compliance:** Yes

The surface has eroded in some areas and may be slippery in wet conditions - Reinstate the surface

This design / configuration of tunnel mound is well established and has been successfully included in large quantities of playgrounds throughout the UK. Whilst the design does not fully meet the requirements of BS EN 1176 with regards to falls in excess of 600mm over the edge of the tunnel to the surface below, it has been risk assessed as fit for purpose and no changes are recommended to the design - Monitor - No remedial work recommended

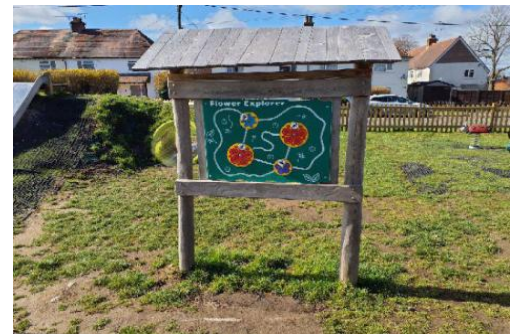
**Item:** Play Panel  
**Manufacturer:** Eibe Play Ltd  
**Surface Type:** Grass  
**Item Quantity:** 1  
**Equipment Compliance:** Yes  
**Surface Area Compliance:** N/A

The item is slightly loose in its foundations - Monitor for any further deterioration and repair as required

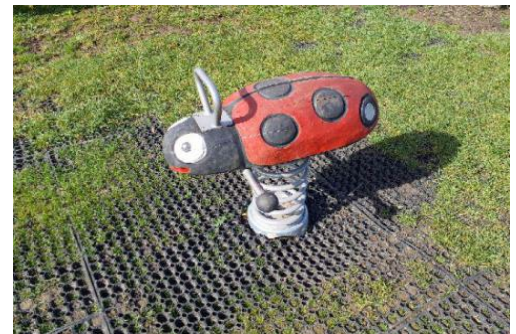
**Item:** Spring Ladybird  
**Manufacturer:** Eibe Play Ltd  
**Surface Type:** Grass Matrix Tiles  
**Item Quantity:** 1  
**Equipment Compliance:** Yes  
**Surface Area Compliance:** Yes

A number of fixing(s) have worked loose - Secure all loose fixings

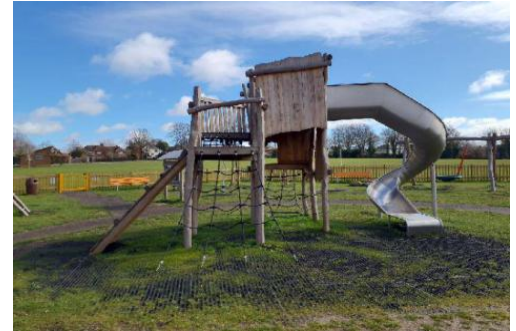
**Item:** Multi Play (Junior)  
**Manufacturer:** Eibe Play Ltd  
**Surface Type:** Grass Matrix Tiles  
**Item Quantity:** 1  
**Equipment Compliance:** No  
**Surface Area Compliance:** No

There is/are finger entrapment/s in the slide starting section and the item fails to meet the requirements of BS EN 1176 Part 1 4.2.7.6 Entrapment of fingers - Monitor - No remedial work recommended

There is/are finger entrapment/s in the structure and the item fails to meet the requirements of BS EN 1176 Part 1 4.2.7.6 Entrapment of fingers - Monitor - No remedial work recommended

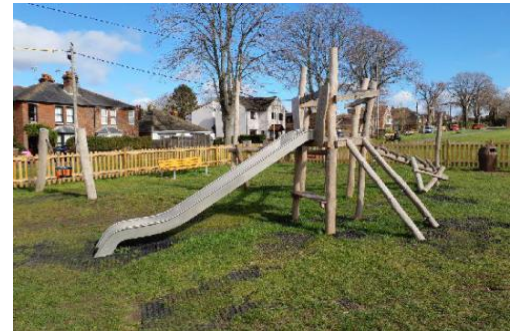
**Item:** Multi Play (Junior)  
**Manufacturer:** Eibe Play Ltd  
**Surface Type:** Grass Matrix Tiles  
**Item Quantity:** 1  
**Equipment Compliance:** No  
**Surface Area Compliance:** Yes

There is/are finger entrapment/s in the platform and the item fails to meet the requirements of BS EN 1176 Part 1 4.2.7.6 Entrapment of fingers - Monitor - No remedial work recommended

The item has exposed edges and corners with a radius of less than 3mm and fails the requirements of BS EN 1176 - Provide a 3mm radius to all exposed edges and corners

There is/are finger entrapment/s in the slide starting section and the item fails to meet the requirements of BS EN 1176 Part 1 4.2.7.6 Entrapment of fingers - Monitor - No remedial work recommended

There is an opening in the barriers exceeding the width allowed (500mm) in BS EN 1176, and no guardrail has been provided; this is a low risk failure and no remedial action is required - Refer to the manufacturer

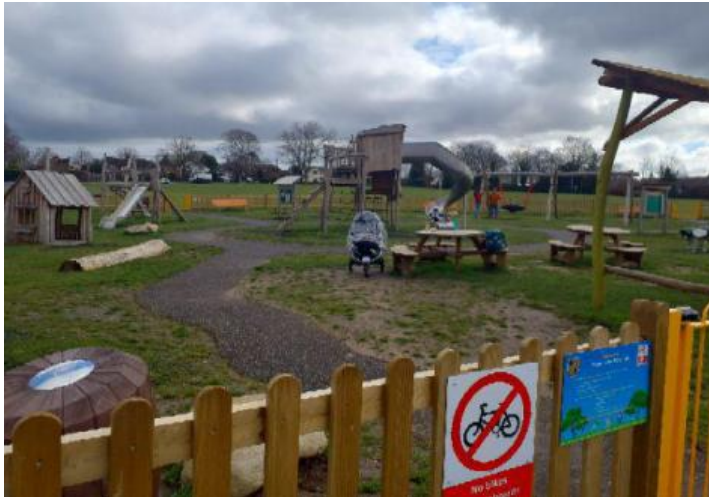
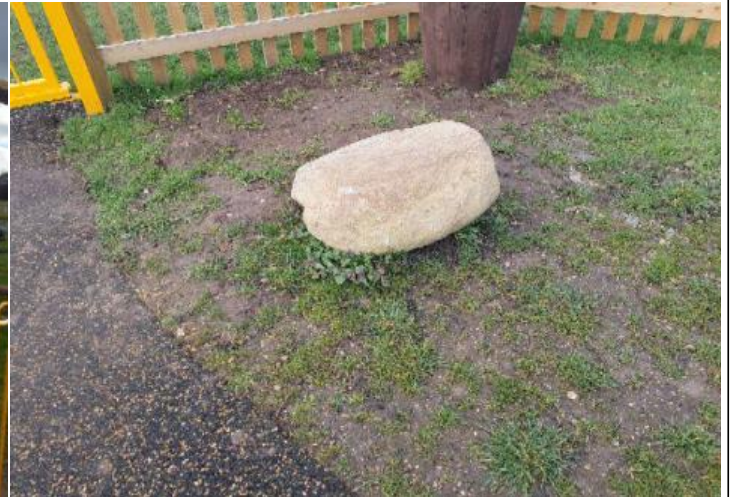
**Item:** Ancillary Items - Site General  
**Manufacturer:** Owner/Operator

**Finding:** The area around the item has eroded and may become slippery

**Finding:** The surface has eroded and the foundations are exposed

**Action:** Reinstate eroded area

**Action:** Reinstate surrounding surfaces to cover the foundations

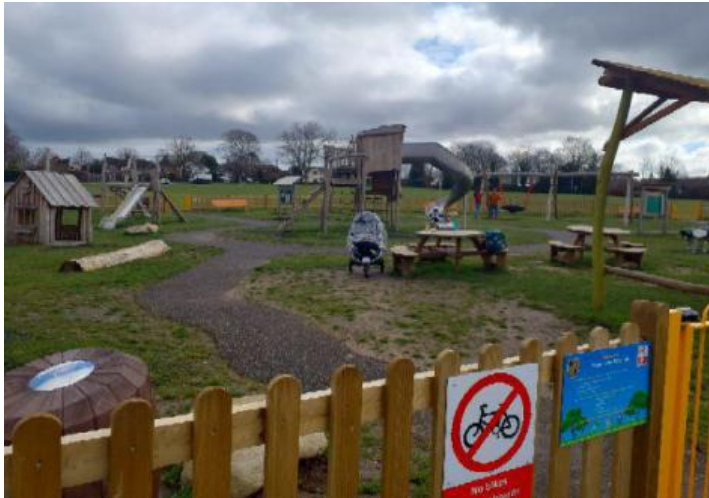
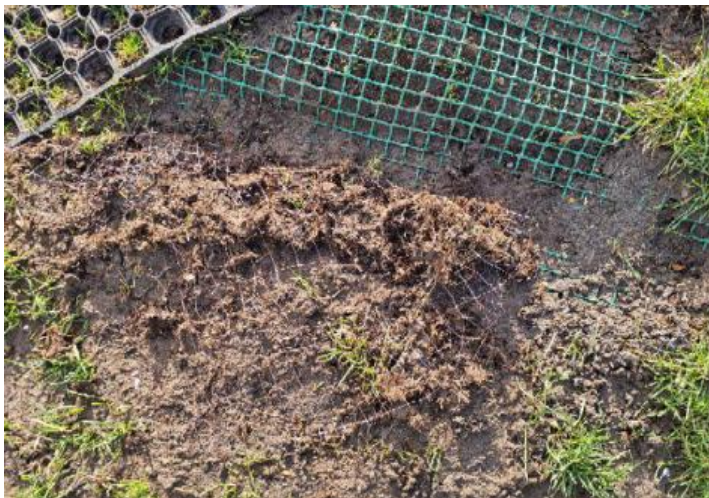
**Item:** Ancillary Items - Site General  
**Manufacturer:** Owner/Operator

**Finding:** The safety surface is low and the membrane is exposed creating trip points throughout the site

**Action:** Remove or resecure the exposed membrane

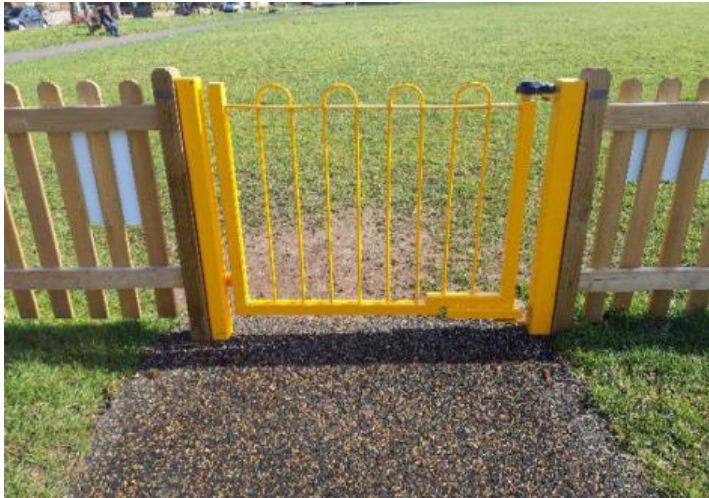
**Item:** Gates - Gate - Self Closing  
**Manufacturer:** Not Identified

**Finding:** The area around the item has eroded and may become slippery

**Action:** Reinststate eroded area

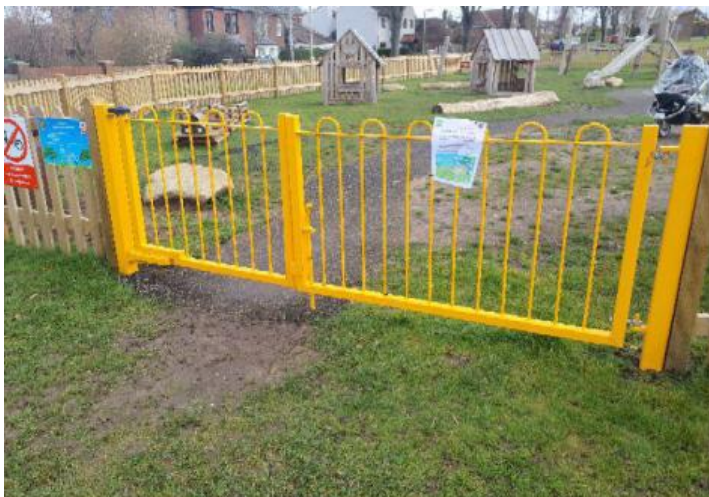
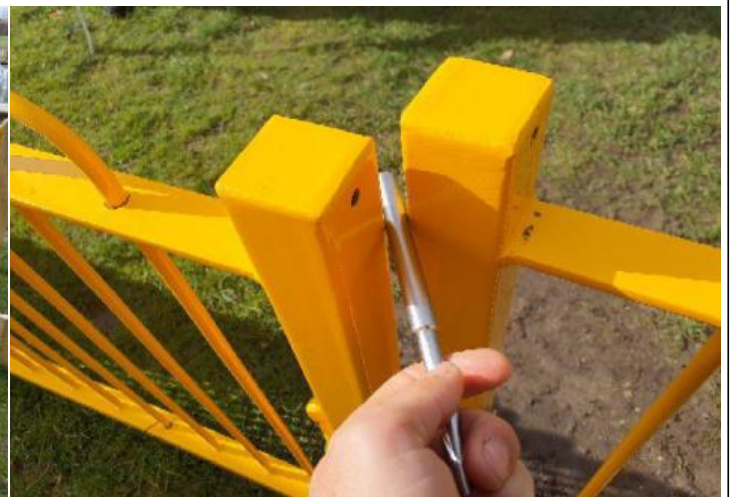
**Item:** Gates - Gate - Combination  
**Manufacturer:** Not Identified

**Finding:** There are openings that are less than 12mm that could trap or crush fingers

**Action:** Provide a 12mm gap throughout full range of motion at both sides of gate

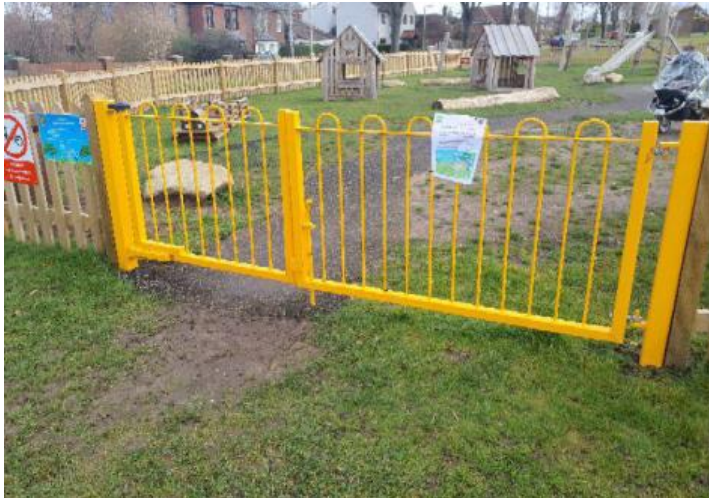
**Item:** Gates - Gate - Combination  
**Manufacturer:** Not Identified

**Finding:** There is no padlock on the maintenance gate

**Action:** Provide a padlock to secure the gate

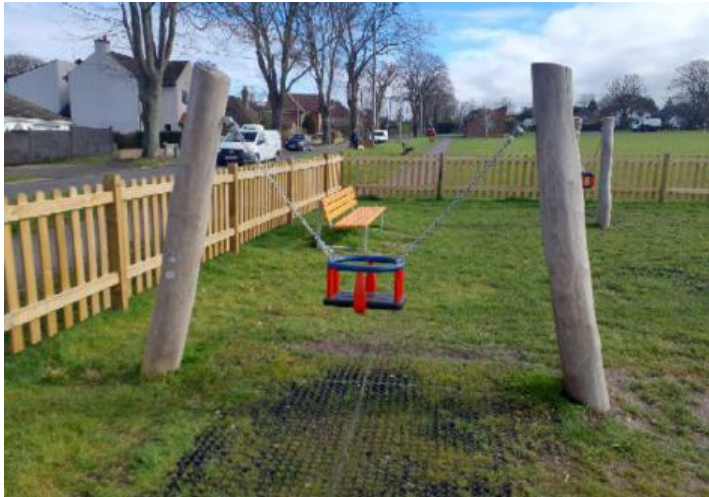
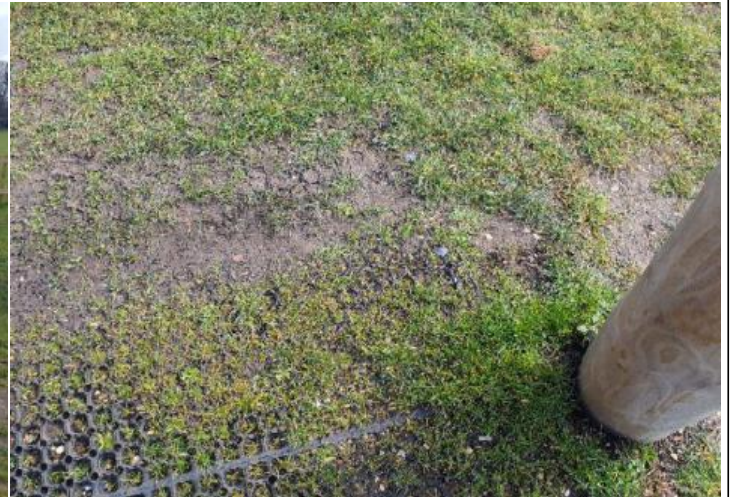
**Finding:** Fixing Pins have been installed in the impact areas of the grass mats

**Action:** Remove pins from impact areas

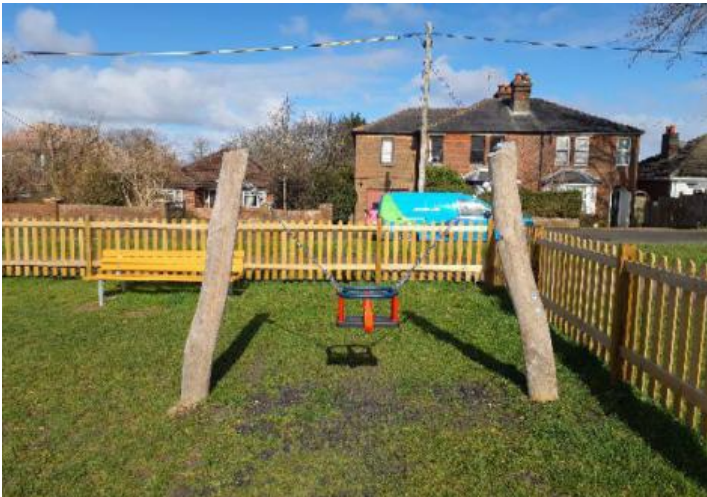
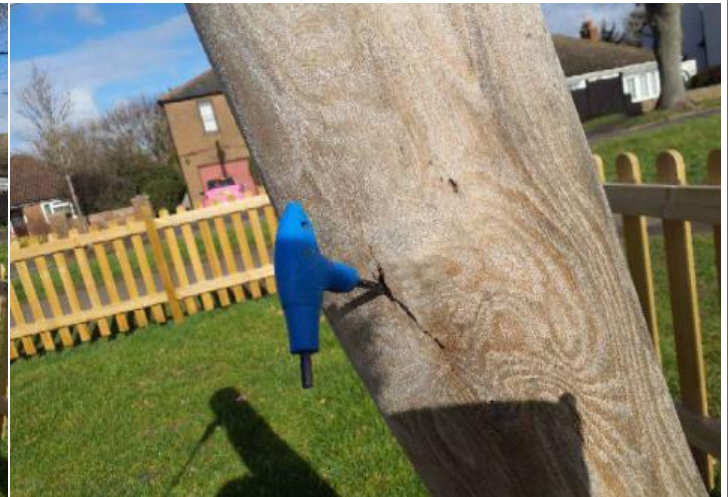
**Finding:** There is a cavity in the timber  
**Action:** Refer to manufacturer

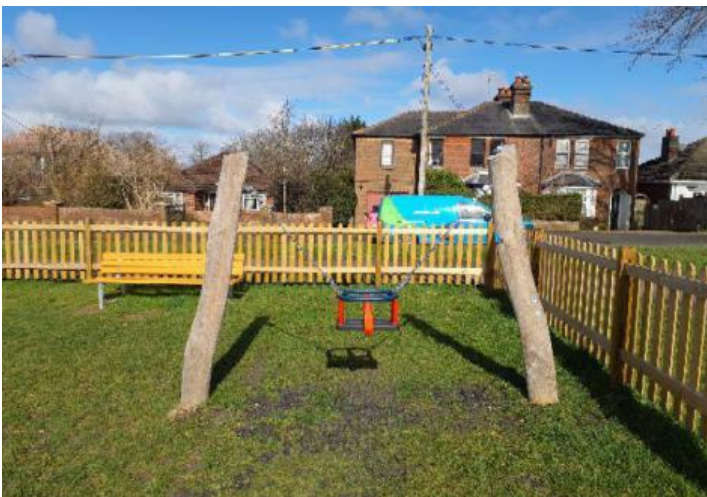
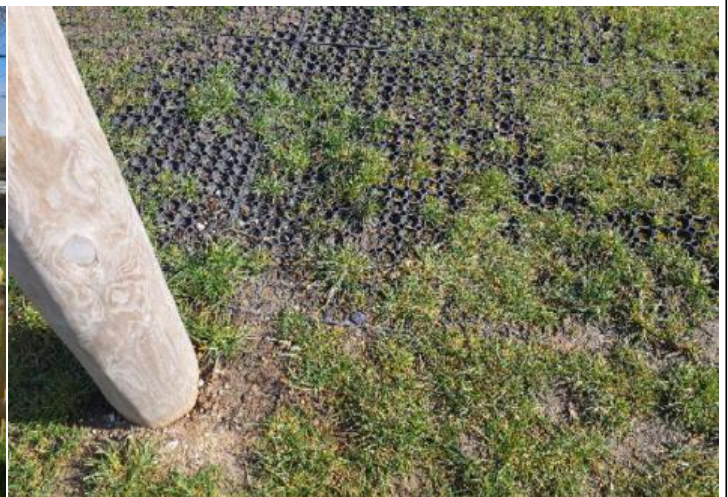
**Finding:** Fixing Pins have been installed in the impact areas of the grass mats

**Action:** Remove pins from impact areas

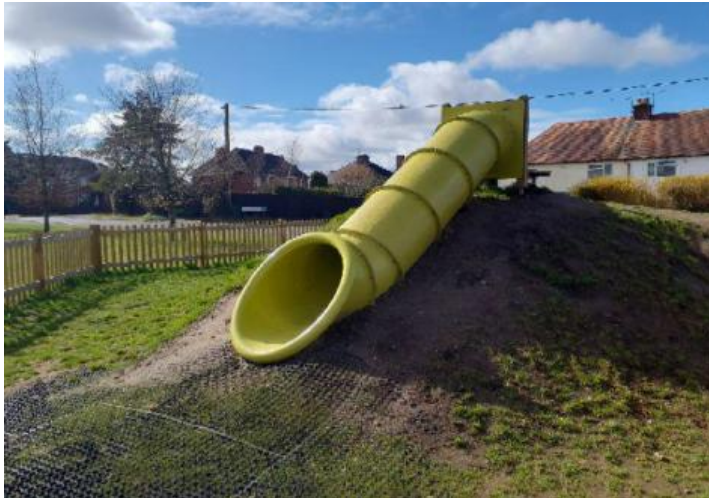
**Finding:** Fixing Pins have been installed in the impact areas of the grass mats  
**Action:** Remove pins from impact areas

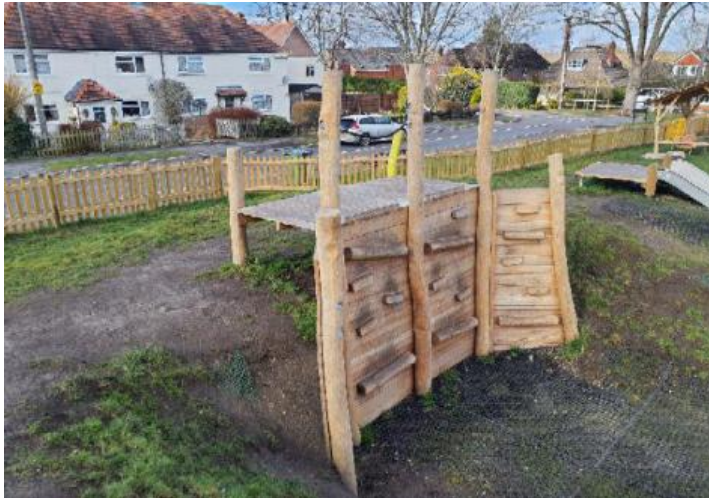
**Finding:** Fixing Pins have been installed in the impact areas **Action:** Remove pins from impact areas of the grass mats

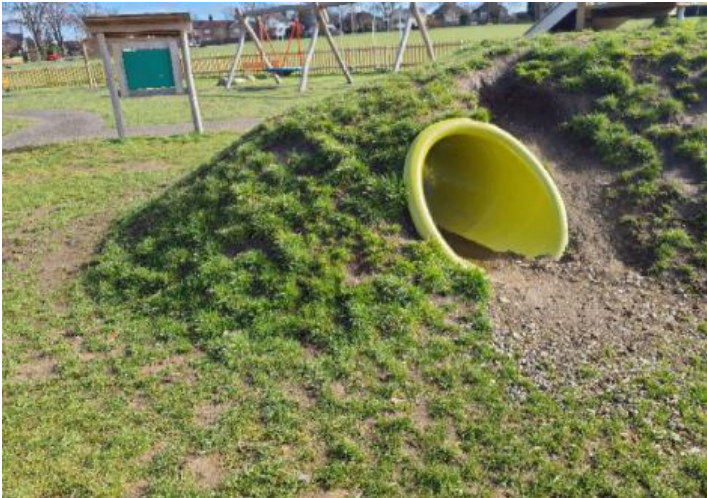
**Finding:** There is some water and dirt/debris on the surfacing

**Action:** Clean and maintain / Consider adding drainage

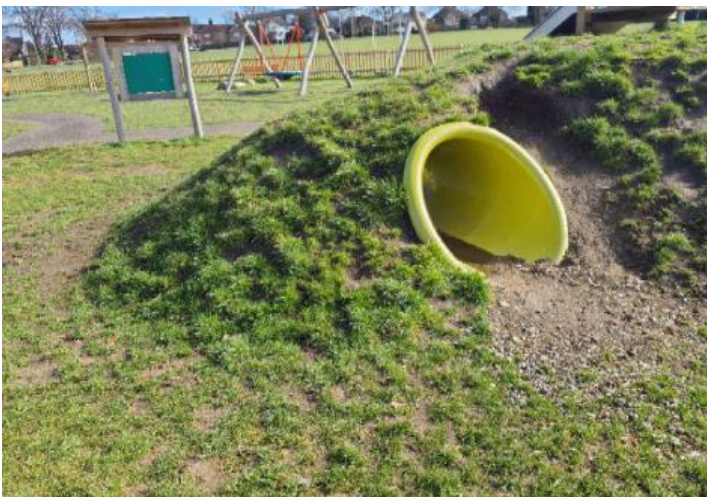
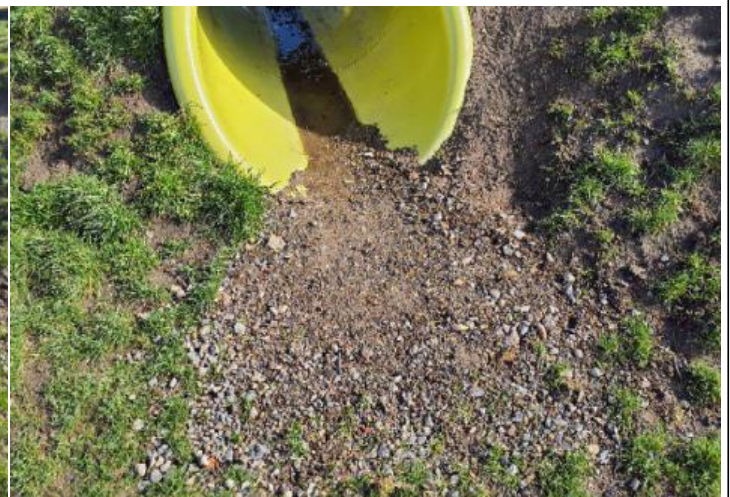
**Finding:** The surfacing has numerous stones present within the surface and will not perform as intended in relation to Head Injury Criterion testing

**Action:** Ensure stones are removed

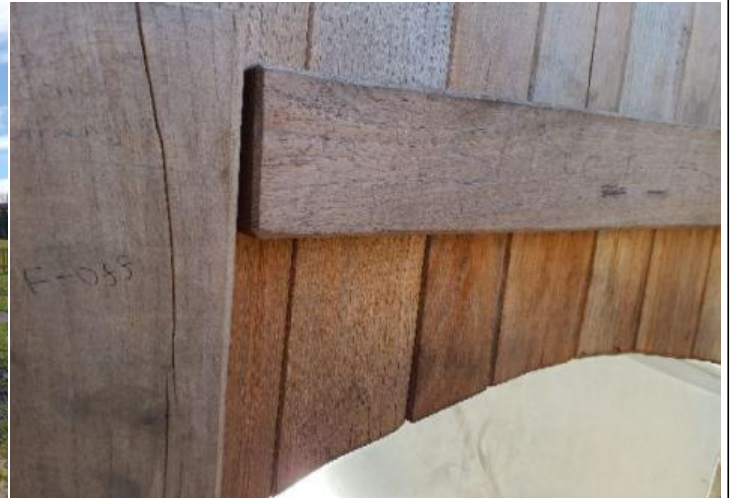
**Finding:** There is offensive graffiti present

**Action:** Remove as soon as practicable
