the **play inspection** company

Annual Inspection

Winchester City Council

Sun Hill Recreation Ground (New Alresford)

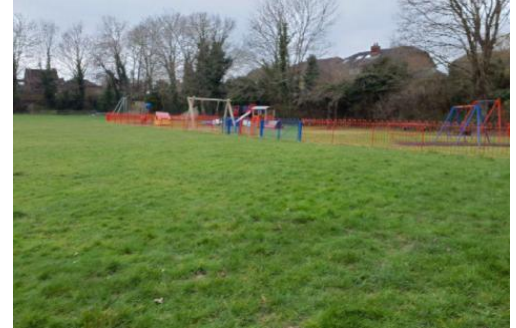
Item: Site General
Manufacturer: Owner/Operator
Surface Type: N/A
Item Quantity: 1
Equipment Compliance: N/A
Surface Area Compliance: N/A

There is algae, silt or moss growth on the surface resulting in slippery conditions - Clean and treat appropriately

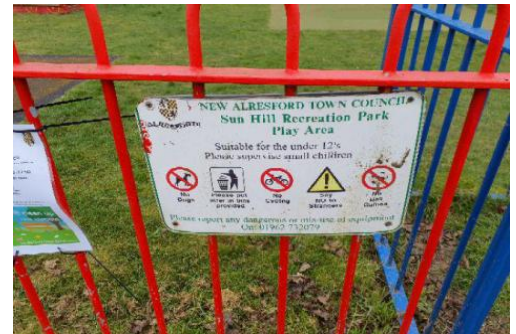
Item: Sign
Manufacturer: Not Identified
Surface Type: N/A
Item Quantity: 1
Equipment Compliance: N/A
Surface Area Compliance: N/A

There is some damage to the item - Monitor for any further deterioration and repair as required

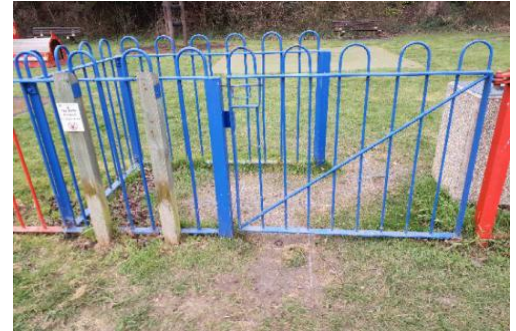
Item: Kissing Gate
Manufacturer: Not Identified
Surface Type: Grass Matrix Tiles
Item Quantity: 1
Equipment Compliance: N/A
Surface Area Compliance: N/A

The rubber buffer is missing from the latch plate - Replace rubber buffer

Cable ties have been used on the item and there are sharp projecting ends - Remove if not required or replace with a more appropriate alternative fixing method if used as a fixing

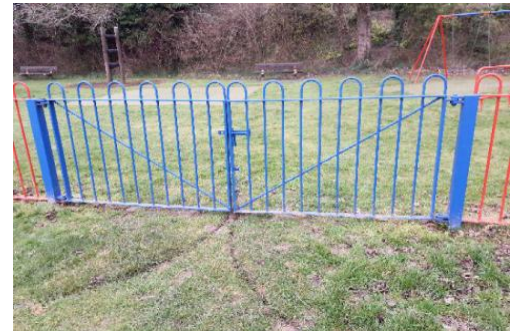
Item: Gate - Maintenance
Manufacturer: Not Identified
Surface Type: Grass
Item Quantity: 1
Equipment Compliance: N/A
Surface Area Compliance: N/A

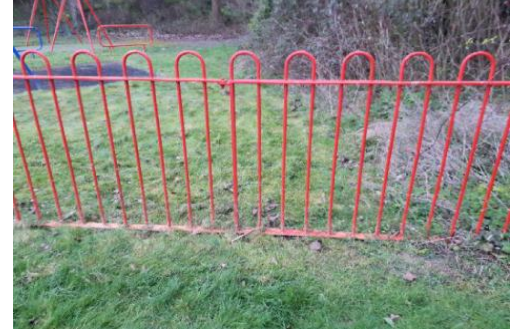
Item: Fence - Bow Top
Manufacturer: Not Identified
Surface Type: Grass
Item Quantity: 1
Equipment Compliance: N/A
Surface Area Compliance: N/A

There is some damage to the fence sections - Monitor for any further deterioration and repair as required

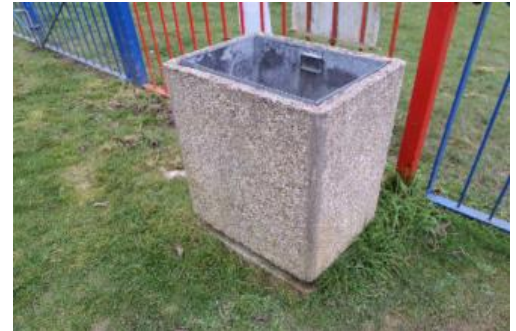
Item: Litter Bin
Manufacturer: Not Identified
Surface Type: Grass
Item Quantity: 1
Equipment Compliance: N/A
Surface Area Compliance: N/A

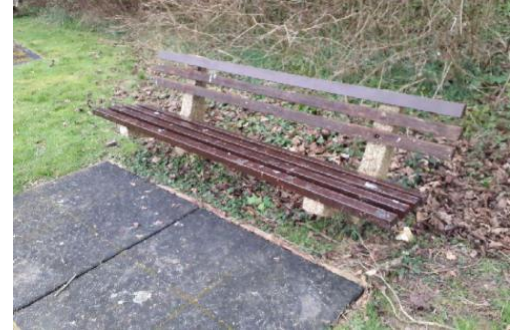
Item: Bench
Manufacturer: Not Identified
Surface Type: Grass
Item Quantity: 2
Equipment Compliance: N/A
Surface Area Compliance: N/A

There are gaps opening in between the tiles - Monitor for any further deterioration and repair as required

There is/are inserts missing - Replace missing inserts

There is some evidence of rot in the timber - Monitor for any further deterioration and replace as required

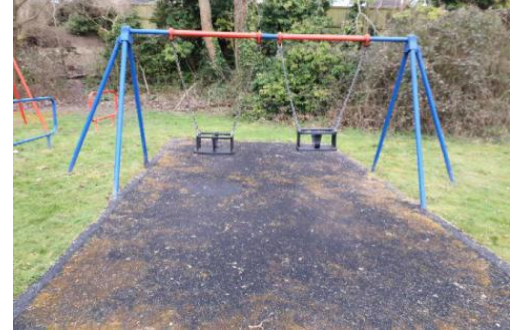
Item: 1 Bay 2 Seat (Cradle)
Manufacturer: Wicksteed Playgrounds
Surface Type: Wet Pour
Item Quantity: 1
Equipment Compliance: No
Surface Area Compliance: Yes

The shackles have been overtightened or seized transferring wear to the chain links below - Loosen shackles to ensure free movement at the pivot

There is some wear to the shackles. - Monitor for any further deterioration and replace when 40% worn

The split pins are missing from the shackles - Insert split pins to secure the shackles

The connecting links are in excess of 8.6mm and less than 12mm and fail the requirements of BS EN 1176 Part 1; clause 4.2.13, Chains - Monitor - No remedial work recommended

The chain openings are in excess of the 8.6mm as recommended by BS EN 1176 - Monitor - No remedial work recommended

There is some notable evidence of connecting link wear - Monitor for any further deterioration and replace when 40% worn

There is some notable evidence of chain wear - Monitor for any further deterioration and replace when 40% worn

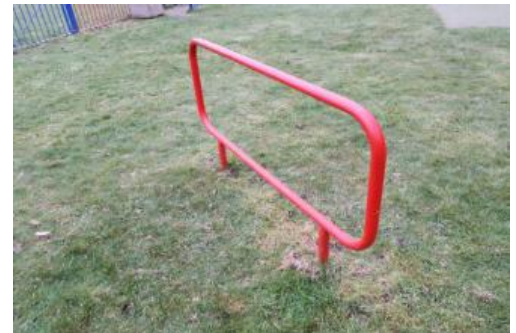
Item: Swing Barrier
Manufacturer: Not Identified
Surface Type: Grass
Item Quantity: 3
Equipment Compliance: N/A
Surface Area Compliance: N/A

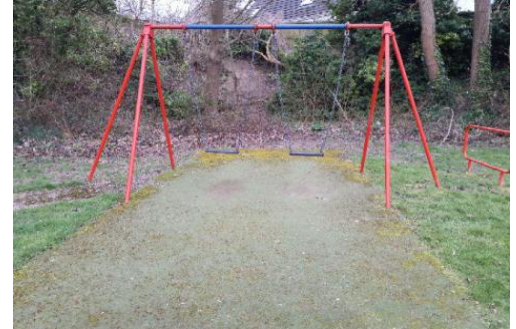
Item: 1 Bay 2 Seat (Flat)
Manufacturer: Wicksteed Playgrounds
Surface Type: Carpet System
Item Quantity: 1
Equipment Compliance: Yes
Surface Area Compliance: Yes

The safety surface around the area is beginning to wear - Monitor for any further deterioration and repair as required

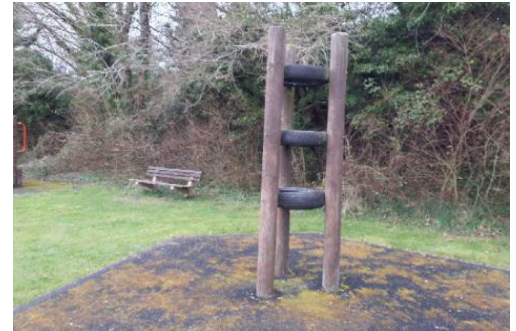
Item: Tyre Climber
Manufacturer: Lappset UK Ltd
Surface Type: Wet Pour
Item Quantity: 1
Equipment Compliance: Yes
Surface Area Compliance: No

The tyres are losing their integrity - Replace as required

The surfacing dimensions are short and do not meet with the requirements of the current applicable standard - Monitor - no remedial action recommended

There is some minor damage to the surface - Monitor for any further deterioration and repair as required

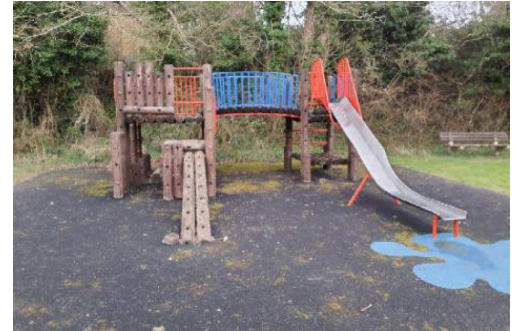
Item: Multi Play (Junior)
Manufacturer: Wicksteed Playgrounds
Surface Type: Wet Pour
Item Quantity: 1
Equipment Compliance: No
Surface Area Compliance: Yes

There are a number of dents in the slide surface - Monitor for any further deterioration and repair as required

The item fails to meet the requirements of BS EN 1176 Part 1 4.2.7.2 head and neck entrapment in the barriers and/or steps - Monitor - No remedial work recommended

The inspector is unable to ascertain if there are metal feet below ground supporting the timber posts, if there are not, then the majority of timber posts on the structure appear to have rotted - Investigate further and replace all affected timbers

There are areas or parts of the timber on the structure that have rotted - Replace all affected timbers

There are splits in the timber running through fixing points and creating some instability in the structure - Replace all affected timber parts

The access ramp height is greater than 600mm and the angle of ascent is less than 38 degrees. Barriers or guardrails are required to comply with the requirements BS EN 1176 - Monitor - No remedial work recommended

The item has missing component(s) leaving a trip hazard - Replace missing components

The unit is easily accessible and should have the appropriate barriers installed to meet the requirements of BS EN 1176 Part 1 as the height of the unit exceeds 600mm - Monitor - No remedial work recommended

There is/are finger entrapment/s in the slide starting section and the item fails to meet the requirements of BS EN 1176 Part 1 4.2.7.6 Entrapment of fingers - Monitor - No remedial work recommended

There is / are toggle entrapment/s present in contravention of the recommendations set out in BS EN 1176 Part 3 - Monitor - no remedial work recommended

The paintwork on this item has been damaged or worn exposing the metal underneath which is rusting / corroding - Treat affected areas and repaint

The fixings have corroded excessively - Replace all corroded fixings

NOTE: This item is coming towards to, or is at the end of its shelf life - Consider removal and replacement of this item

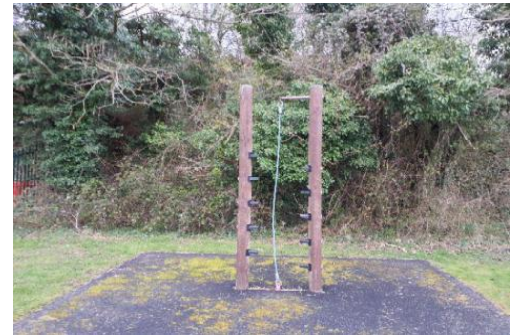
Item: Climbing Post
Manufacturer: Lappset UK Ltd
Surface Type: Wet Pour
Item Quantity: 1
Equipment Compliance: No
Surface Area Compliance: Yes

The anchor bar and protruding bracket form hard objects within the falling space of the equipment in contravention of the requirements of BS EN 1176 Part 1 - Provide an appropriate impact absorbing surface on the bar

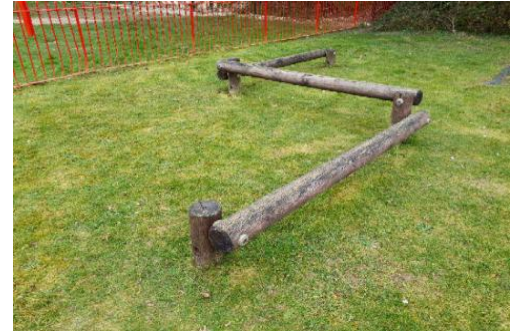
Item: Balance Beam
Manufacturer: Lappset UK Ltd
Surface Type: Grass
Item Quantity: 1
Equipment Compliance: Yes
Surface Area Compliance: Yes

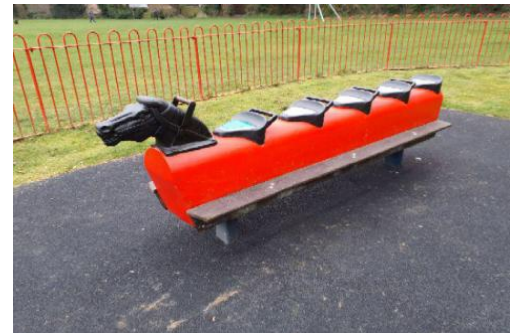
Item: Rocking Horse
Manufacturer: Wicksteed Playgrounds
Surface Type: Wet Pour
Item Quantity: 1
Equipment Compliance: No
Surface Area Compliance: Yes

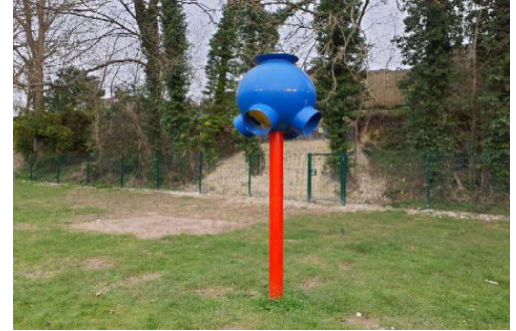
Item: Ball Shoot
Manufacturer: Wicksteed Playgrounds
Surface Type: Grass
Item Quantity: 1
Equipment Compliance: Yes
Surface Area Compliance: N/A

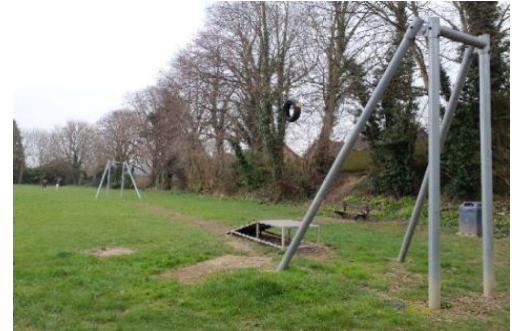
Item: Cable Runway
Manufacturer: Wicksteed Playgrounds
Surface Type: Grass Matrix Tiles
Item Quantity: 1
Equipment Compliance: No
Surface Area Compliance: No

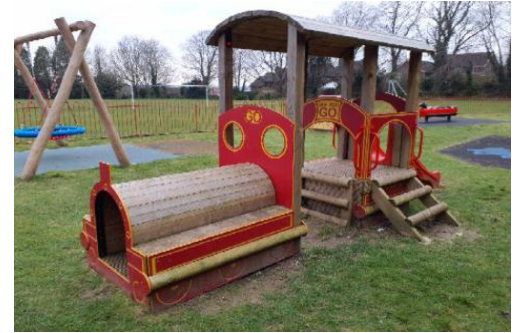
Item: Train
Manufacturer: Not Identified
Surface Type: Grass
Item Quantity: 1
Equipment Compliance: No
Surface Area Compliance: Yes

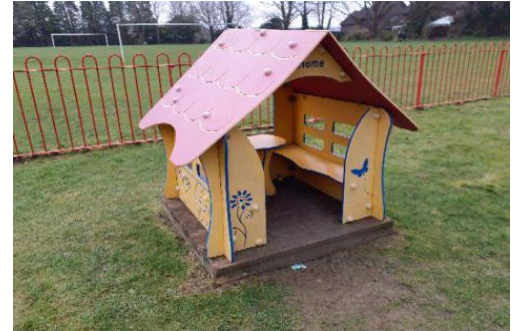
Item: Playhouse
Manufacturer: Not Identified
Surface Type: Grass
Item Quantity: 1
Equipment Compliance: No
Surface Area Compliance: Yes

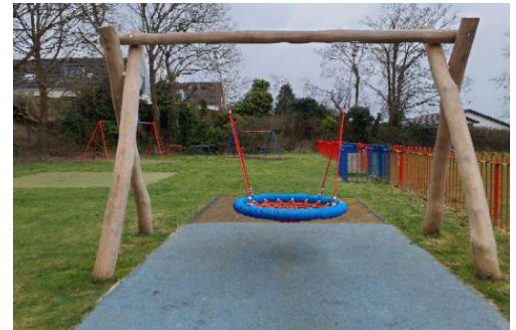
Item: Basket Swing - Type 1
Manufacturer: Dylan Group Ltd
Surface Type: Wet Pour
Item Quantity: 1
Equipment Compliance: No
Surface Area Compliance: Yes

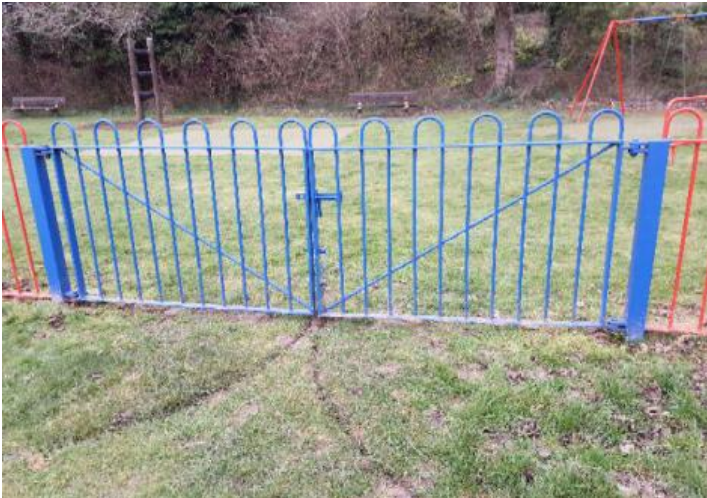
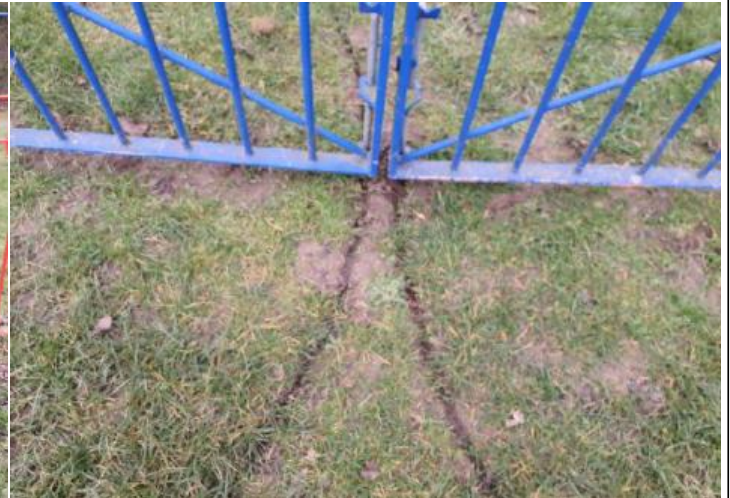
Item: Gates - Gate - Maintenance
Manufacturer: Not Identified

Finding: The gate has no drop bolt sleeves and/or drop bolts fitted

Action: Provide drop bolt sleeves and/or drop bolts

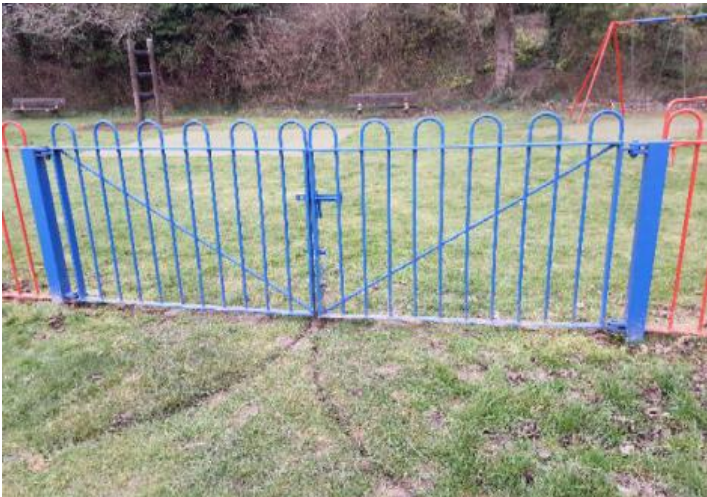
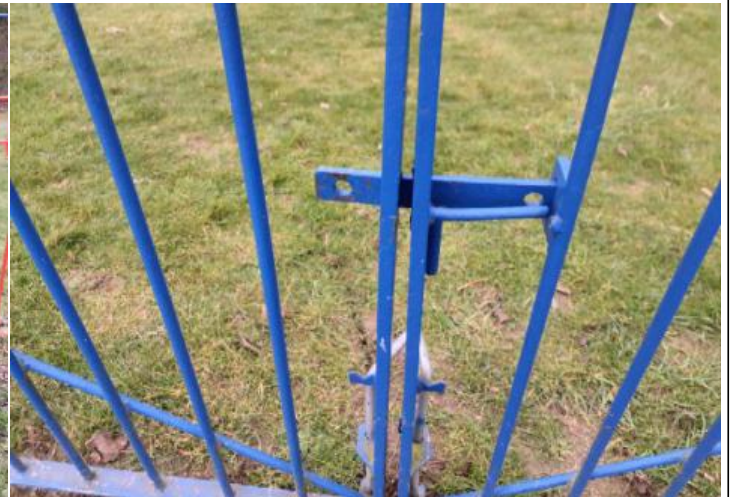
Item: Gates - Gate - Maintenance
Manufacturer: Not Identified

Finding: There is no padlock on the maintenance gate

Action: Provide a padlock to secure the gate

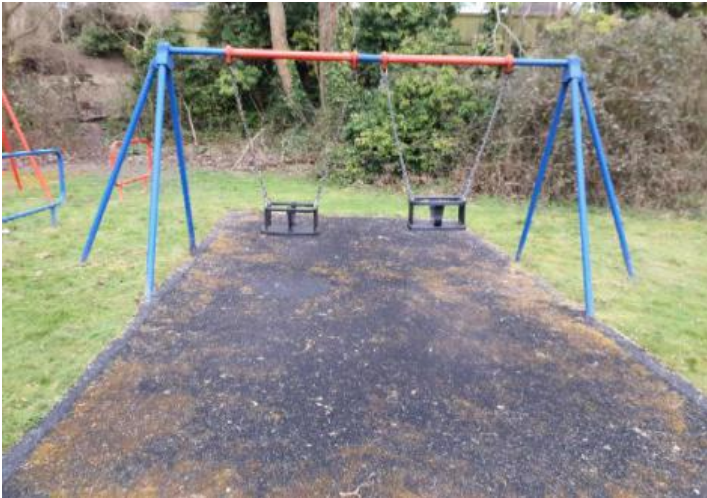
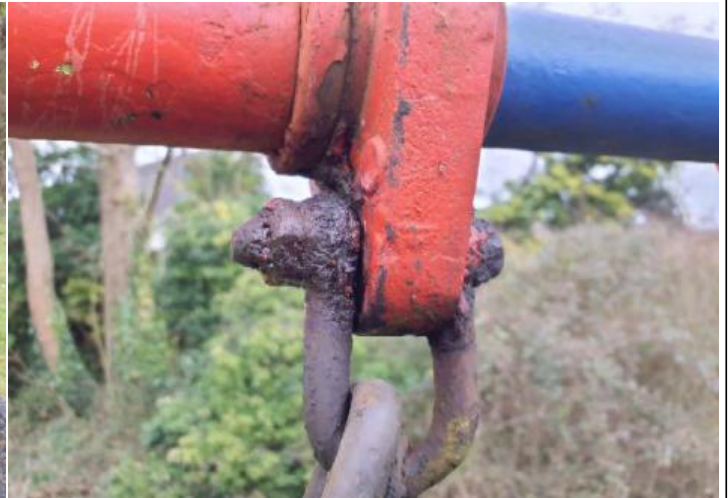
Item: Swings - 1 Bay 2 Seat (Cradle)
Manufacturer: Wicksteed Playgrounds

Finding: There is excess grease on the shackle

Action: Remove

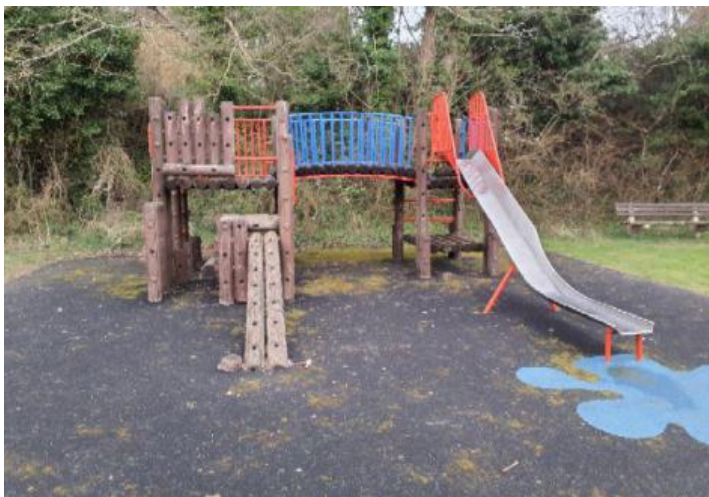
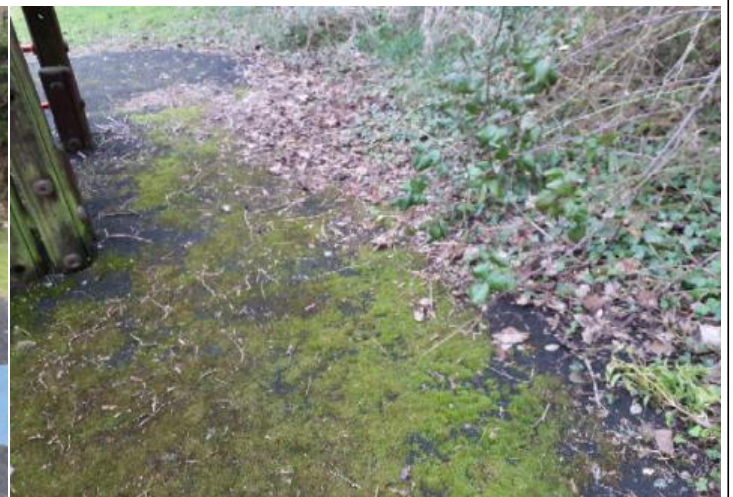
Item: Activity Equipment - Multi Play (Junior)
Manufacturer: Wicksteed Playgrounds

Finding: The adjacent foliage is overhanging
Action: Cut back and maintain

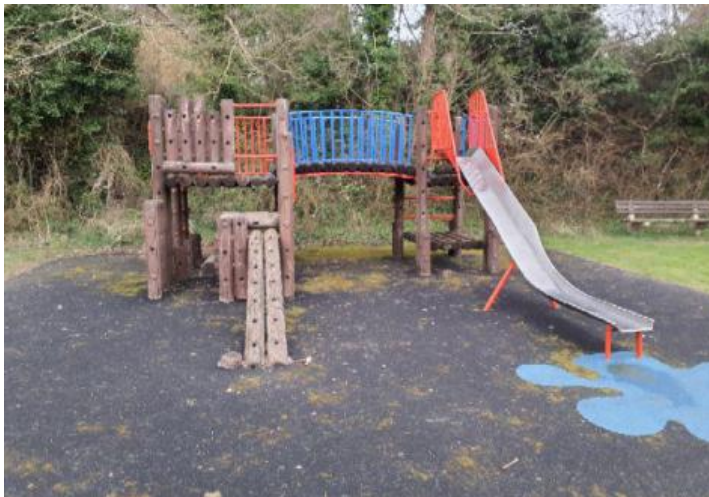
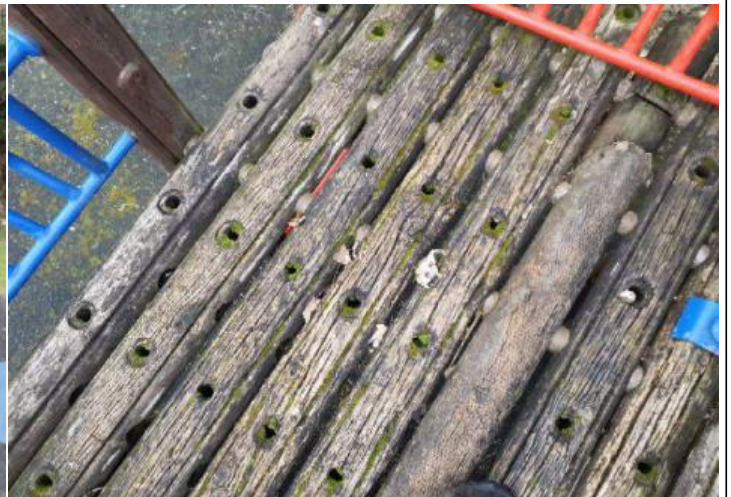
Item: Activity Equipment - Multi Play (Junior)
Manufacturer: Wicksteed Playgrounds

Finding: There is algae or moss on the surface of the equipment

Action: Clean and treat appropriately

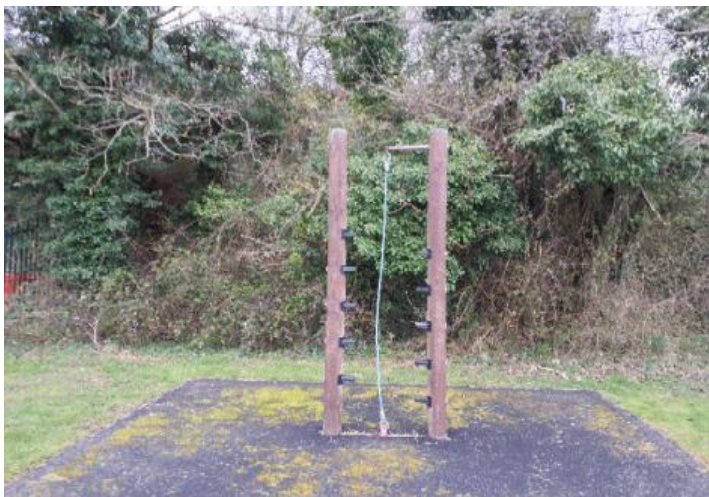
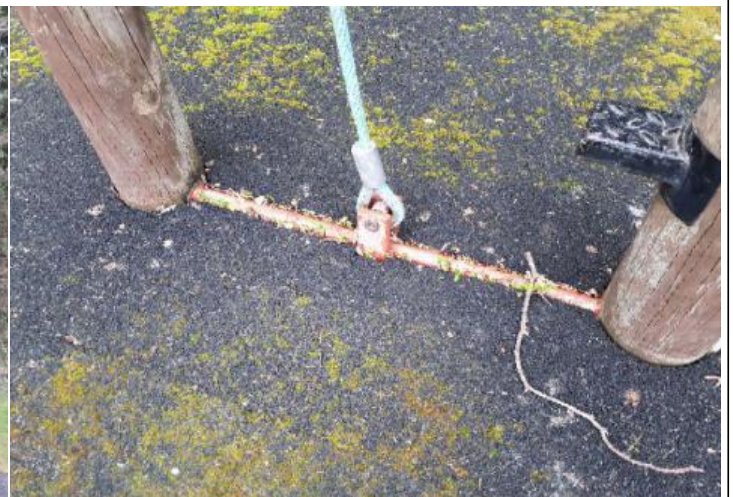
Item: Activity Equipment - Climbing Post
Manufacturer: Lappset UK Ltd

Finding: The anchor bar and protruding bracket form hard objects within the falling space of the equipment in contravention of the requirements of BS EN 1176 Part 1
Action: Provide an appropriate impact absorbing surface on the bar

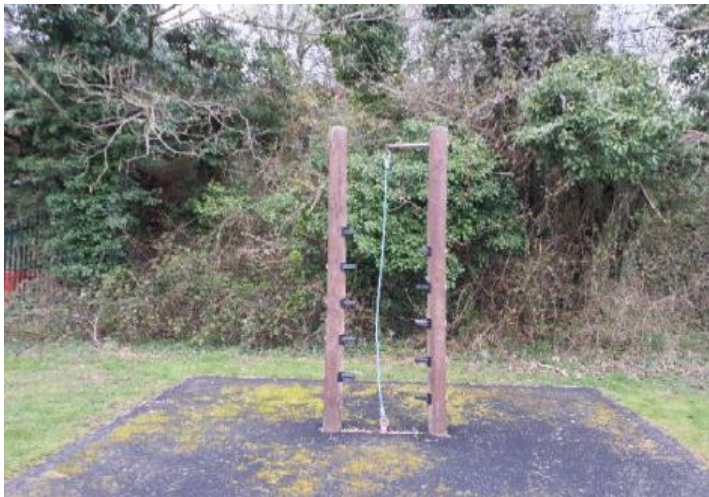
Item: Activity Equipment - Climbing Post
Manufacturer: Lappset UK Ltd

Finding: There is surface corrosion / rust present on the item

Action: Consider treating the item

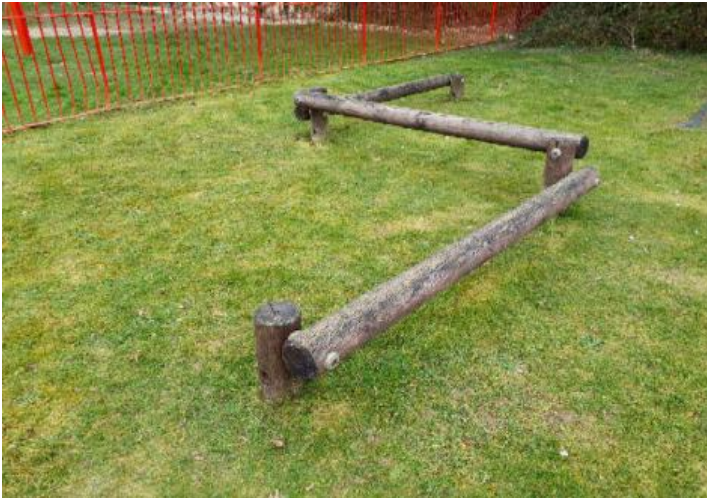
Item: Activity Equipment - Balance Beam
Manufacturer: Lappset UK Ltd

Finding: There is some damage to the item

Action: Monitor for any further deterioration and repair as required

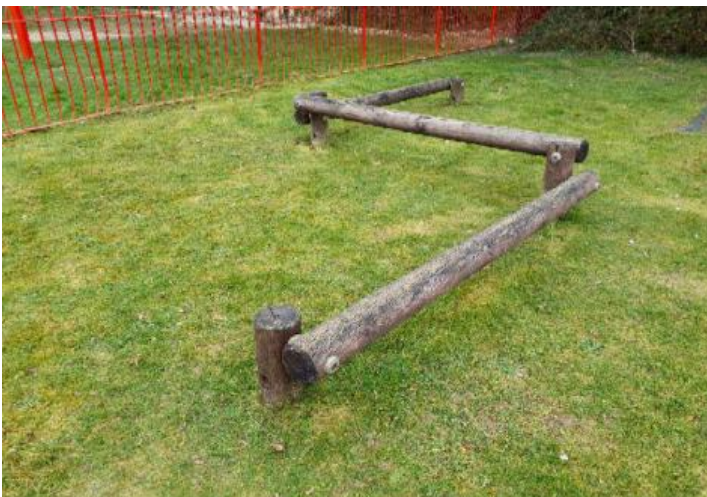
Item: Activity Equipment - Balance Beam
Manufacturer: Lappset UK Ltd

Finding: There is some strimmer / machinery damage apparent on the posts, this can penetrate the preservative applied to the timber and accelerate the rotting process

Action: Monitor for any deterioration (rot) and replace as required

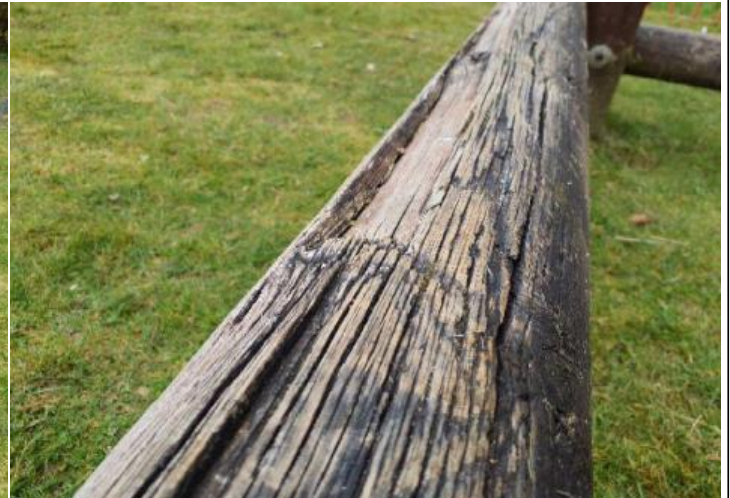
Item: Activity Equipment - Balance Beam
Manufacturer: Lappset UK Ltd

Finding: Parts of the timber are rough or splintered

Action: Remove all rough or sharp edges

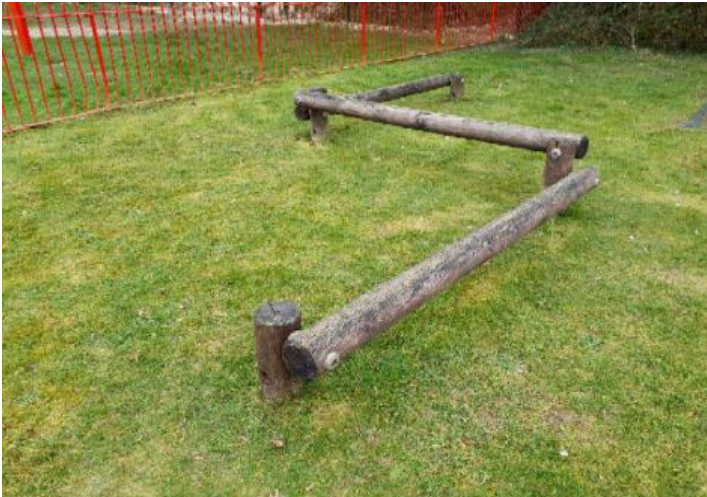
Item: Activity Equipment - Balance Beam
Manufacturer: Lappset UK Ltd

Finding: There is some evidence of rot in the timber

Action: Monitor for any further deterioration and replace as required

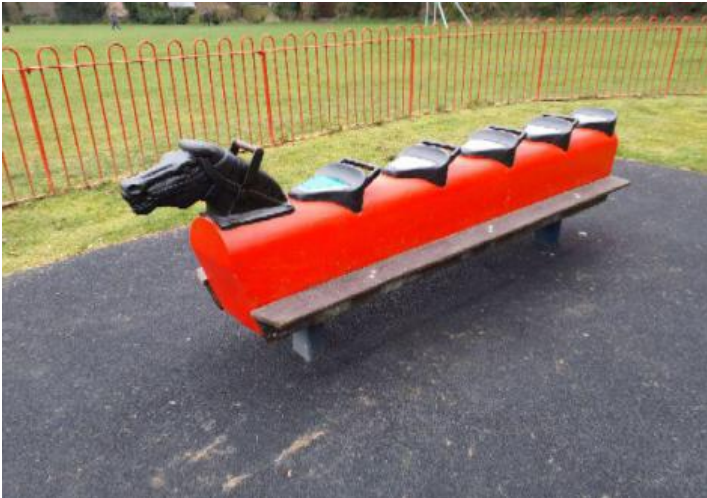
Item: Rocking Equipment - Rocking Horse
Manufacturer: Wicksteed Playgrounds

Finding: There is no gaiter protection for accessible moving parts (possible shear trap) as recommended in BS EN 1176 Part 1; 4.2.6 Moving Parts

Action: Monitor - No remedial work recommended

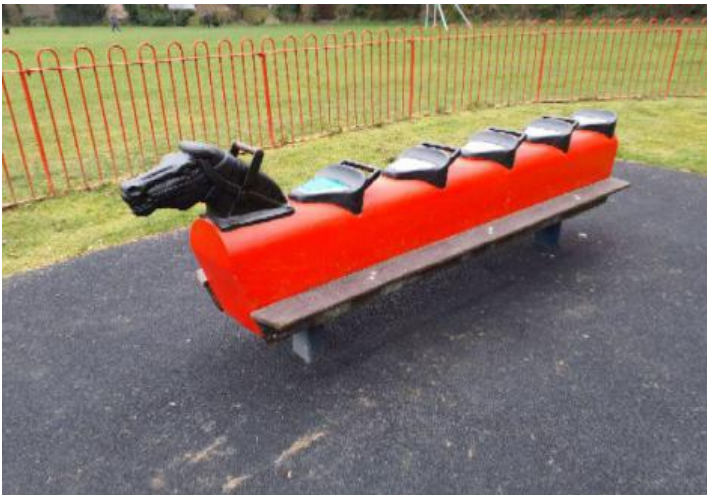
Item: Rocking Equipment - Rocking Horse
Manufacturer: Wicksteed Playgrounds

Finding: There is some evidence of rot in the timber

Action: Monitor for any further deterioration and replace as required

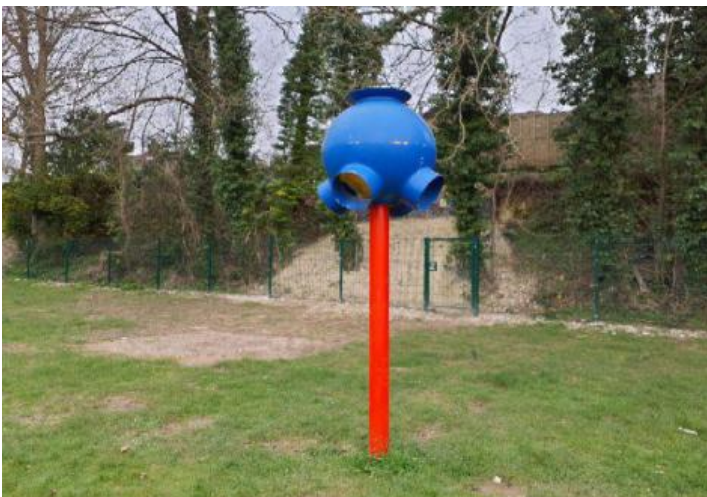
Item: Other - Ball Shoot
Manufacturer: Wicksteed Playgrounds

Finding: The surface has eroded and the foundations are exposed

Action: Reinststate surrounding surfaces to cover the foundations

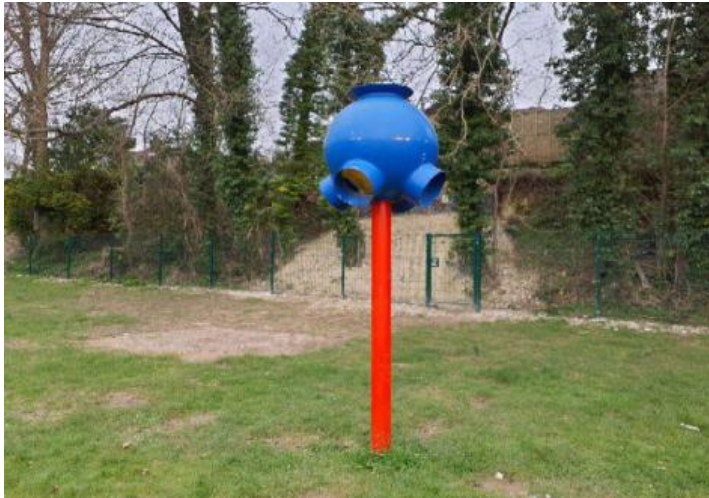
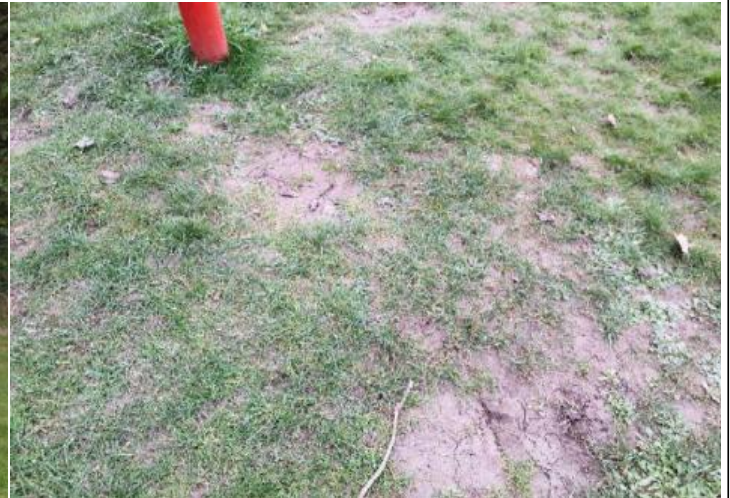
Item: Other - Ball Shoot
Manufacturer: Wicksteed Playgrounds

Finding: The area around the item has eroded and may become slippery

Action: Reinstate eroded area

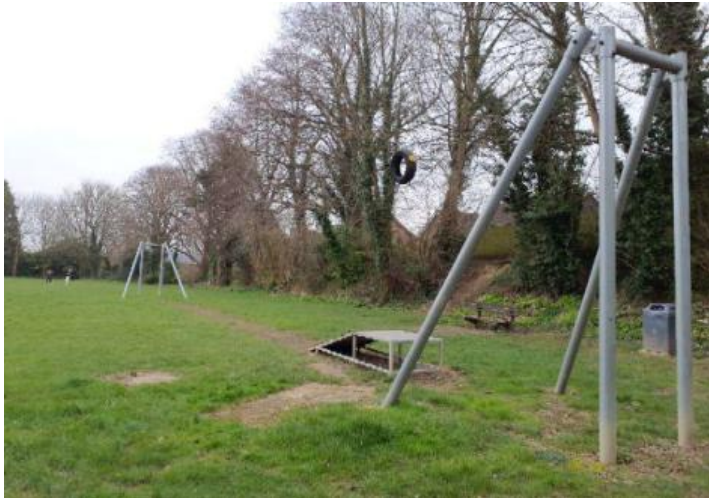
Item: Other - Cable Runway
Manufacturer: Wicksteed Playgrounds

Finding: We have completed a visual inspection of the suspension links, cable and fixing points from ground level, however it is not possible to fully inspect these areas without either hiring equipment to gain access or removing the cable and suspension and inspecting at ground level. We recommend that the main cable and fixing security is thoroughly inspected at least in accordance with the manufacturers recommendations to check for wear, damage, security or internal rusting; this will help to ensure the continued safe use of the equipment

Action: Inspect in accordance with the manufacturers recommendations

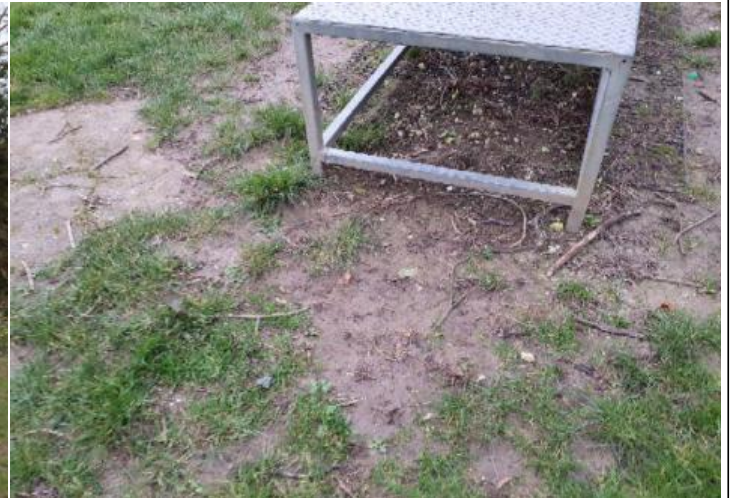
Item: Other - Cable Runway
Manufacturer: Wicksteed Playgrounds

Finding: The area around the item has eroded and may become slippery

Action: Reinststate eroded area

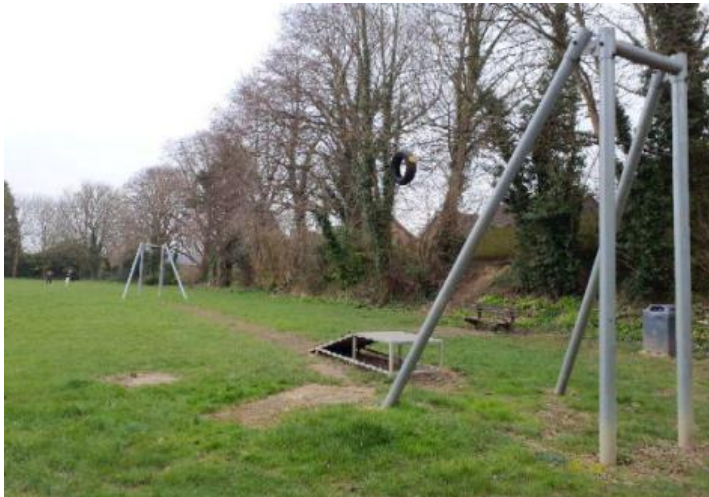
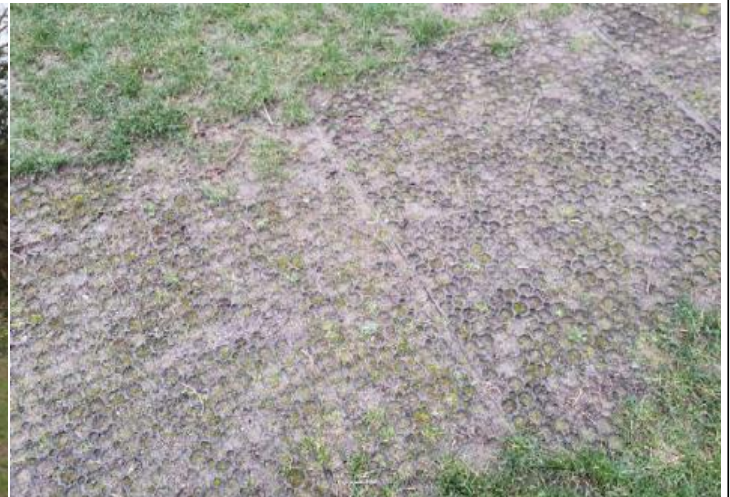
Item: Other - Cable Runway
Manufacturer: Wicksteed Playgrounds

Finding: There are gaps opening between the grass mat tiles

Action: Provide additional ties or secure / reinststate surface

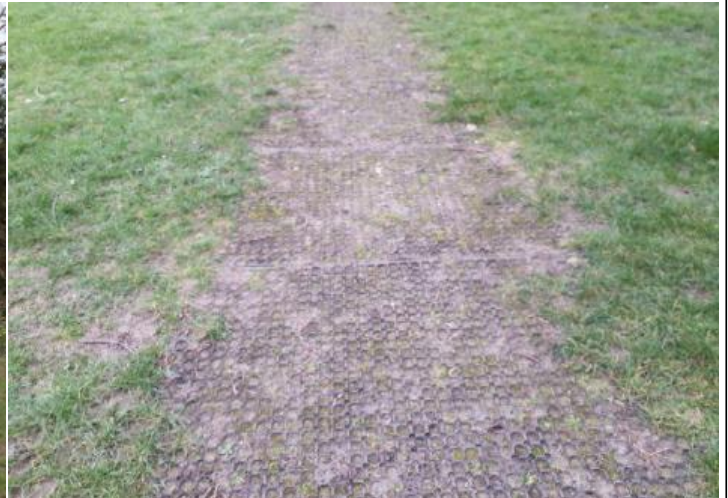
Item: Other - Cable Runway
Manufacturer: Wicksteed Playgrounds

Finding: The grass mats are silted up and the soil is compacted; this may have an effect on the impact absorbing properties of the surface. Consideration should be given to HIC testing the surface to verify impact attenuating properties (<https://playinspections.co.uk/inspection-services/safety-surface-testing/>)

Action: Contact our office for a quotation for this service

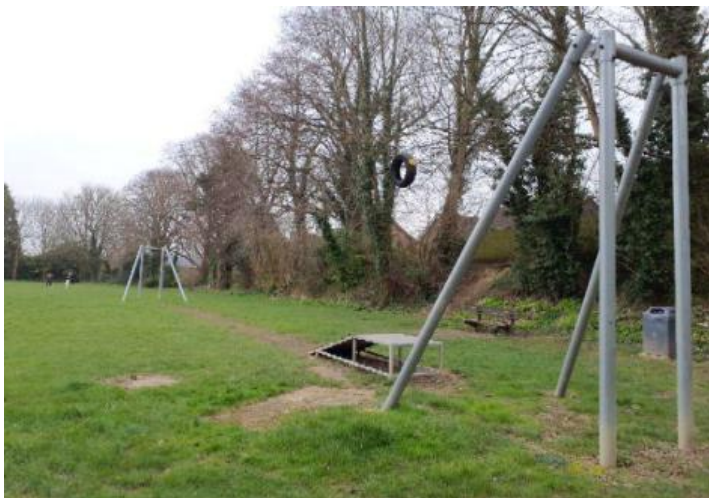
Item: Other - Cable Runway
Manufacturer: Wicksteed Playgrounds

Finding: The seat connection cannot be inspected without dismantling the seat

Action: Dismantle the seat to inspect the seat connection for wear

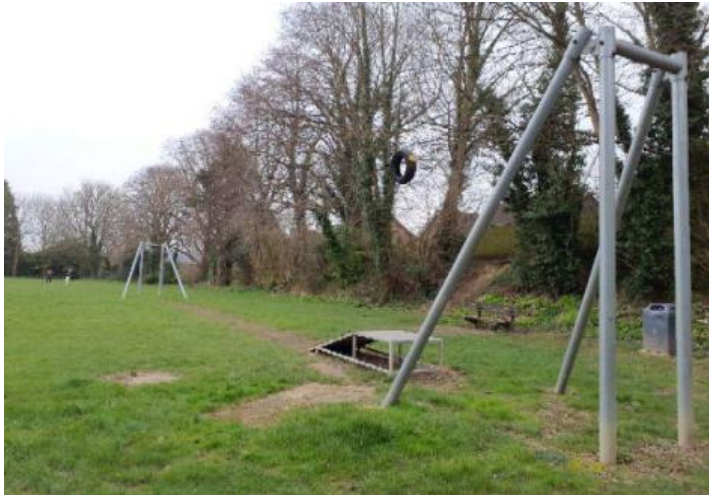
Item: Other - Cable Runway
Manufacturer: Wicksteed Playgrounds

Finding: There is some notable evidence of chain wear

Action: Monitor for any further deterioration and replace when 40% worn

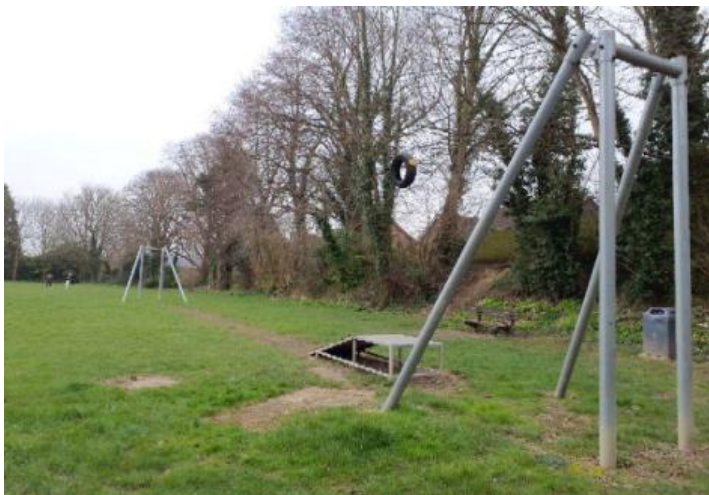
Item: Other - Cable Runway
Manufacturer: Wicksteed Playgrounds

Finding: The connecting lugs are showing signs of wear

Action: Monitor for any further deterioration and repair as required

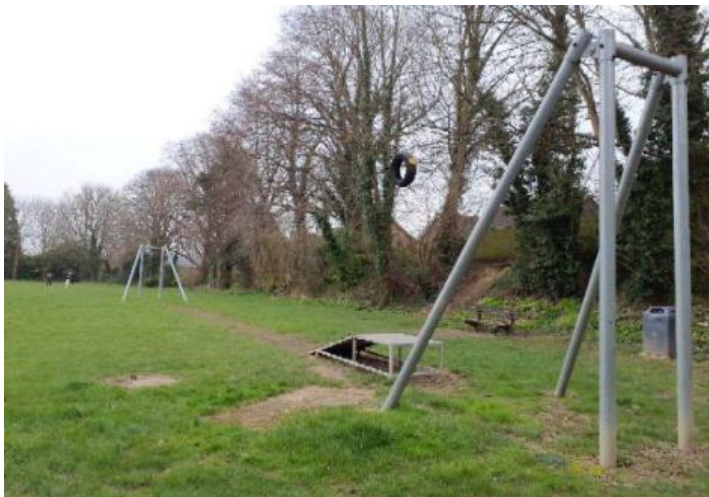
Item: Other - Cable Runway
Manufacturer: Wicksteed Playgrounds

Finding: The chain openings are in excess of the 8.6mm as recommended by BS EN 1176
Action: Monitor - No remedial work recommended

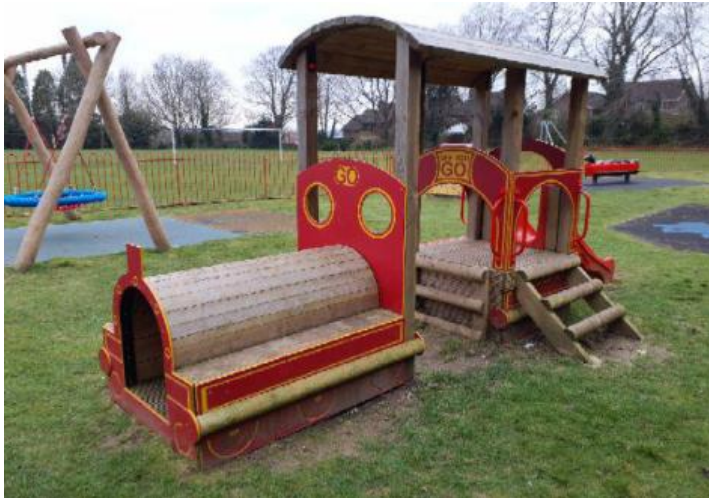
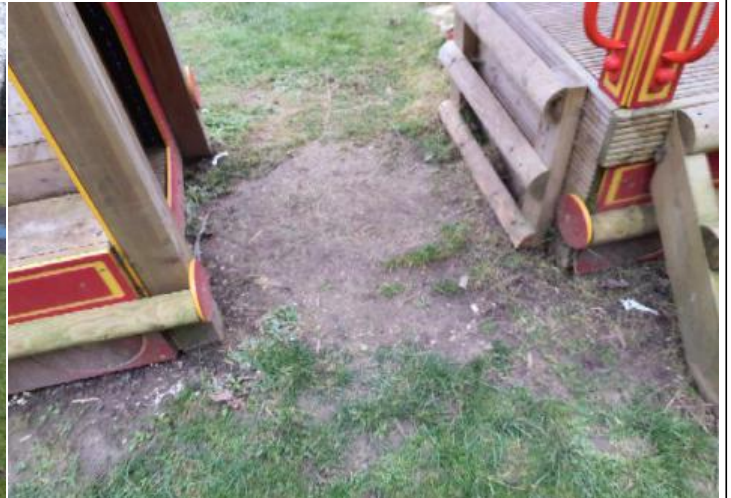
Item: Activity Equipment - Train
Manufacturer: Not Identified

Finding: The area around the item has eroded and may become slippery

Action: Reinststate eroded area

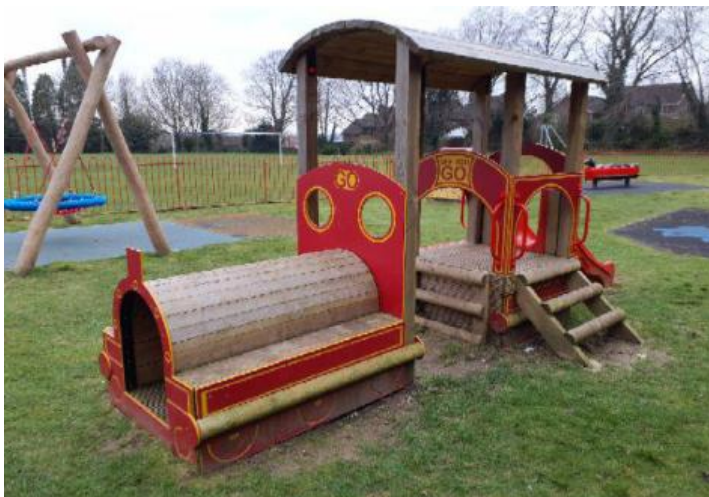
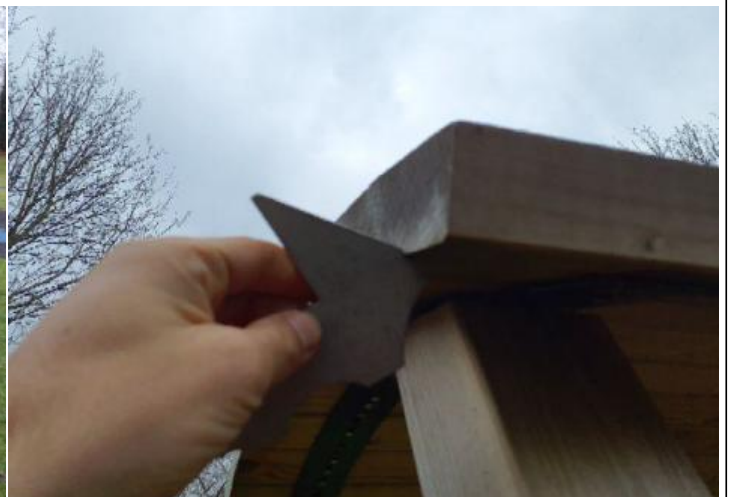
Item: Activity Equipment - Train
Manufacturer: Not Identified

Finding: The item has exposed edges and corners that are sharp, or with a radius of less than 3mm, and does not meet the requirements of BS EN 1176 Part 1 - 4.2.5

Action: Provide a 3mm radius to all exposed edges and corners, or remove sharp edge

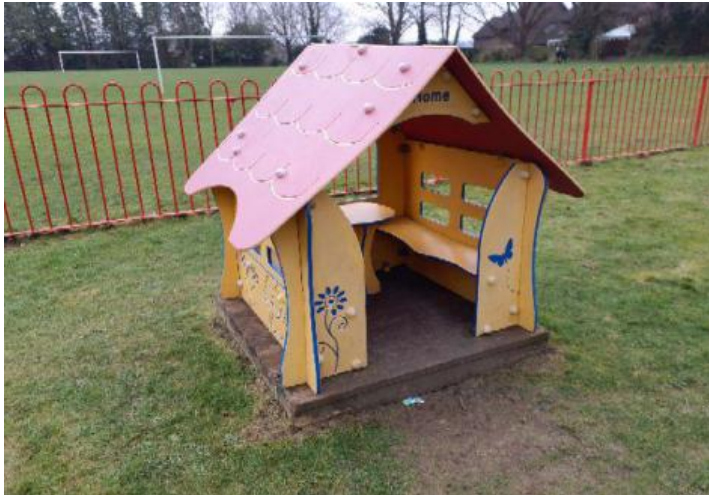
Item: Activity Equipment - Playhouse
Manufacturer: Not Identified

Finding: The item fails to meet the requirements of BS EN 1176 Part 1 4.2.7.2 head and neck entrapment in the barriers and/or steps
Action: Monitor - No remedial work recommended

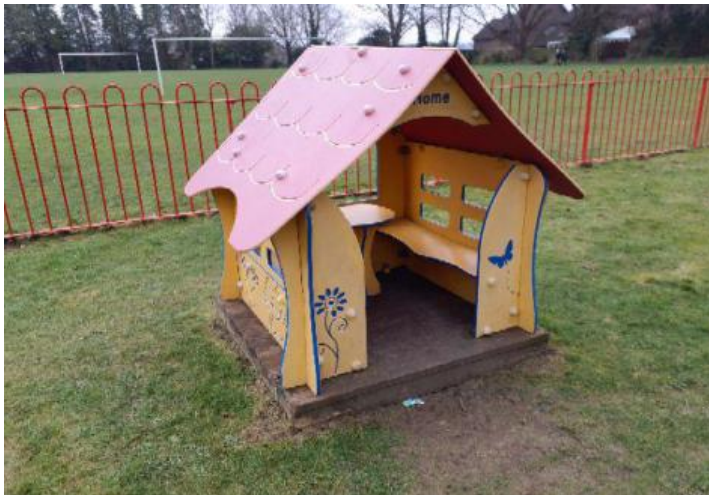
Item: Activity Equipment - Playhouse
Manufacturer: Not Identified

Finding: A number of fixing(s) have worked loose
Action: Secure all loose fixings

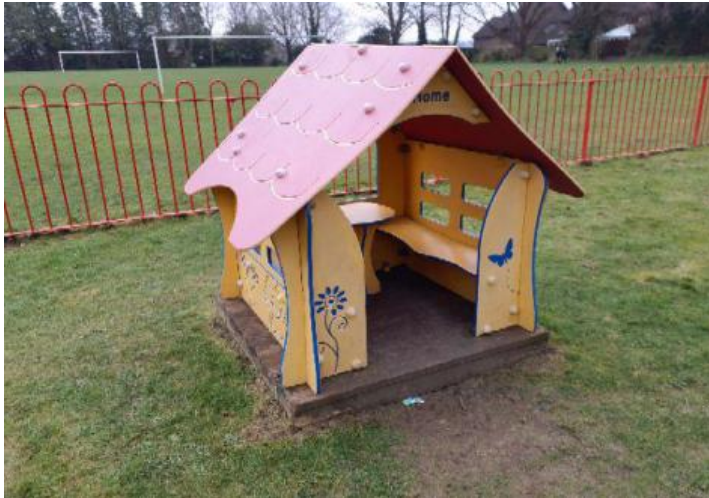
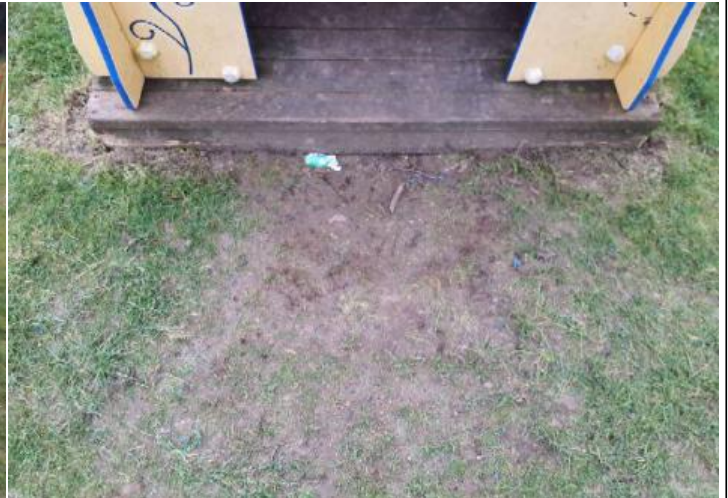
Item: Activity Equipment - Playhouse
Manufacturer: Not Identified

Finding: The area around the item has eroded and may become slippery

Action: Reinststate eroded area

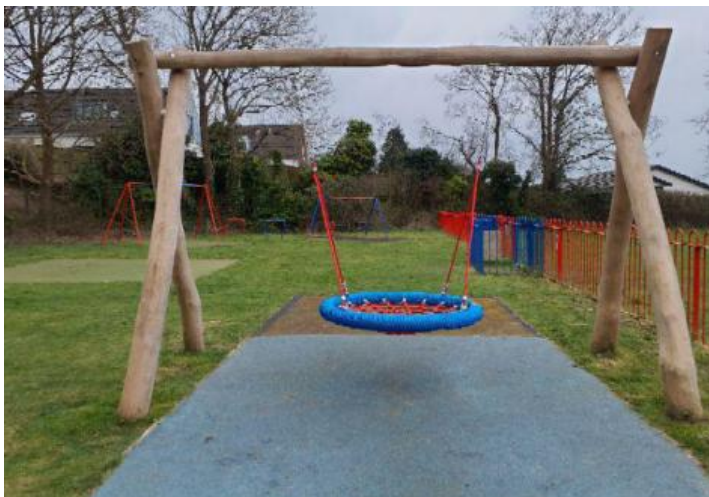
Item: Swings - Basket Swing - Type 1
Manufacturer: Dylan Group Ltd

Finding: The connecting links are in excess of 8.6mm and less than 12mm and fail the requirements of BS EN 1176 Part 1; clause 4.2.13, Chains

Action: Monitor - No remedial work recommended
